ACT
Government

Transport Canberra and
City Services

FREEDOM OF INFORMATION COVERSHEET

FOI reference: 22-046

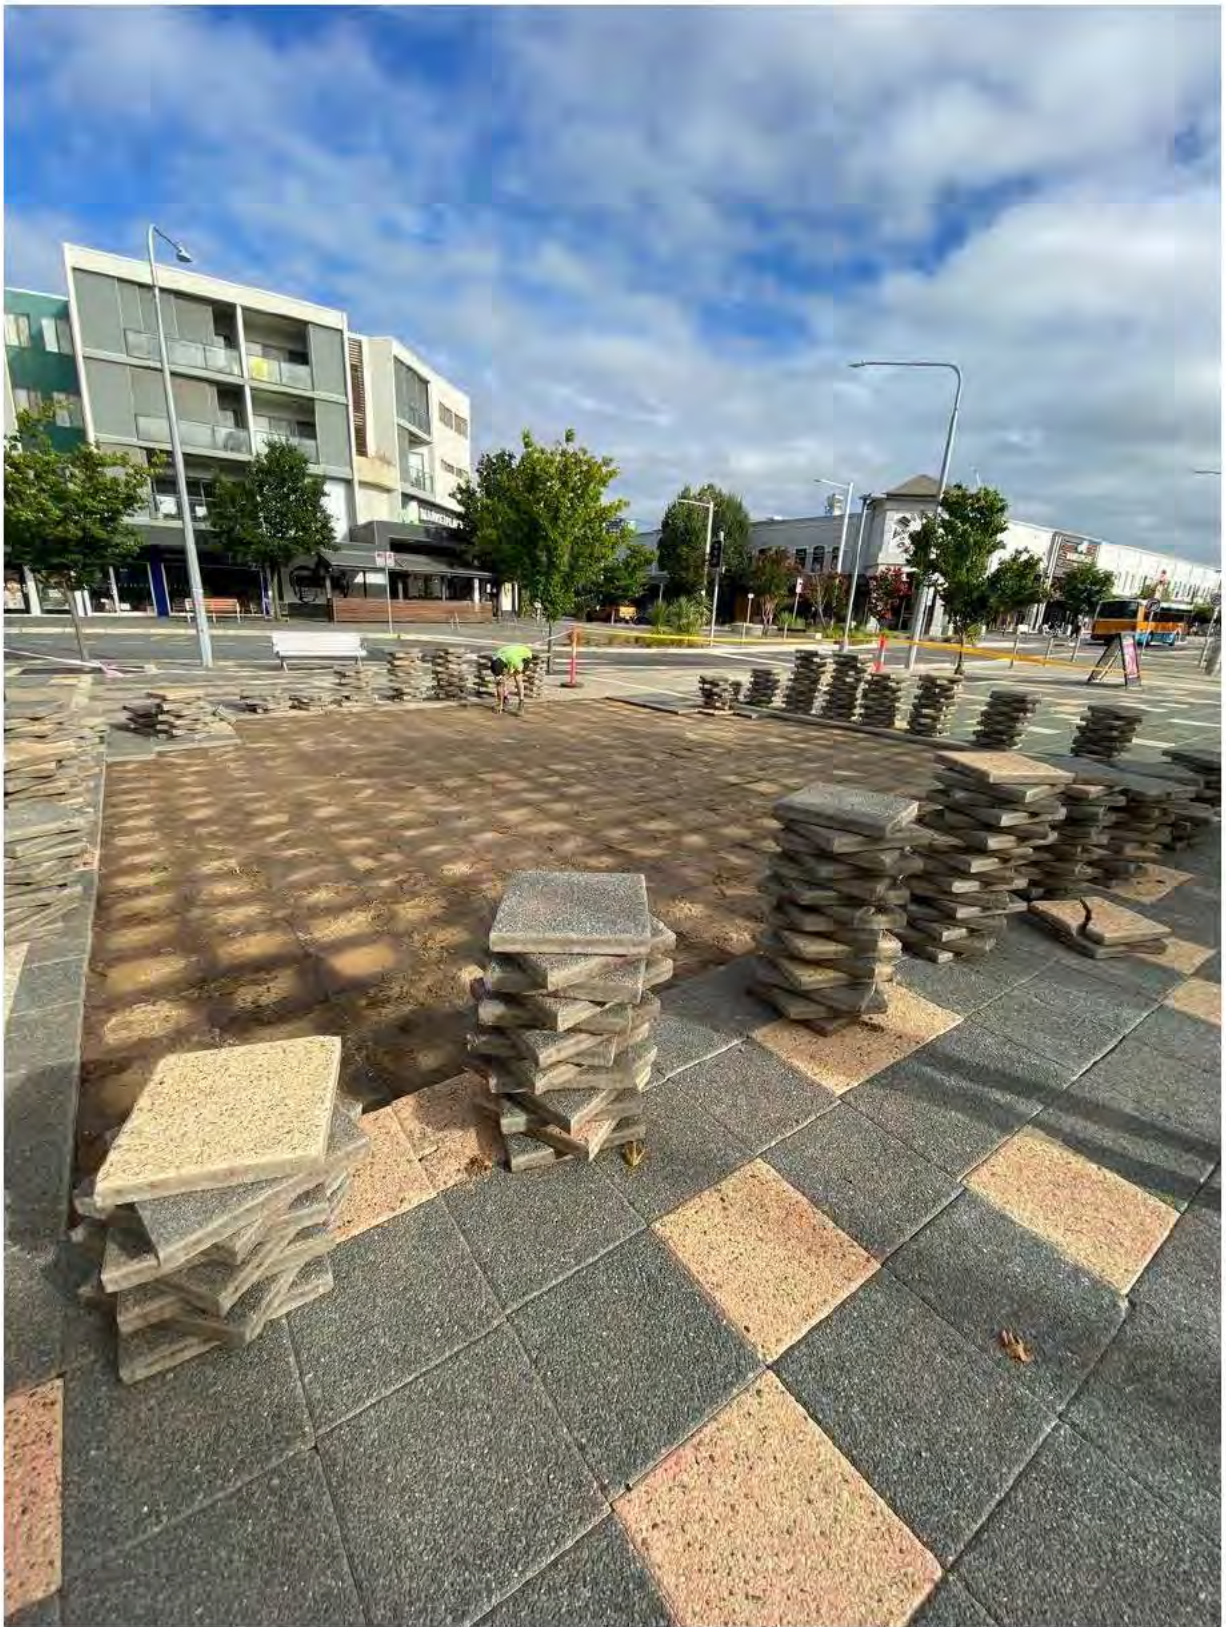
70m2 seen in this image.

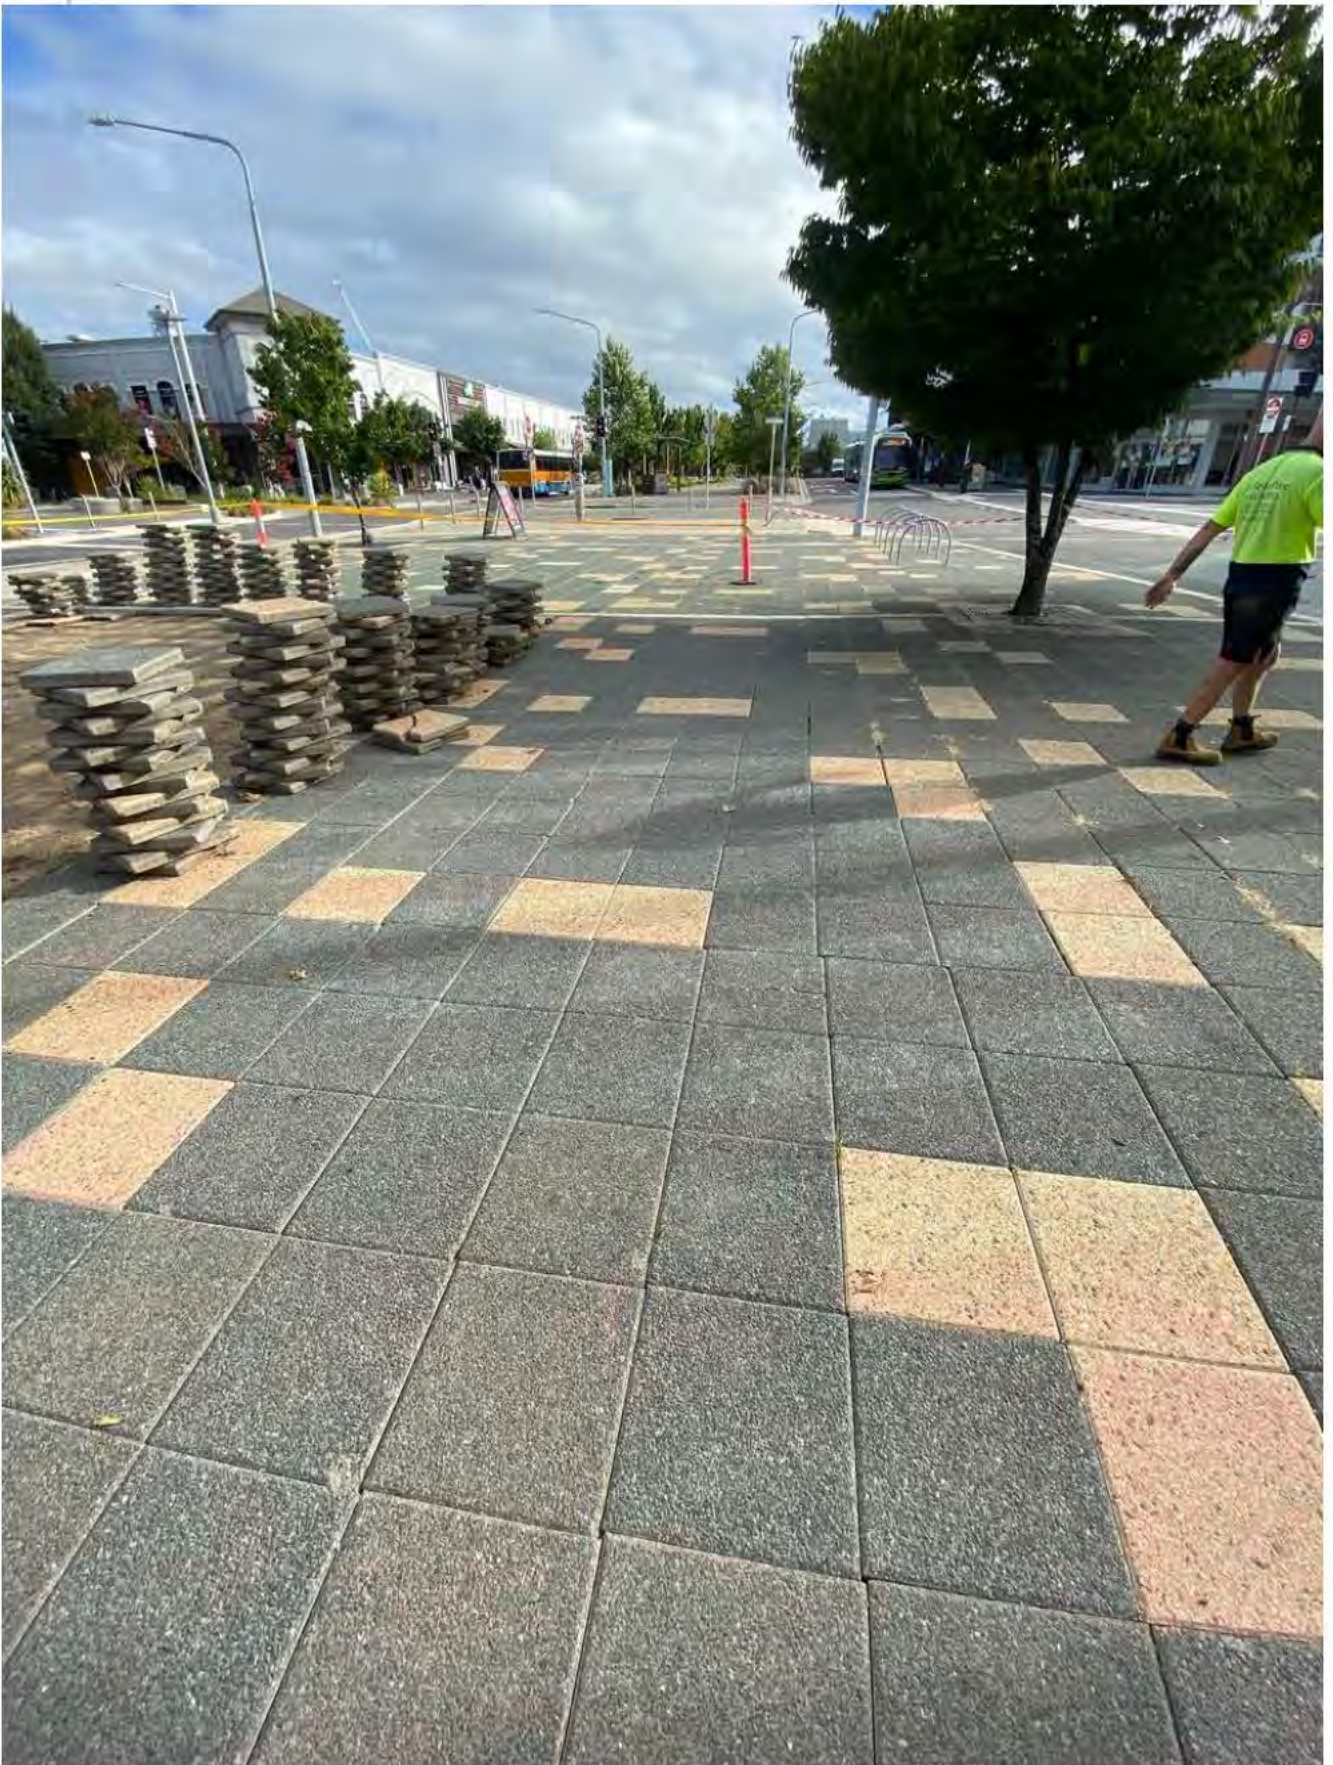
15m2
