Lake Ginninderra Community Path Feasibility Study Report

Transport Canberra and
City Services

Tait Network

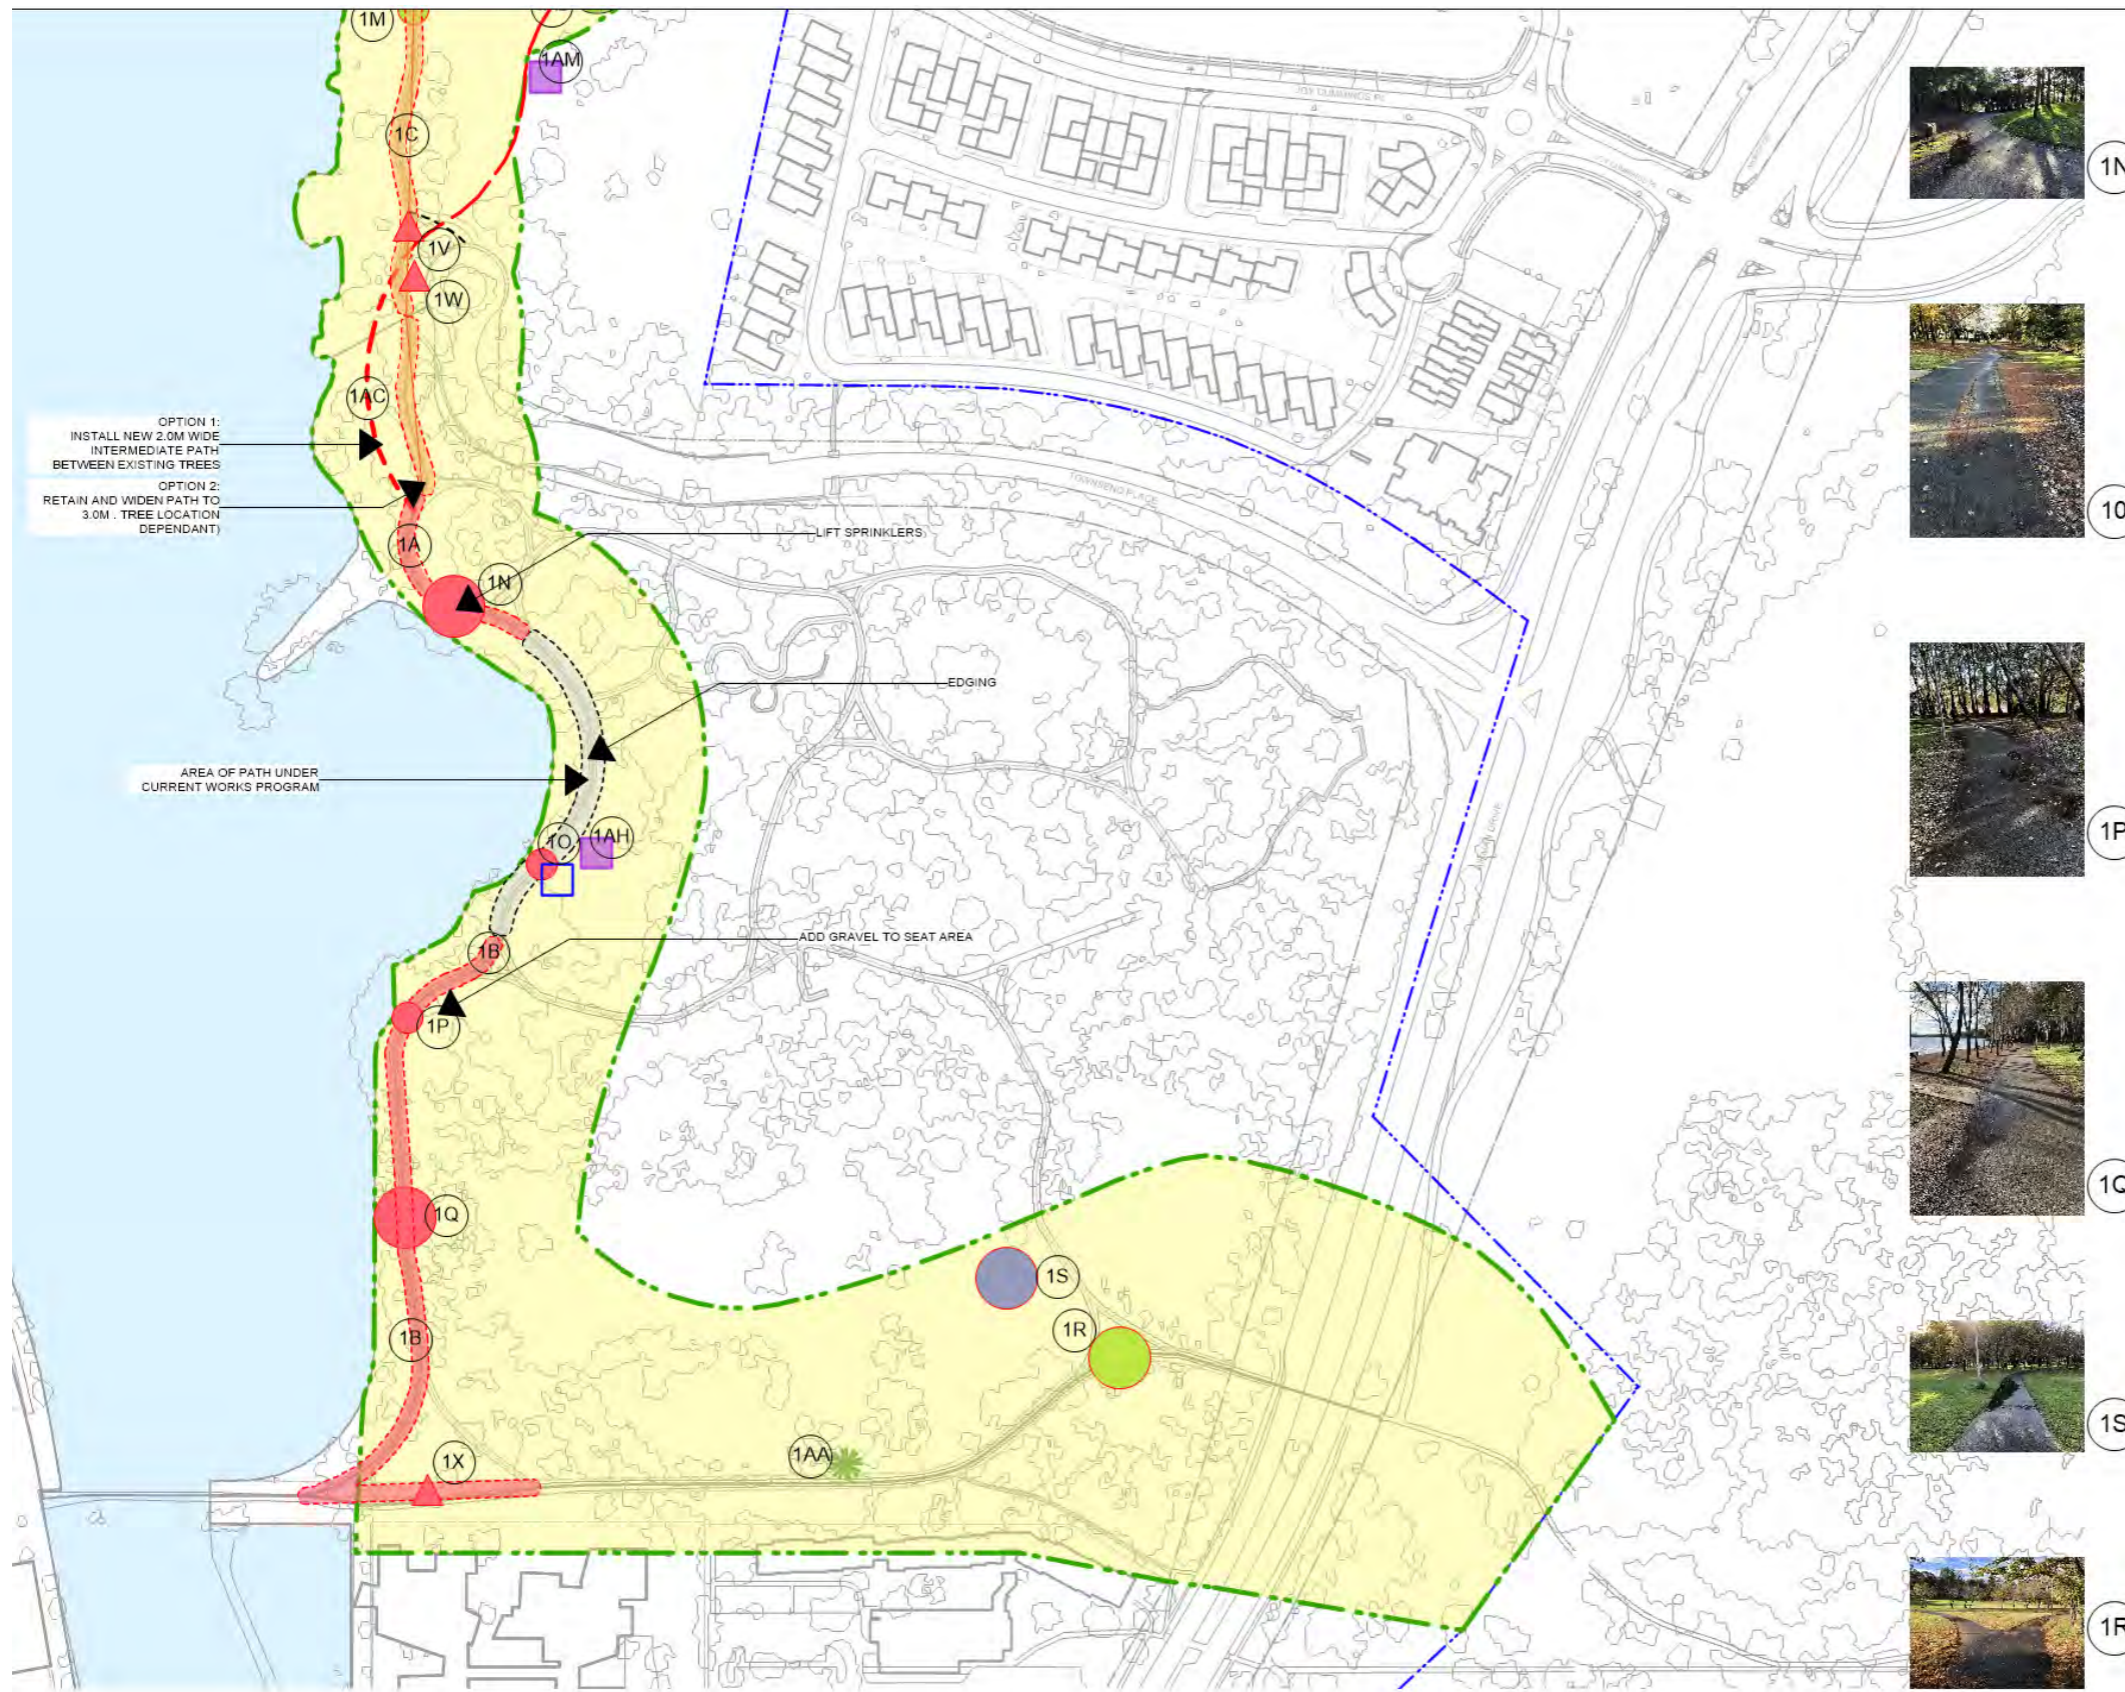
A section of path within the southern section of Corridor 1 is in the current works program for removal and replacement. It is proposed to continue this replacement of path to either side, (asset numbers 1A and 1B) resulting in a new length of path which also resolves a number of existing path safety and defect issues.

Short term options have been considered, with the recommendation of providing a connection to the on road cycle lane considered the most viable short term option.

The low level bridge proposal has been provided at this Feasibility Study stage of the project for consideration.

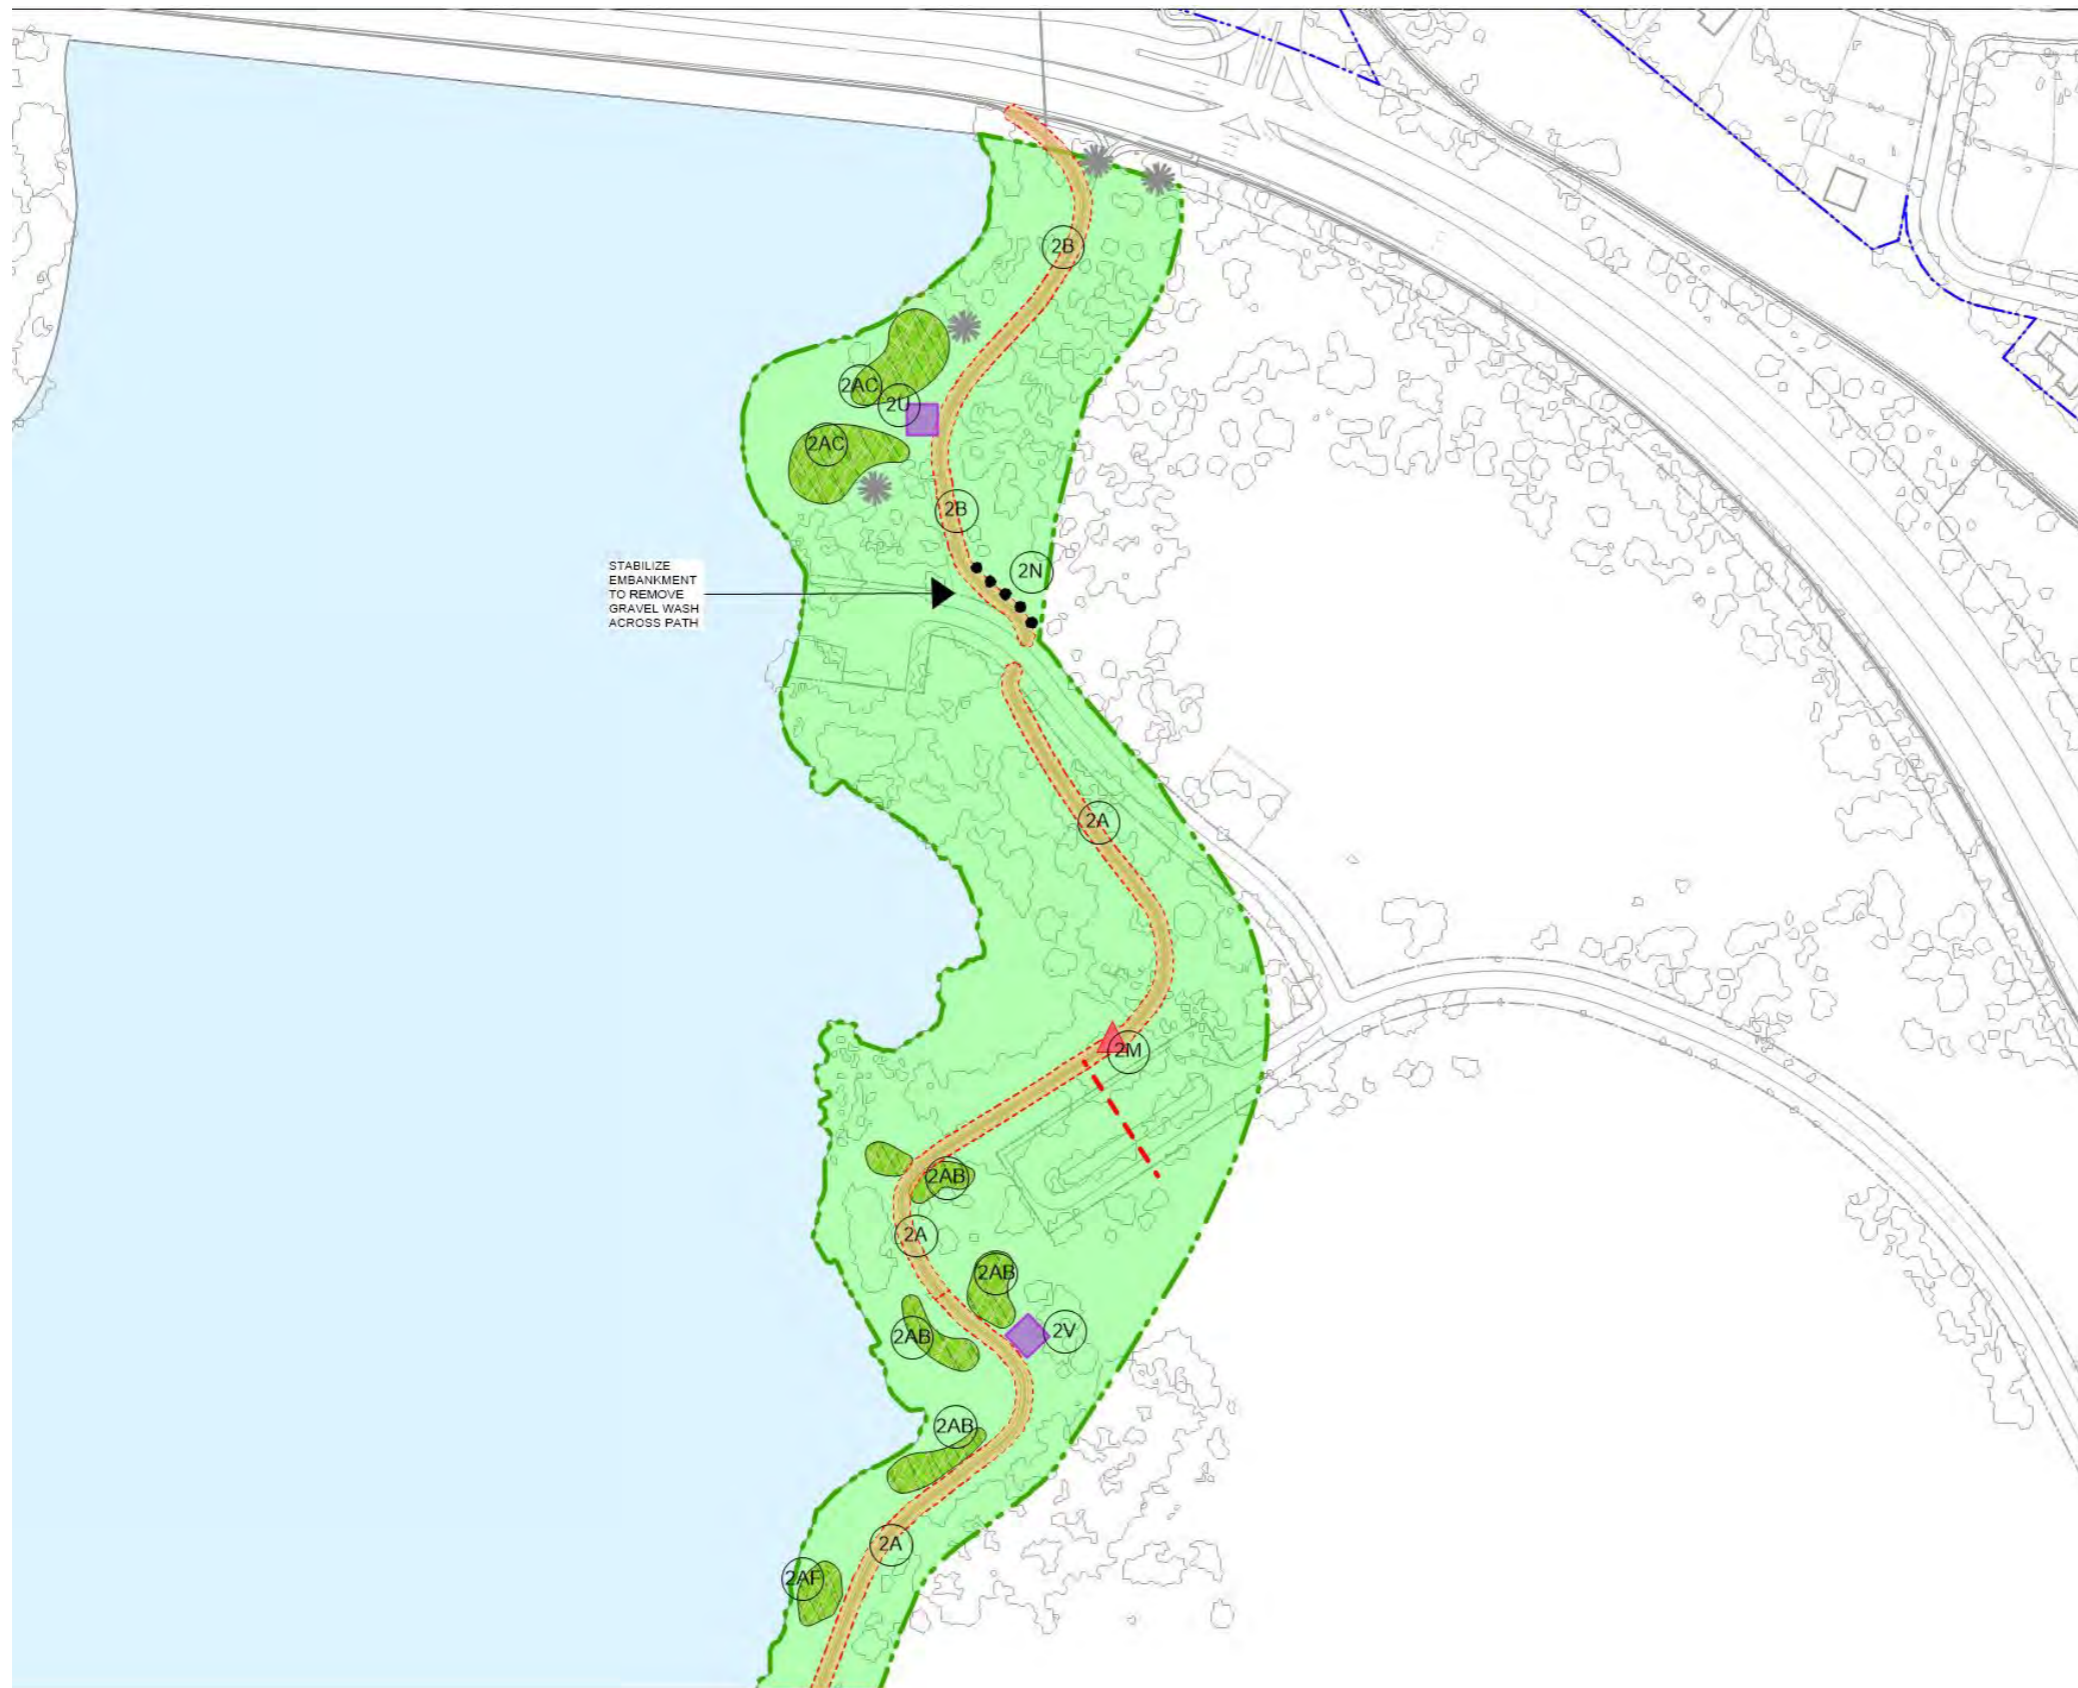
The overarching proposal in this corridor is the widening of the existing path (Paths 2A, 2B and 2C) to 4m allowing for increased capacity. A number of path defects will be addressed in conjunction with the path widening.

The path area at the eastern end of the corridor adjacent to the Ginninderra Drive underpass contains the following defect issues:

- Poor drainage results in path flooding (2D) which will be resolved through path regrading and the installation of culverts and swales
- A major desire line cuts across from the main path to the connection to the bridge (2Q). This is to be formalised to become the main path route. This path connection is proposed to be lit, with one new light column centrally located, one to the southern end of the new path and an existing light to the northern end of the path being converted to a double sided luminaire.
- An area of erosion adjacent to the bridge connection path (2P) causes dirt and gravel to wash across the path. This is to be remediated through stabilisation works

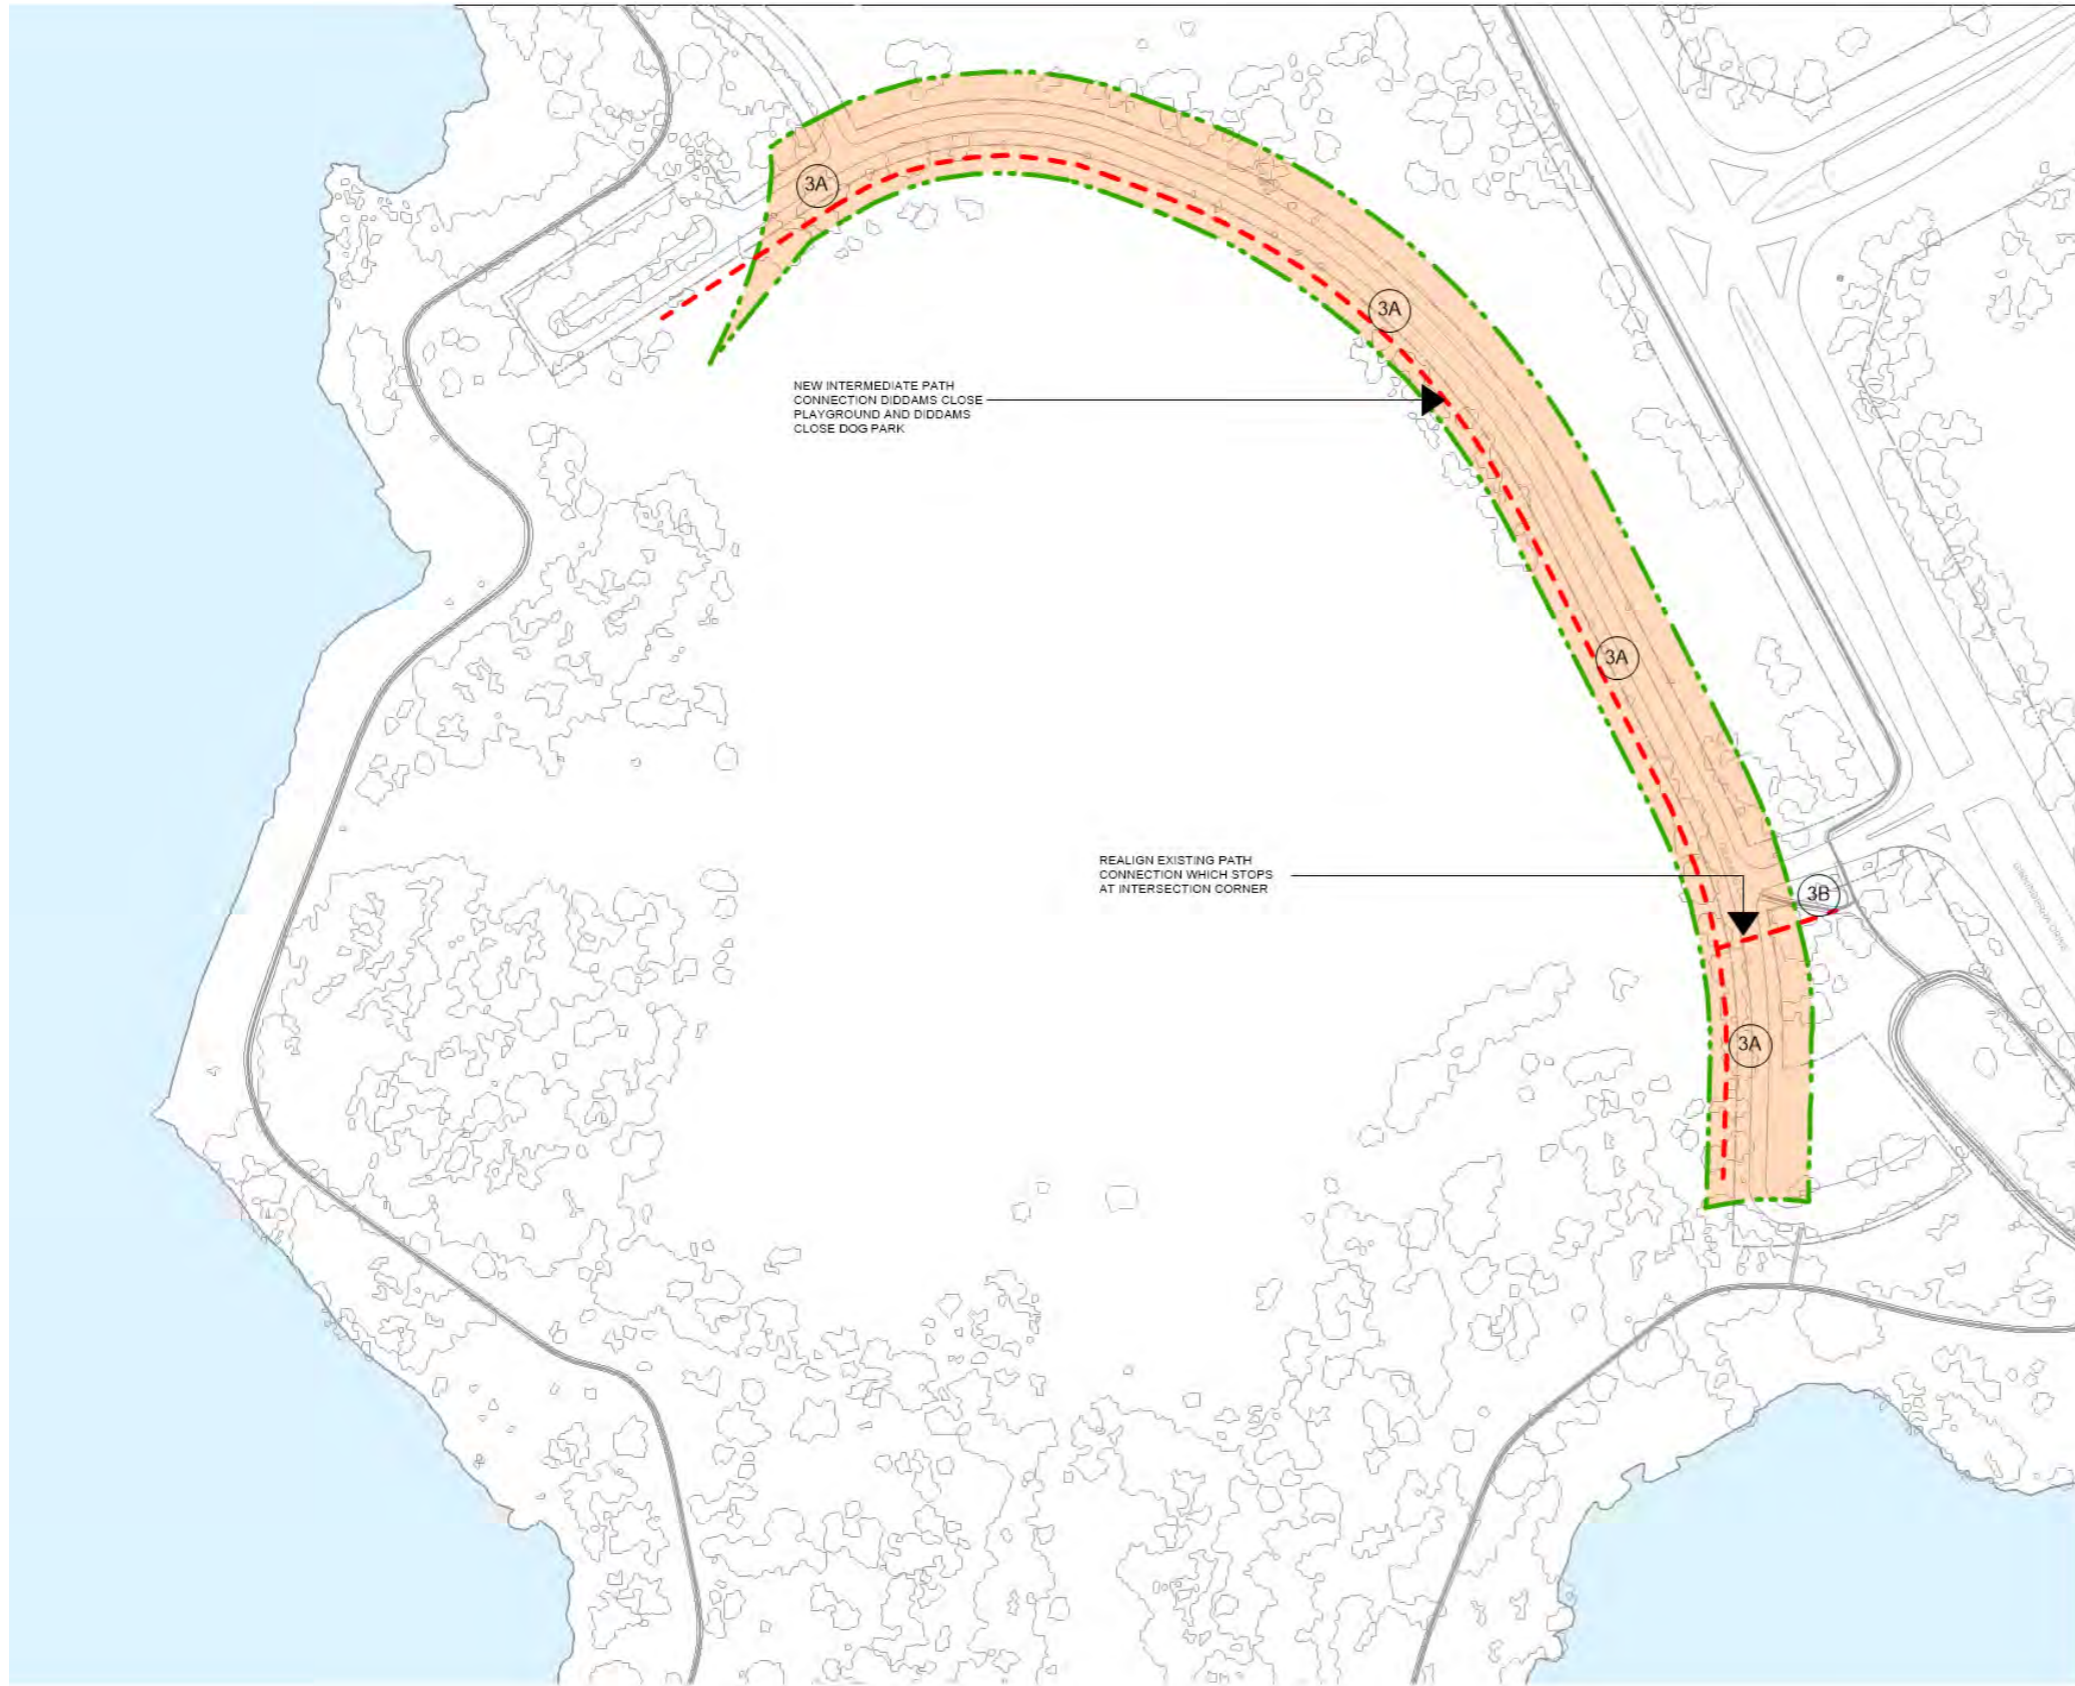
Corridor 3 extends between the parking areas to Diddams Close east and west. Strava data indicates that this is a route taken by walkers who potentially use this as a walking circuit connecting to the peninsular path. A 2m wide intermediate path (3A) is proposed to be constructed to the verge of Diddams Close, formalising this connection. The existing path connection to the corner of Diddams Close is to be re-aligned to provide a safe road crossing, connecting to the proposed intermediate path.

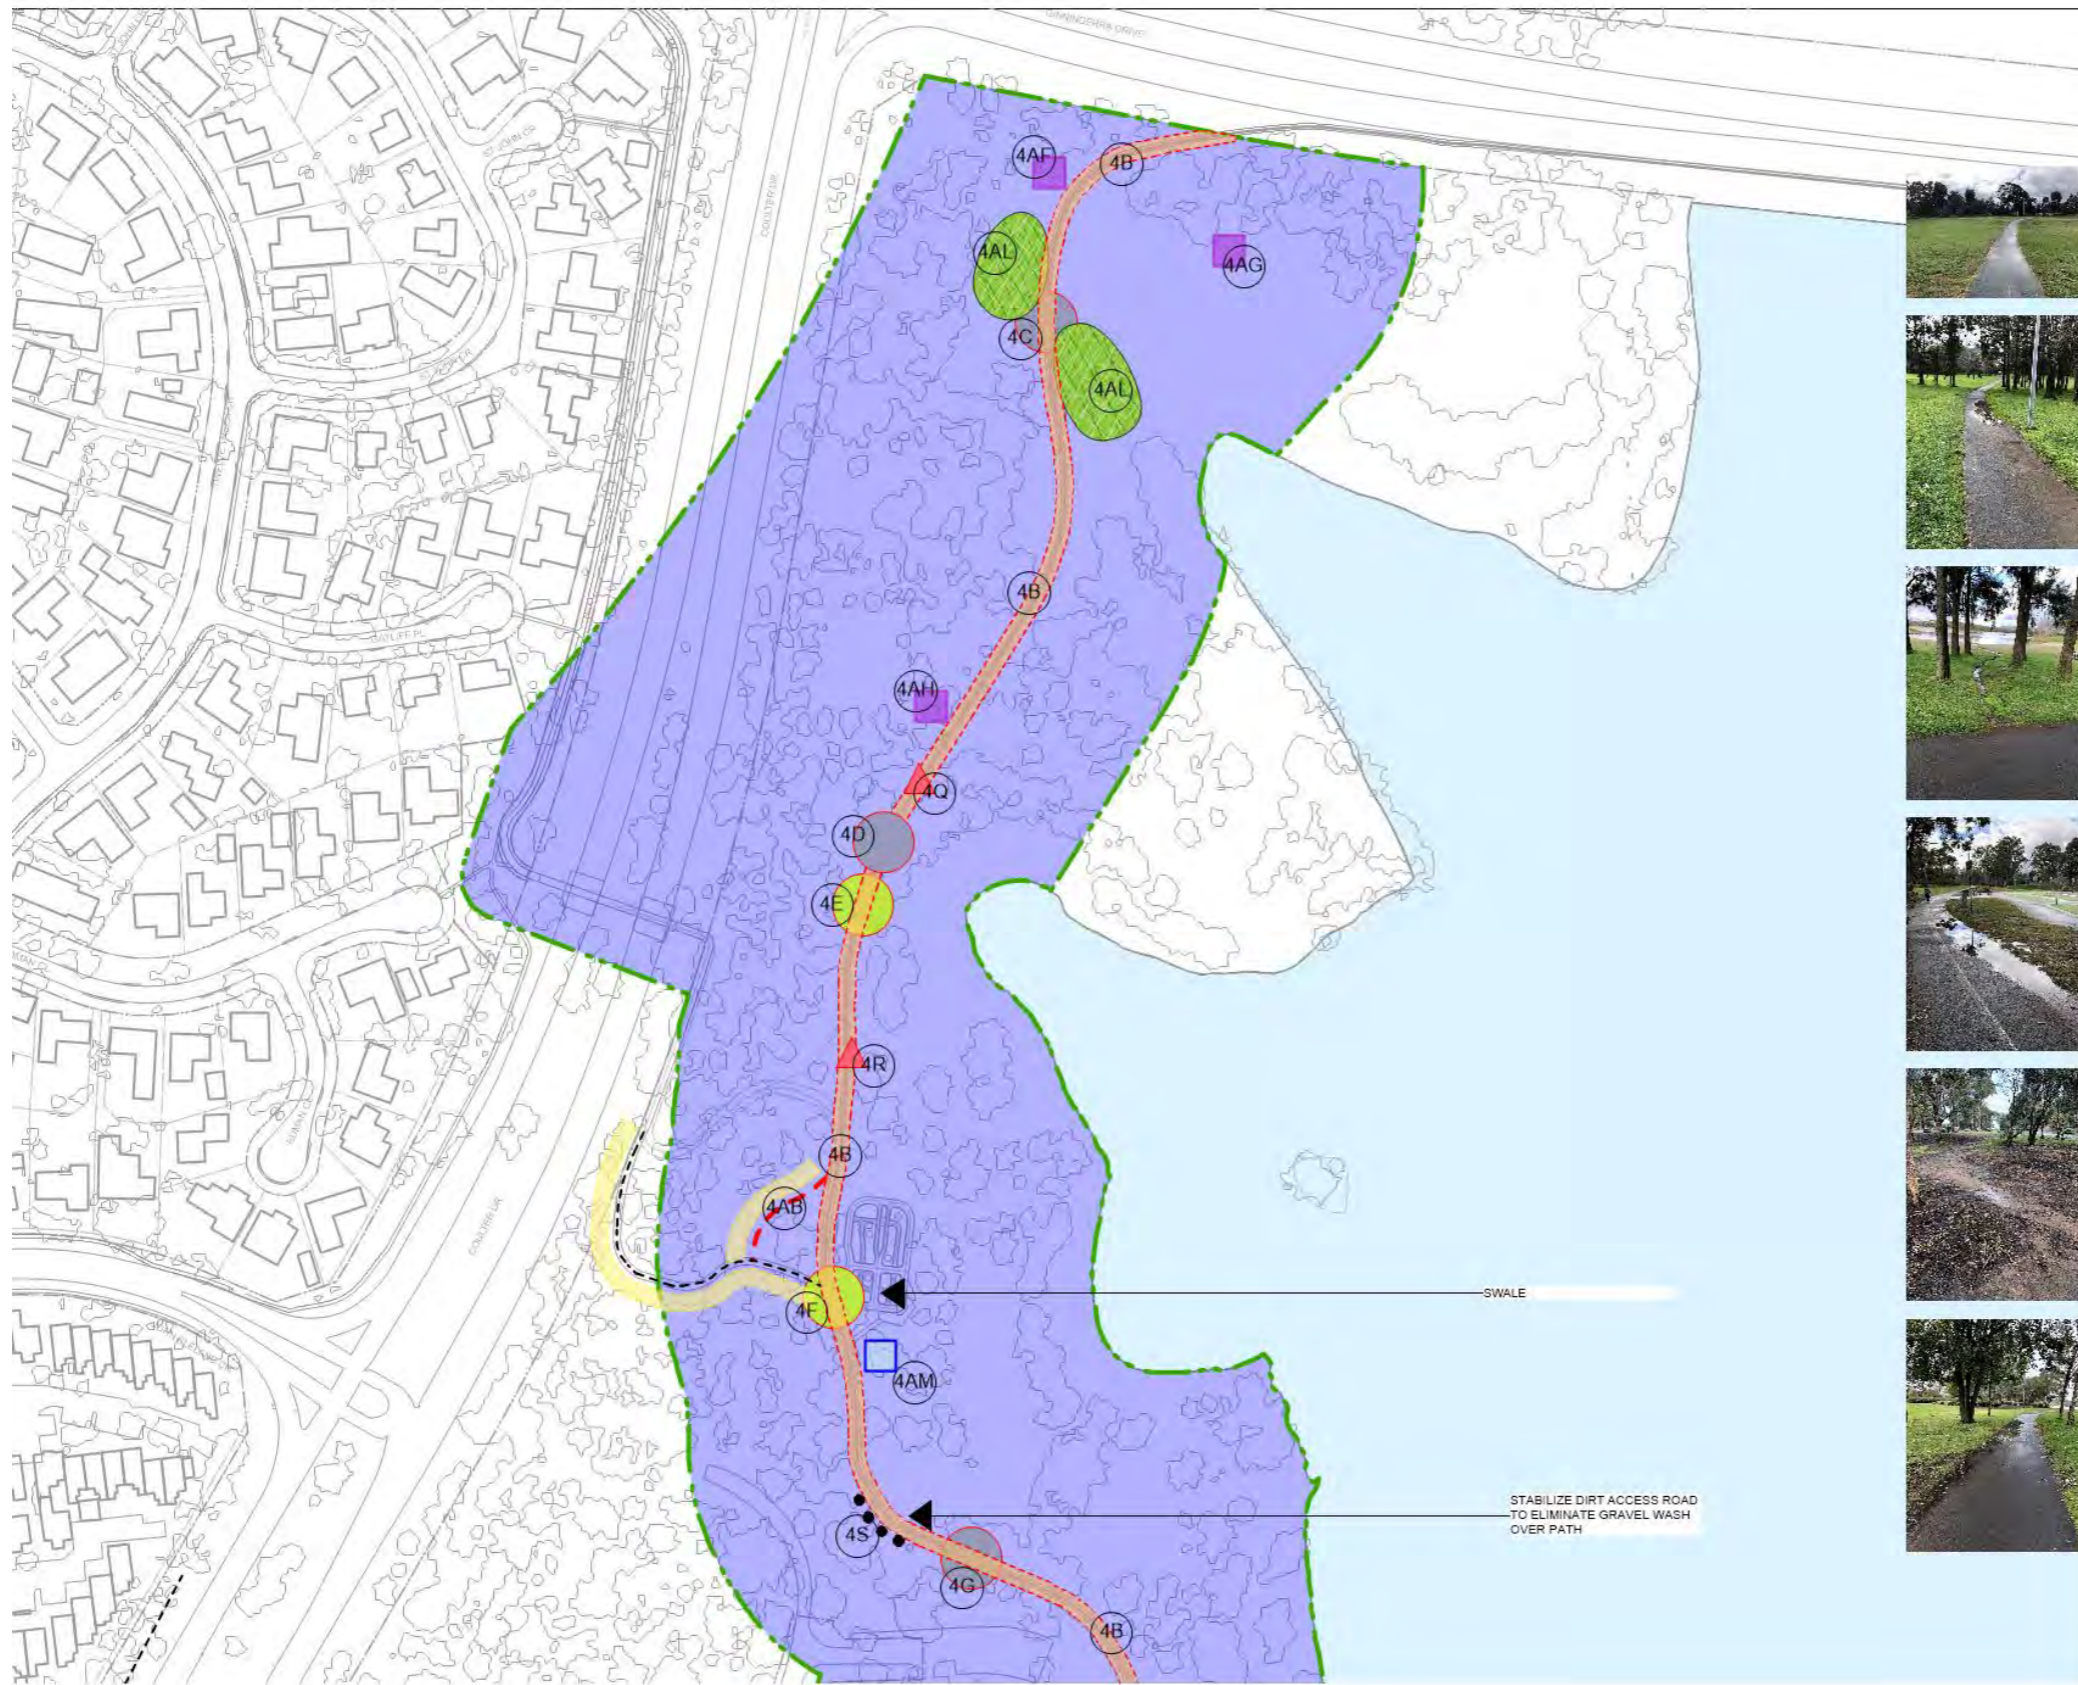
A number of path defects have been identified, to be remediated through path and adjacent surface regrading and the installation of culverts.

The site of the previous Lake Ginninderra Water Police headquarters, located to the north of Emu Inlet, is currently a vacant site. This block of land is currently under the control of the Suburban Land Agency. The SLA have indicated that there are plans to develop this site. This proposed development creates potential conflicts with this project proposal to locate a new path connection between Emu Inlet and the lake circuit path to the north of the Lake Ginninderra Sea Scouts hall. This proposed path connection is not to be included within this project scope. For future TCCS and SLA coordination to complete the foreshore path link.

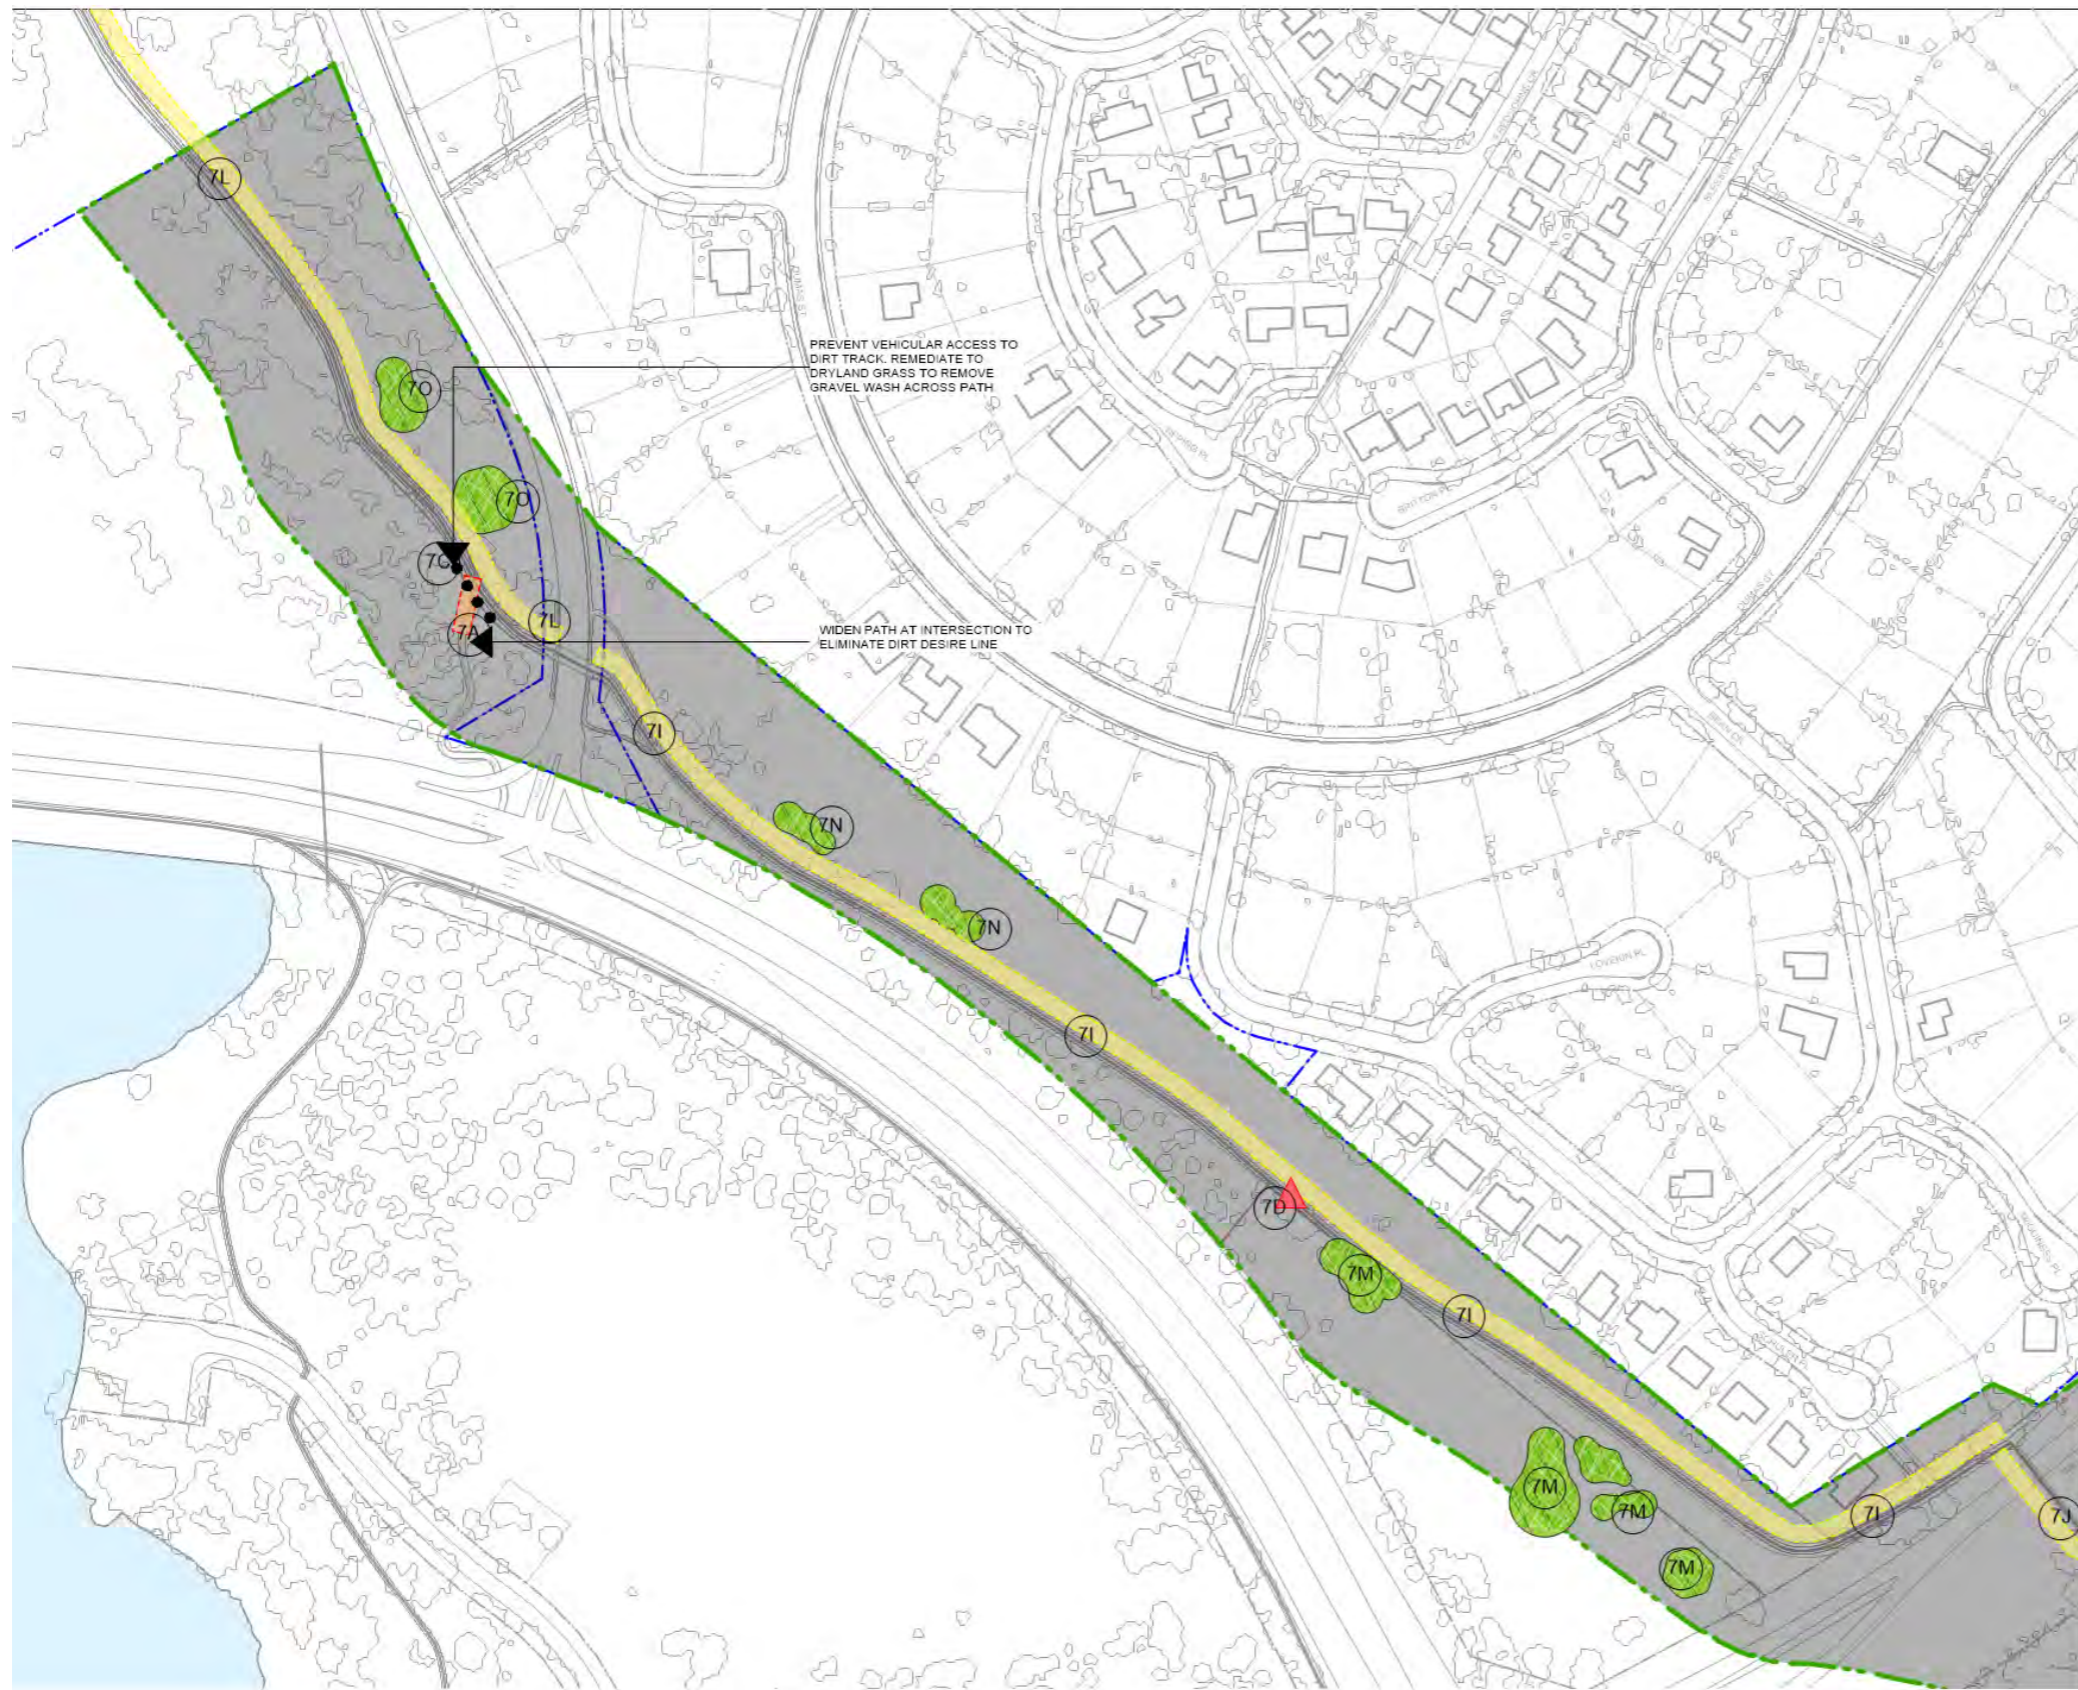
Construction works are currently underway for the duplication of Gundaroo Drive, which borders the project site at this Corridor. These duplication works include an on road cycle lane to the southern traffic lane, and new bus stop locations. These duplication works have minor impacts on the project site, with path connections proposed to link into the project path within Corridor 7 and associated path lighting. Coordination with Gundaroo Drive works is to be included within the final DR submission.
