local shopping centre upgrade program 2016-17

forward design report  
15 December 2017

campbell shops

CAMPBELL Shops  
 Local Shopping Centre Upgrade Program 2016-2017  
 Feasibility Design Studies

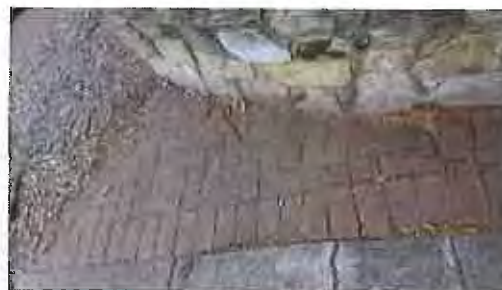
*Cracked and tired pavements*

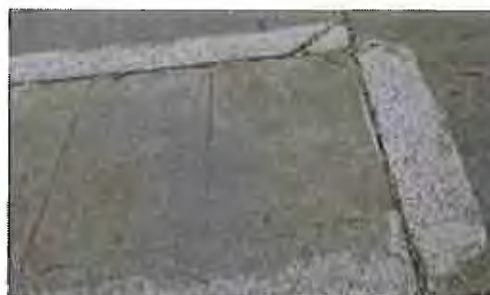
*Cracked and uneven pavements*

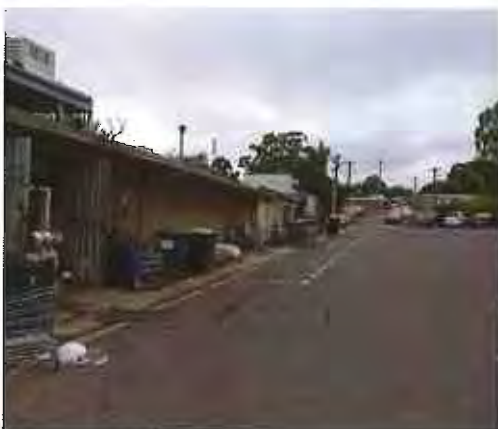
*Back of house cluttered with cars and waste*

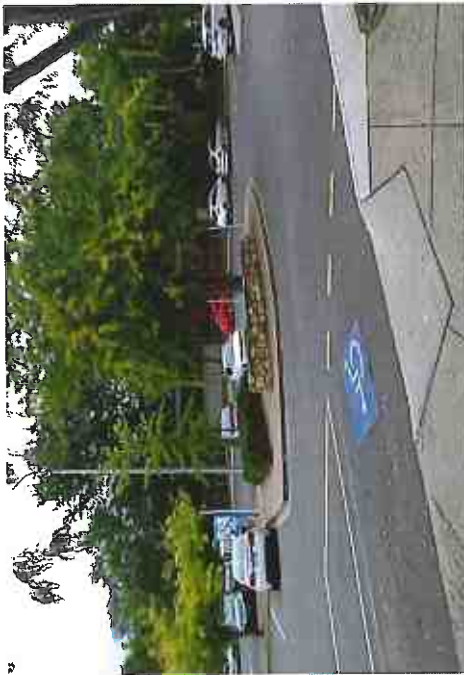
The shared space between the two disabled spaces marked will need a bollard installed to prevent cars from parking in it. It is noted the space on the south side of this shared space is not long enough. The space will need to be reshaped to allow the correct length as per AS2890.6.

1 Disable carparks - non-compliant

- Construct compliant access from Chauvel Street via the rear service area to shop front
- Replace two disabled parking spaces in a new location with new complying kerb ramp.

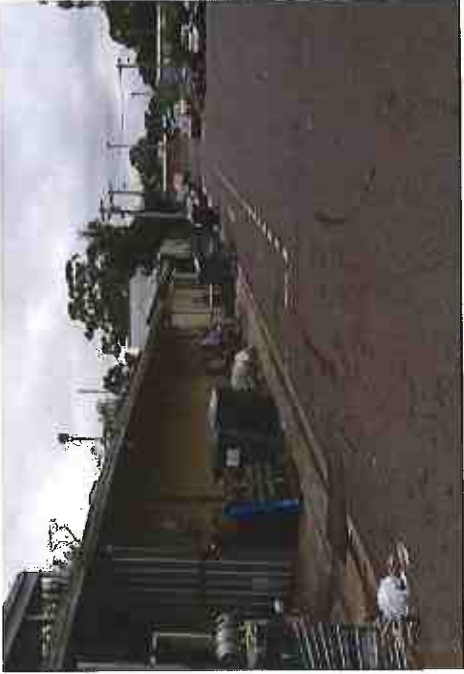
2 No disable carpark in rear/employee carpark

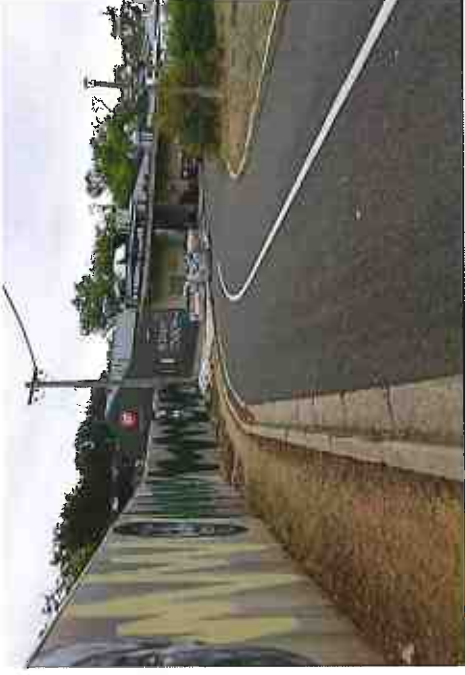
3 No pedestrian path from rear of shops

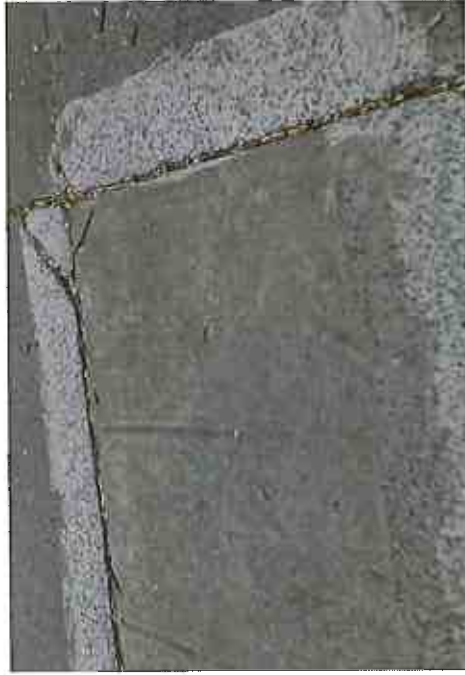
Cracked paving

- Increase width of footpath on the northside of the carpark improving connectivity to from Blamey Street into the shops
- Remove trip hazards and uneven surfaces (by selective grinding / replacement of panels) in paths which are not fully replaced

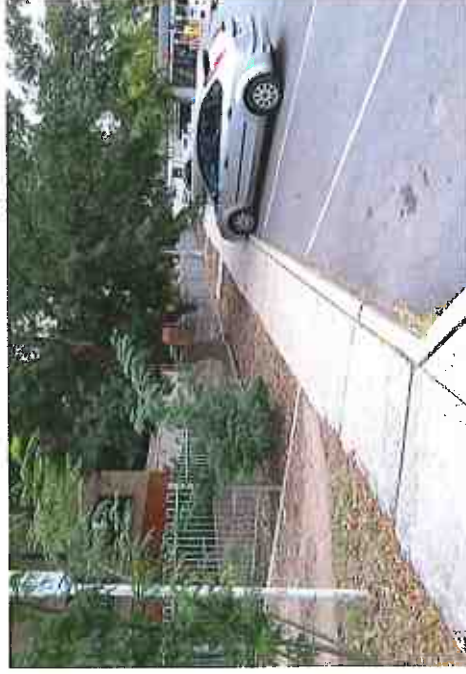
- The recommended minimum width for these paths adjacent car parks is 1600mm to allow for adequate clearance from vehicle overhang and an adjacent hazard such as a road.
- The footpath on the South Eastern corner (next to the Scout Hall) does not comply as the width is 1170mm and cross falls are in excess of 1 in 40 (2.5%).

Non compliant path width with car overhang

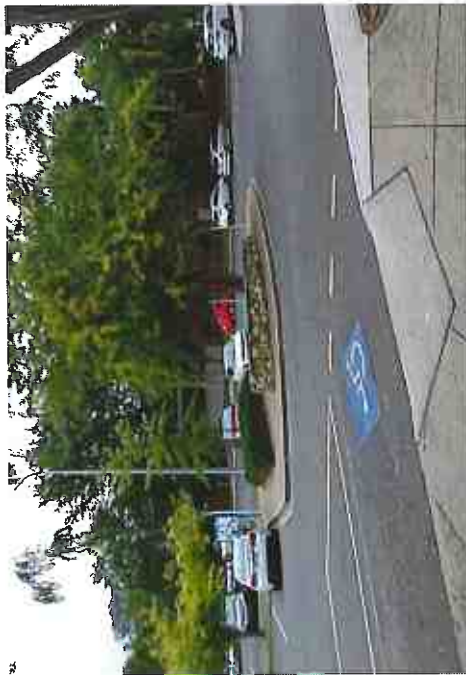
1 Disable carparks - non-compliant

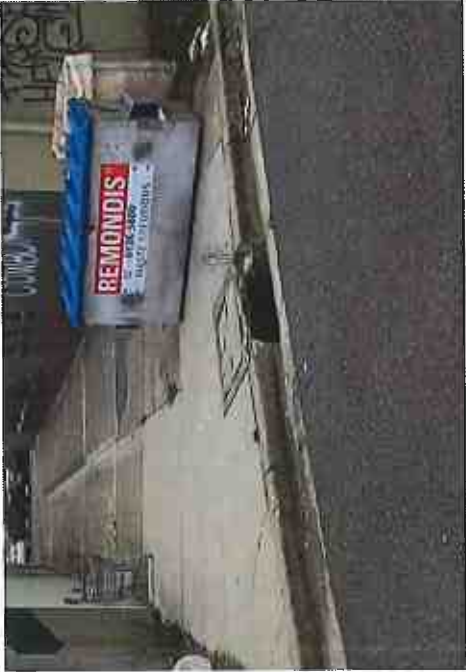
2 Damaged service lids

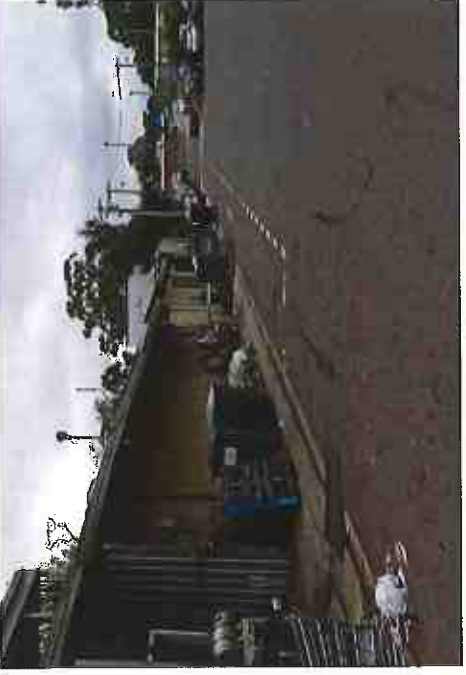
3 Uncontrolled waste and deliveries at rear of shops

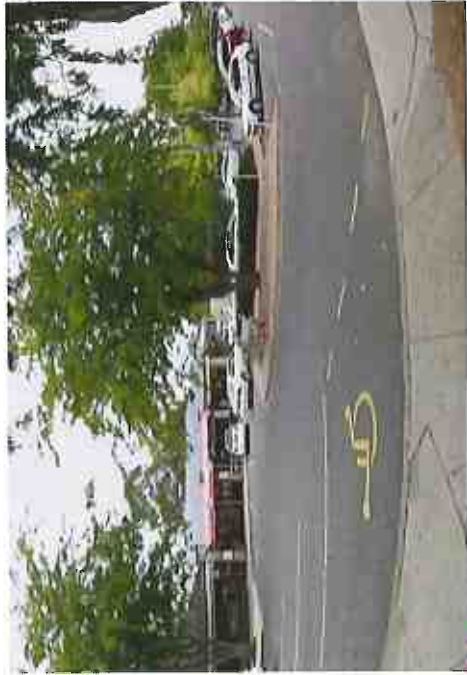
5 Awkward carpark geometry

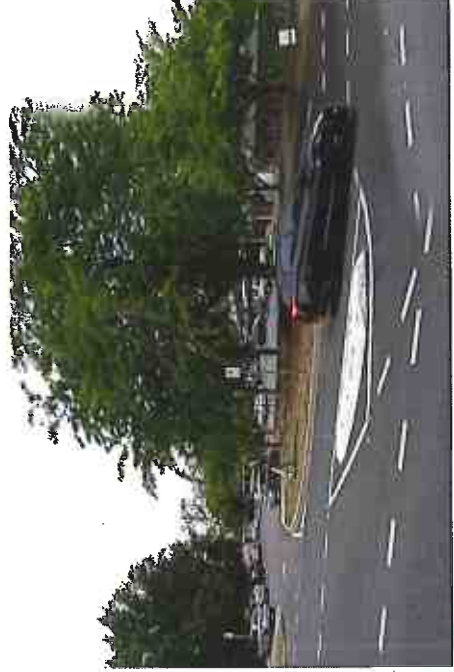
6 Entry and exit points close together

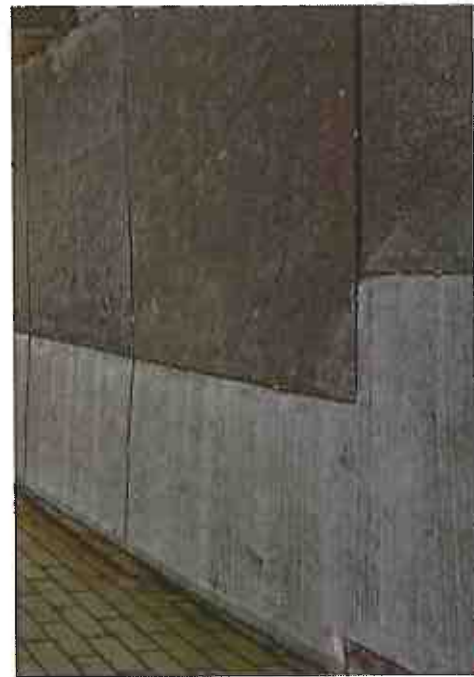
2 Tired concrete paving - mixed concrete finished and colours

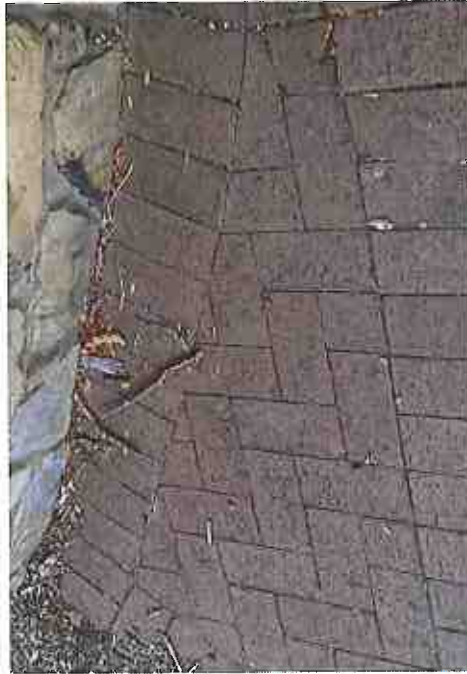
3 Old unit paving

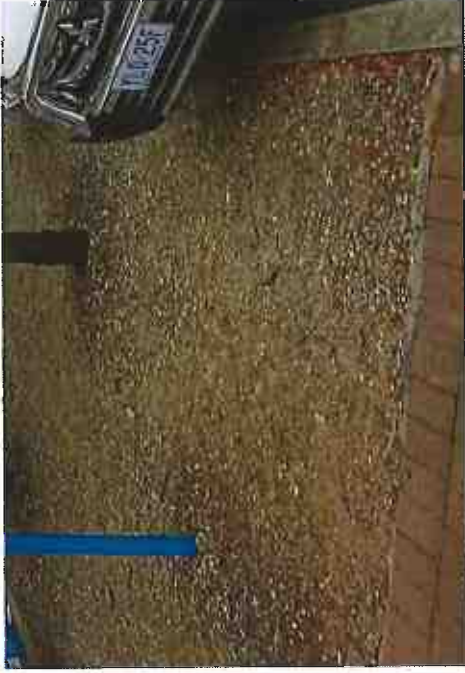
4 Bare granite gravel areas

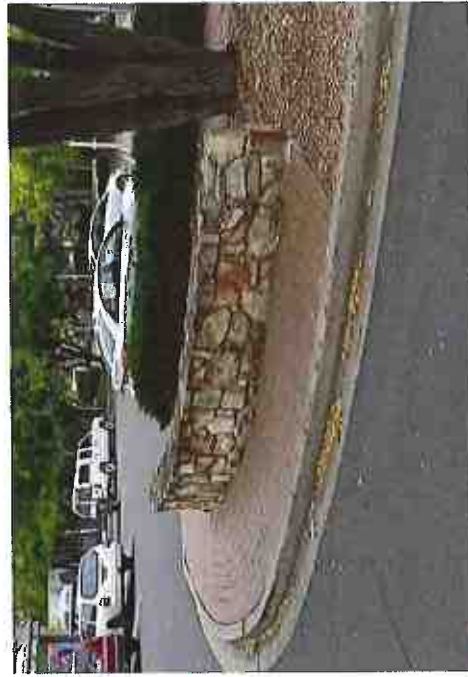
5 Stone walls in reasonable condition

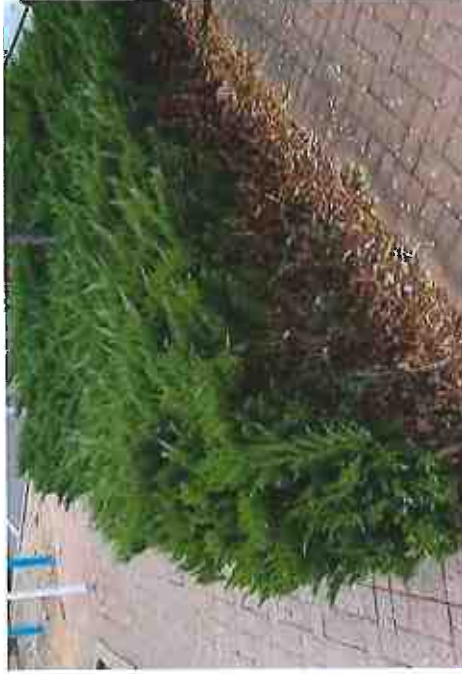
6 Existing Juniper plantings in good condition

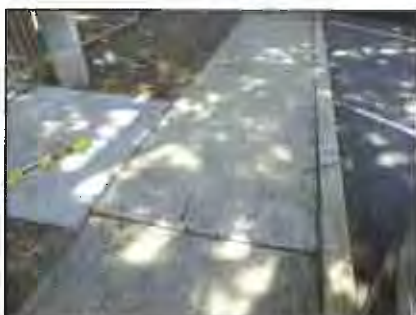
Figure 2

The area generally has a concrete footpath against the kerb or property line with a minimum width of 1340mm. This is not sufficient where a 1600mm width against a kerb is required.

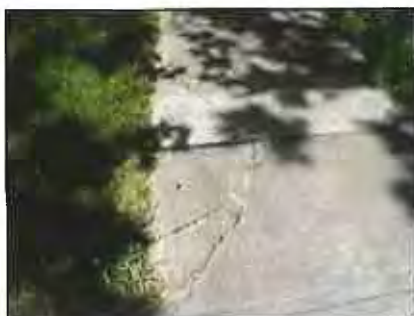
**Figure 3**

The condition of the footpaths is in variable condition. Many cracks exist in the paving posing trip hazards, as noted in Appendix 1 and 3. Most have been ground back to reduce the hazard.

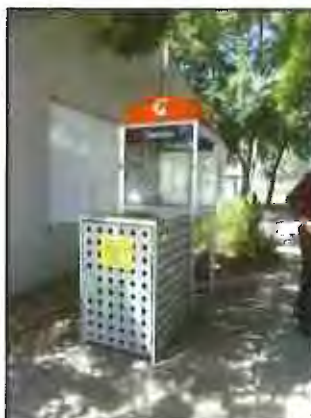
Figure 14

The telephone and PO Box are too high and do not comply.

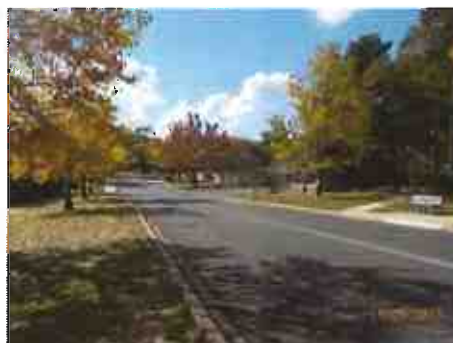
**Figure 4: 114m South on Blamey Crescent**

114m south of shops on Blamey Crescent – small bush is close to 1.15m high and should be removed to remove hazard for drivers as per Austroads standards.

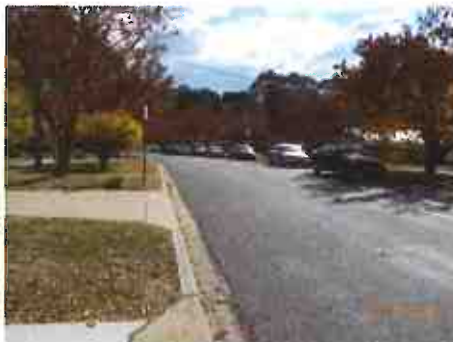
**Figure 7: 90m East on Chauvel Street**

90m east of shops on Chauvel Street – parked cars may be considered an obstruction to drivers view as per Austroads standards, introduction of signage ('no stopping') would remove the hazard.

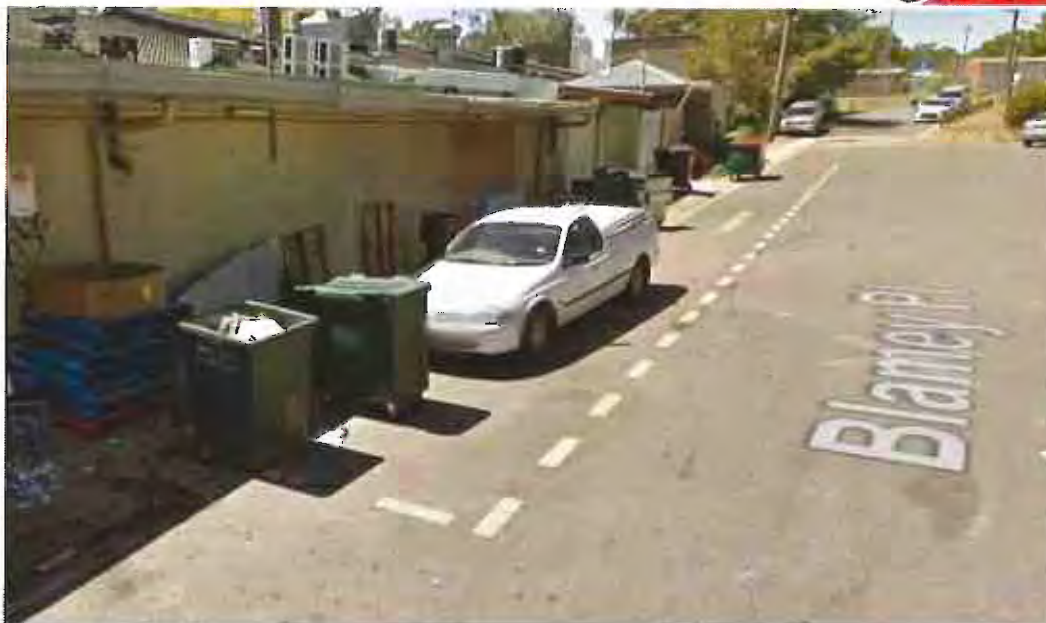
**Figure 9: Foot Path and Loading Zone with Cars and Waste**

The secondary carpark has a concrete path at the rear of the buildings. This concrete path has waste bins and other items stored along it. A section of the path may also be included as part of the Loading Zone. The loading zone has been measured as 2.57m wide from edge of OCI to back of line. The loading zone should be at least 3.5m wide to be compliant to AS2890.2. Figure 9 shows a parked car and waste in the loading zone which flows onto the existing concrete path.
