local shopping centre upgrade program 2016-17

forward design report

15 December 2017

duffy shops

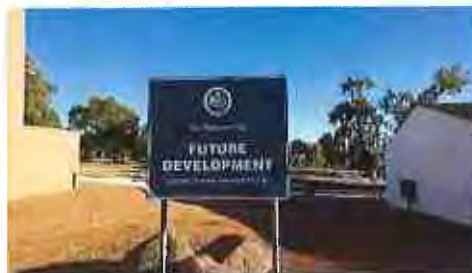
Vacant land adjacent to shops

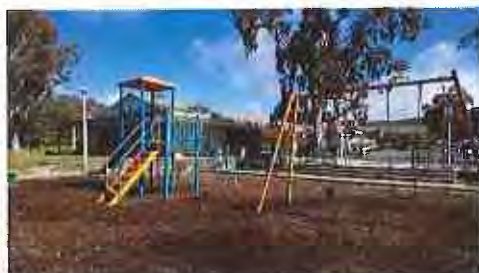
The playground located close to the eastern side of the shops consists of older style of equipment in what appears to be fair condition. The play area is disconnected from the shopfront and has no shade or adequate seating. The general landscaping is not inviting.

Exposed playground east of shops

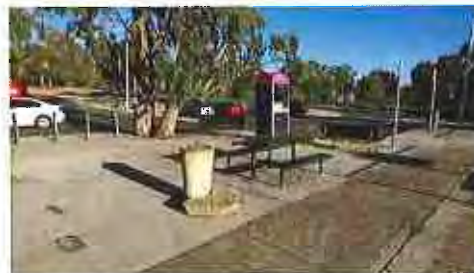
The overall impression of the centre is that it is worn and tired. Cracked, worn pavements, furniture in poor repair, minimal quality shade from structures or planting, dated and damaged retaining walls and worn landscaped areas all contribute to this. Furniture styles and pavement treatments are varied and are of poor aesthetic quality.

Mix of worn pavement and furniture styles

- Removal of trip hazards and uneven surfaces (by selective grinding / replacement of panels) in paths which are not fully replaced
- Complying access from bus stop via rectification of non compliant grades of pathway and crossfalls

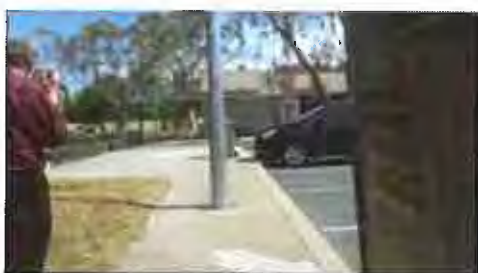
The footpath on the Eastern side of the car park has a pole in the middle of the path with a clearance of 580mm. Footpaths against kerbs are not wide enough where a 1600mm width is required.

Light pole in middle of path

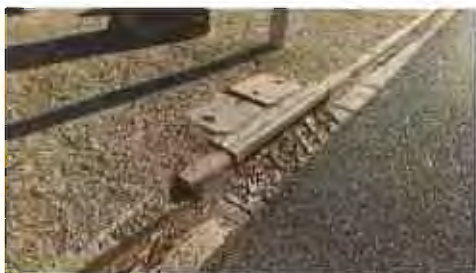
Duffy Shops primary car park has multiple stormwater sumps located in and around the car park. Some of sump lids and surrounds are in poor condition with cracking visible. Some of the lids to the sumps were not flush with the surround. There is a varying gradient throughout the car park which drains to the existing sumps. If the grading of areas of the car park require change due to the improvements, the flow will need to be considered to allow for the stormwater run off to be directed towards the existing sumps.

Damaged service lids and kerbs

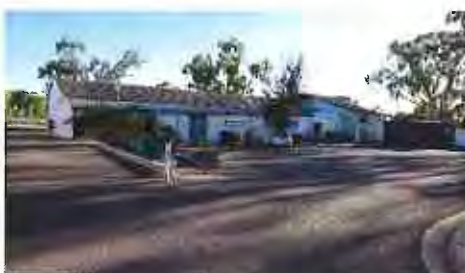
Waste management needed

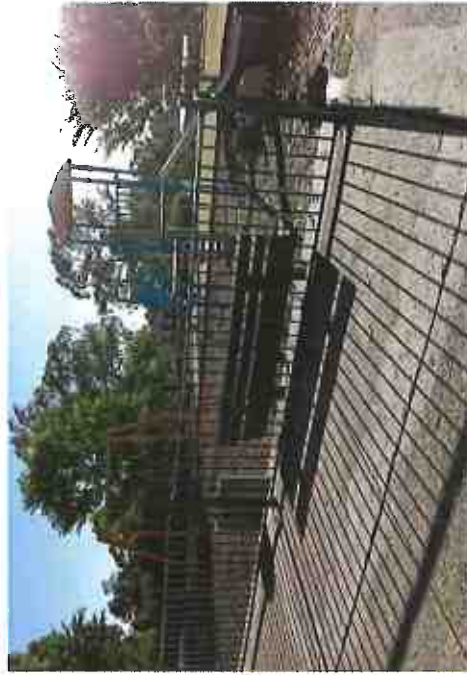
4 Public playground

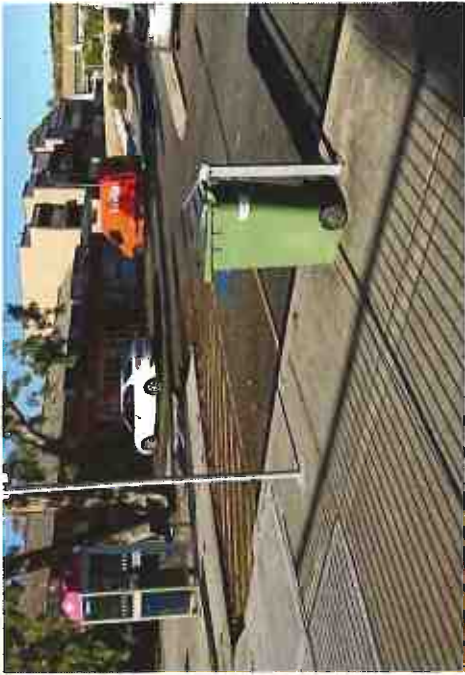
2 Light pole in the middle of path - impedes access

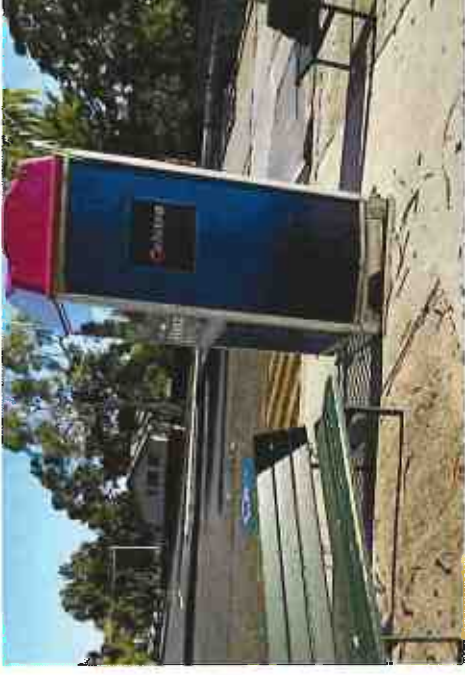
3 Telephone booth not accessible

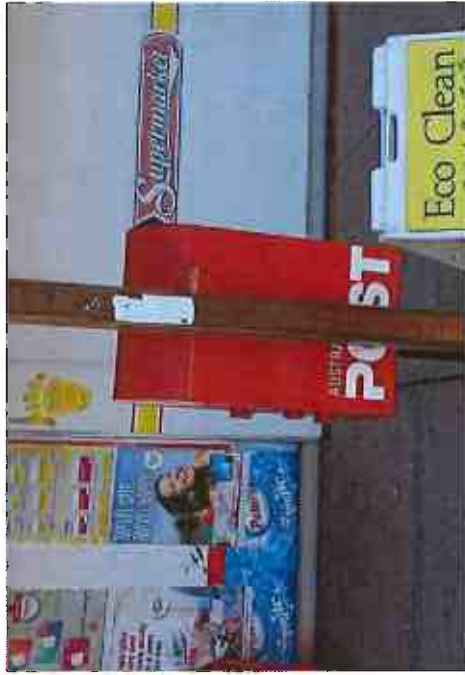
5 P0 box not accessible

- Lower Post box to allow use by persons in wheelchairs – if the existing red post box is lowered to an accessible height, it is found to be at an inappropriate height for other users, and looks out of place
- Lowering height of telephone box – the high cost associated considered not warranted given that there is less reliance on public phone booths

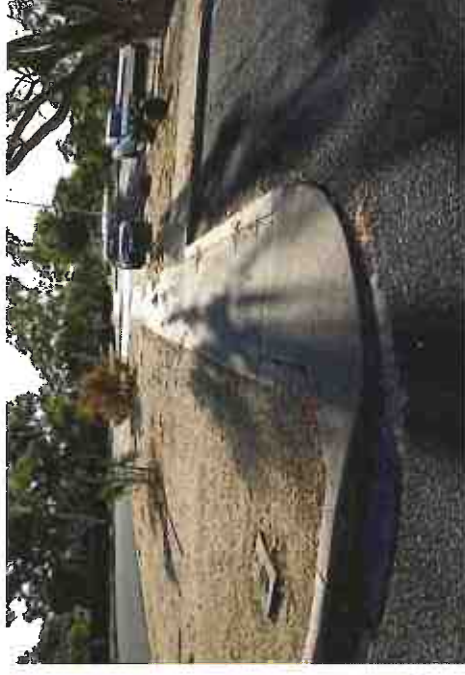
Non-compliant kerb ramps

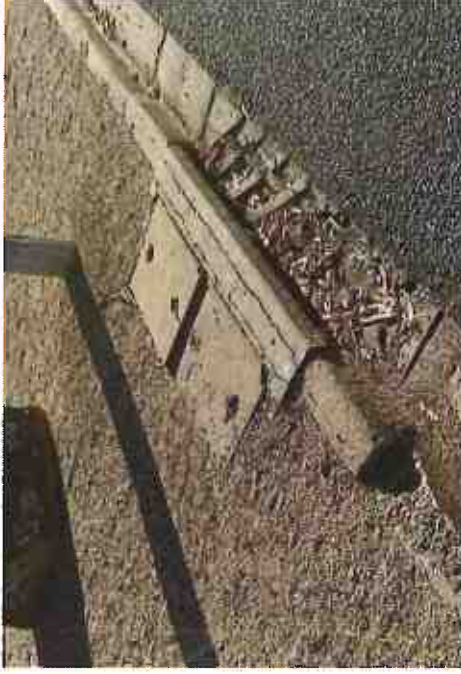
2 Damaged service lids

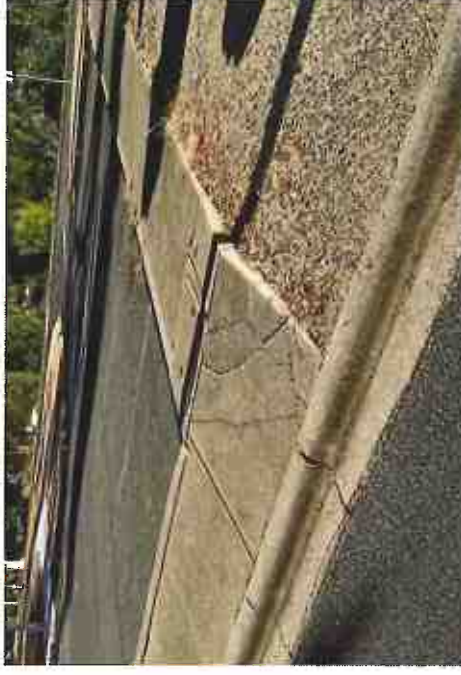
3 Badly damaged paving

Cracked areas should be repaired or replaced.

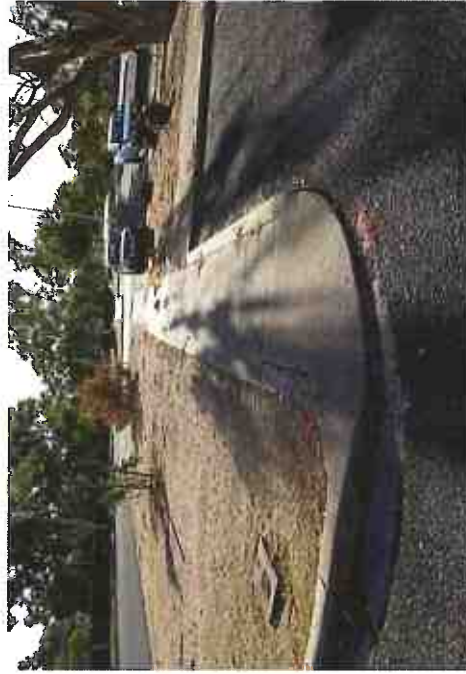
4 Kerb ramps require upgrading

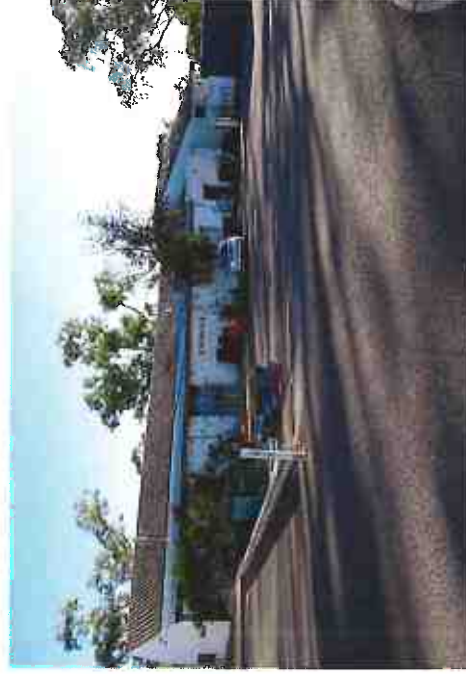
5 Waste management needed

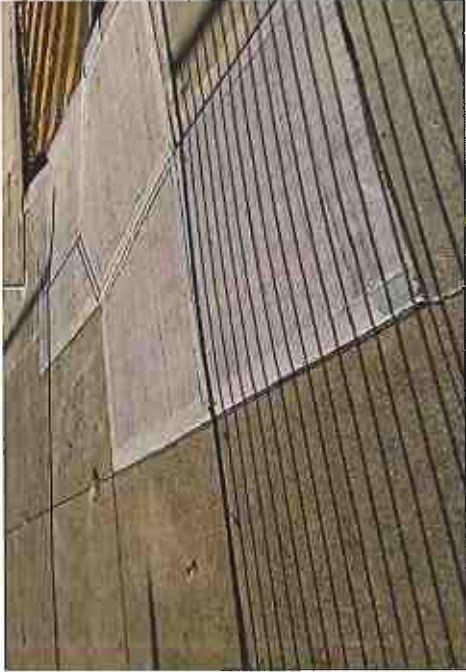
2 Old concrete paving

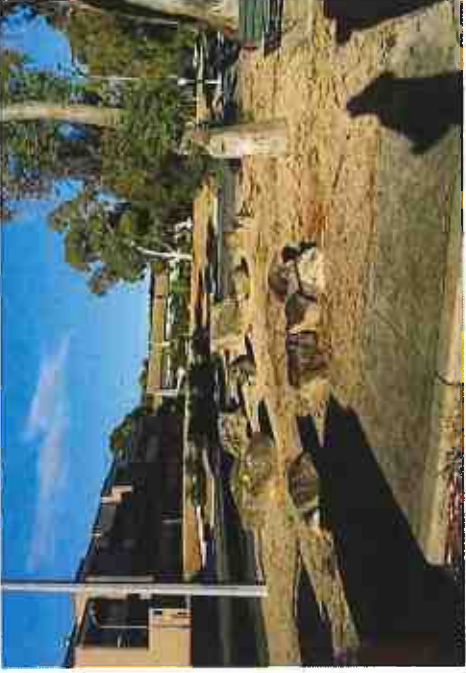
- Most trees on the site are in good health
- Some of the larger Eucalyptus species in the central median, are in poor condition

3 Central median landscape

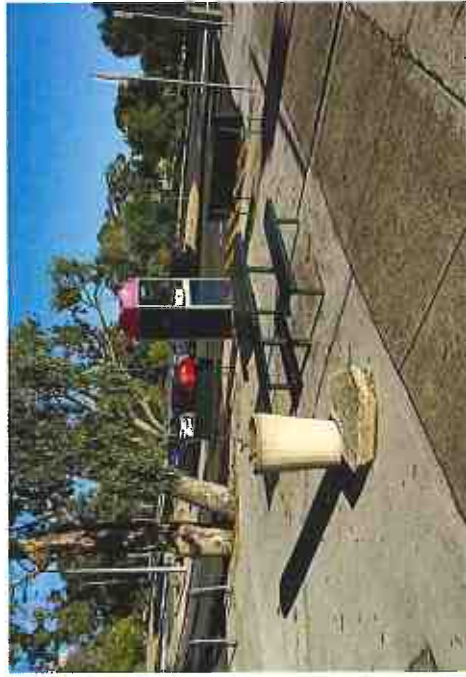
The furniture is in fair condition, but as there are three completely different styles of outdated bench, there is no cohesive palette.

5 Out dated street furniture palette

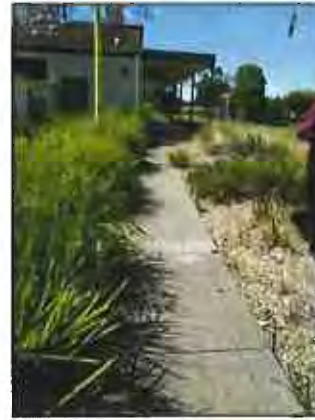
Figure 9

The footpath at the Western end of the shops has gravel on the path posing trip/slip hazard.

Maintain clear access to foot paths trimming overhanging shrubs and removing loose gravel.
