BRITTEN JONES DRIVE

Playground Inventory Report

Playground ID: PLGR121

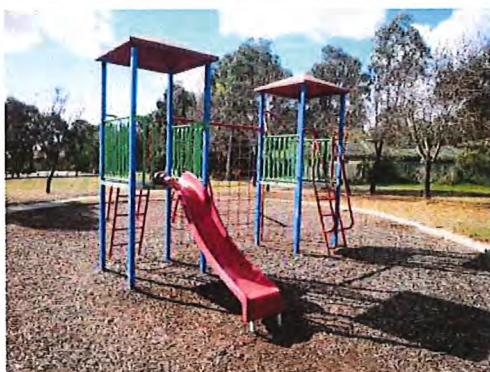
Photo taken: 03/05/2011

Asset_ID	Component	Count	Materials	Date Installed	Est.	Condition	Rocker Type	Removed/Current
1	PLCO6923 Deck (square)	2	Metal (rubber ctd)	1/01/1995	<input checked="" type="checkbox"/>	3		Current
2	PLCO6924 Roof	2	Metal (powder ctd)	1/01/1995	<input checked="" type="checkbox"/>	3		Current
3	PLCO6925 Access (rung ladder)	2	Metal (powder ctd)	1/01/1995	<input checked="" type="checkbox"/>	3		Current
4	PLCO6926 Slide (straight)	1	Fibreglass	1/01/1995	<input checked="" type="checkbox"/>	4		Current
5	PLCO6927 Climber (scramble net)	1	Chain	1/01/1995	<input checked="" type="checkbox"/>	3		Current
			Comments: Chain/H Openings=10/~15mm. Max height=2.4m					
6	PLCO6928 Fire Pole	1	Metal (powder ctd)	1/01/1995	<input checked="" type="checkbox"/>	3		Current
			Comments: Offset 465mm from deck, diameter=38mm.

Max. deck height=1.4m.
Gaps between barrier rails and in vertical handrails and in openings between fire pole frame and vertical supports are 105-110mm (AS4685 requires gaps <89mm but this is not retrospective, OK under previous Standard which required gaps<125mm).
There could be potential finger traps between the sides of the slide and the vertical hand rails. The minimum openings in the chains on the scramble net are 10mm, hence could be potential finger traps.

Although coating is worn on fire pole, ladders and scramble net chain.
The slide face has been resin coated and is smooth. Monitor.

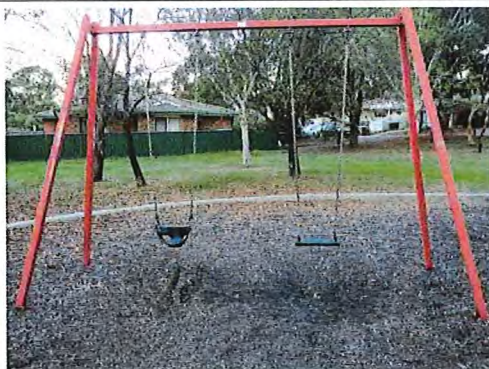
Photo taken: 24/05/2017

Comments: Small split in edge of strap seat, and bent suspension mounts. Monitor.

Replace swing chains (15mm openings) with chains with a maximum opening of 8.6mm in any one direction. Set swing seats at a height of 400-500mm above the under surfacing when 200mm of mulch is present. Chain connections (e.g. S hooks) shall have a maximum opening of >12mm or <8.6mm (the latter is preferred).

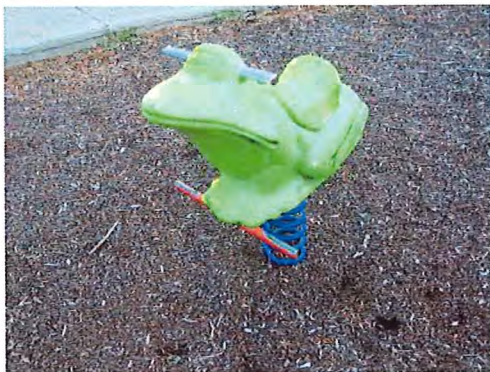
Photo taken: 24/05/2017

Item Components								
Asset_ID	Component	Count	Materials	Date Installed	Est.	Condition 1-new to 5-Bad	Rocker Type	Removed/Current
1	PLCO6931 Rocker (spring)	1	Plastic	1/01/1995	<input checked="" type="checkbox"/>	3	Frog	Current
Comments: Coating is worn on the footrest. Seat height=660mm.

There is a bolt missing from the tail. Replace bolt.

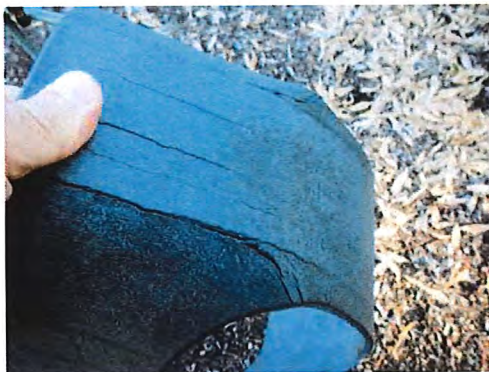
Item Components				Date Installed	Est.	Condition	Rocker Type	Removed/Current
1	PLCO6956	Swing (flat seat)	1	Rubber	1/01/2011	<input checked="" type="checkbox"/>	2	Current
Comments: Height=520mm. Chain/ Hammerlock openings=15/~10mm.								
2	PLCO6957	Swing (toddler seat)	1	Rubber	1/01/2013	<input checked="" type="checkbox"/>	3	Current
Comments: Height=460mm. Chain/ Hammerlock openings=15/~10mm. Seat cracking in base and back. Monitor.

Photo taken: 25/05/2017 Toddler seat cracking. Monitor.

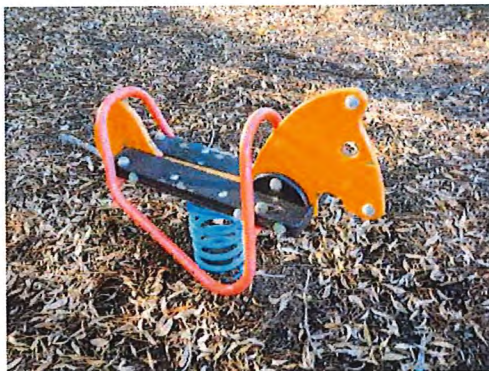
Photo taken: 25/05/2017

Item Components				Date Installed	Est.	Condition	Rocker Type	Removed/Current
1	PLCO6958	Rocker (spring)	1	Plyboard (painted)	1/01/2004	<input checked="" type="checkbox"/>	3	Current
Comments: Kompan Product 'Crazy Horse'. Coating is peeling, hand and footrests are chipped. Seat height=370mm.

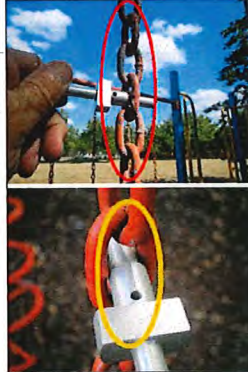
PLAR140. Item 1. Combination Unit (small) - Bridge (clatter) Priority: Low Level of Risk: 3 - Low (E3) Works ID: 6381 Works Type: General Order ID: There is an exposed bolt head on the clatter bridge, and the board is loose. Reset bolt.	Approved: <input type="checkbox"/> Started: <input type="checkbox"/> Completed: <input type="checkbox"/> Checked: <input type="checkbox"/>	Last Observed: 25/05/2017 First Identified: 25/05/2017

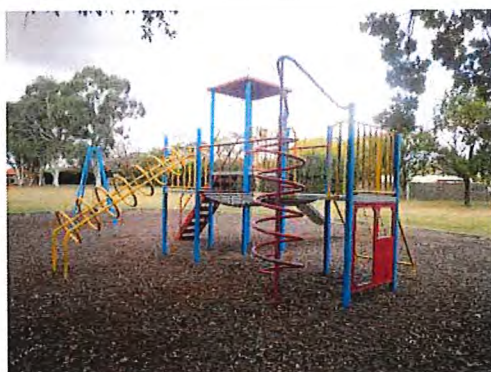
Photo taken: 03/05/2011

2. Is it free of sharp or rough edges or projections that may present a hazard to users? (Cl.2.2.5)	Y	There is an exposed bolt head on the loose board on the clatter bridge.

6. Is the item complete with no missing parts?	Y	
7. Are all joints fastened properly?	N	There are loose clatter bridge boards.
8. Is the protective paint or coating (where req.) in good cond.? (NA for ltrd timber or stainless / galv steel)	N	Coating peeling on steering wheel and corkscrew climber.

12. Is equipment free from other significant damage? (cracking, rust, weld cracks, broken members, wear, warping, distortion, non-lubricated, etc)	N	The slide face is dented. A section of deck coating has been cut out. Clatter bridge boards are wearing where chains are rubbing, minimal movement in boards but not a crush at this stage.

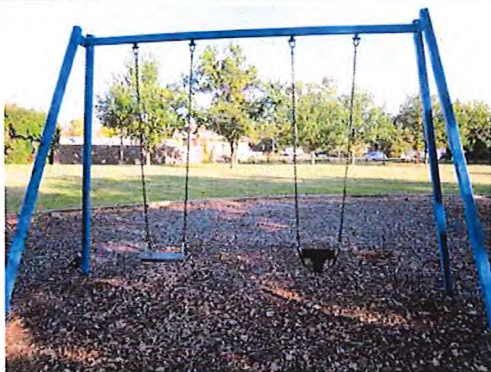
Photo taken: 01/05/2012

Comments: Cuts in edges of toddler seat. Monitor.

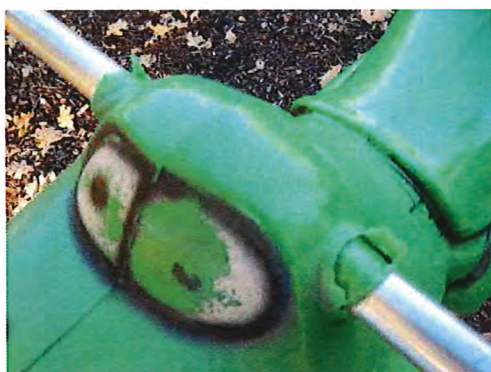
Comments: Seat height=700mm. Plastic peeling near hand supports. Monitor.

Photo taken: 25/05/2017 Plastic peeling. Monitor.

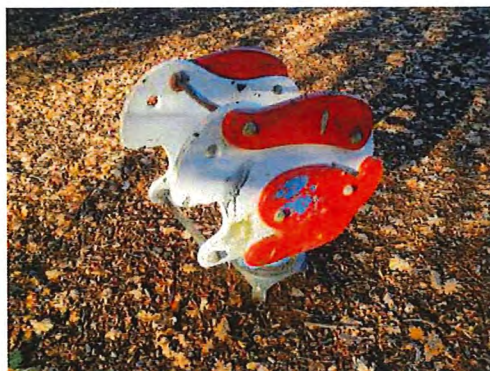
Photo taken: 25/05/2017

Comments: Kompan Product 'Crazy Rabbit'. Seat height=520mm. Hand support is bent and rusting, coating is peeling. Monitor.

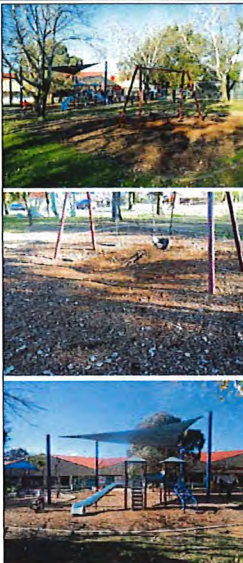
<p>Priority: Medium Level of Risk: 9 - Moderate (C3)</p> <p>Works ID: 5813 Works Type: General Order ID:</p> <p>The exposed tree root at the edge of the main play unit area could be a potential trip point. Remove tree root, or cover with at least 200mm of mulch.</p>	Approved: <input type="checkbox"/> Started: <input type="checkbox"/> Completed: <input type="checkbox"/> Checked: <input type="checkbox"/>	Last Observed: 25/05/2017 First Identified: 23/05/2016

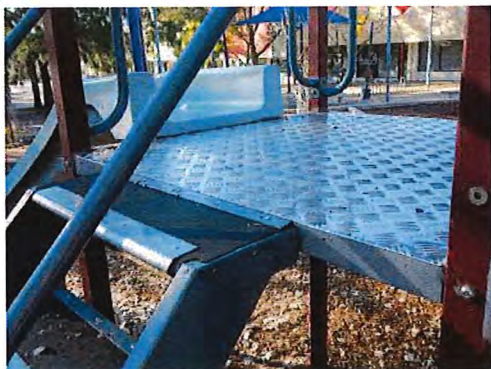
Photo taken: 25/05/2017 Slide deck covered with aluminium sheeting.

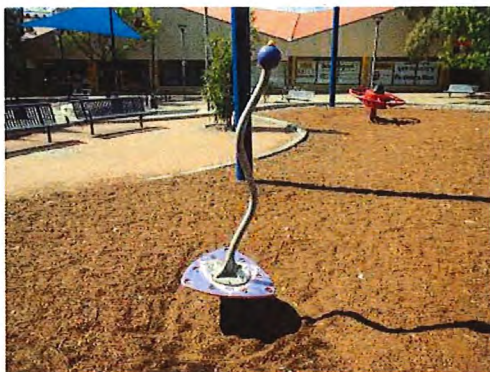
Comments: On a slight lean, bolt caps are worn, top of spinner is loose and the support pole exhibits slight movement - monitor. On a 12 degree tilt.

Photo taken: 01/04/2015 Spin pole on a lean.

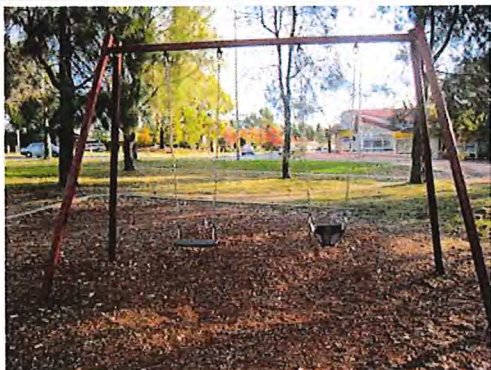
Photo taken: 01/05/2012

Comments: Swing frame coating chipped and top edge of toddler seat exhibits wear. Monitor.

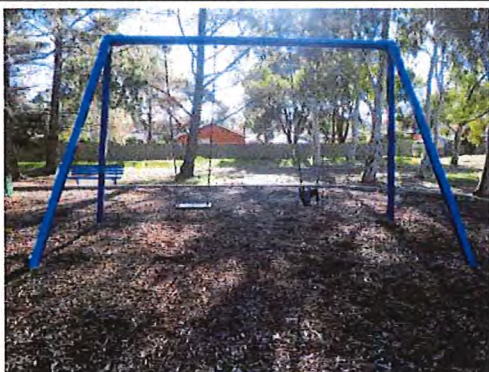
Photo taken: 13/05/2010

Comments: Both seats exhibit small cuts- monitor.

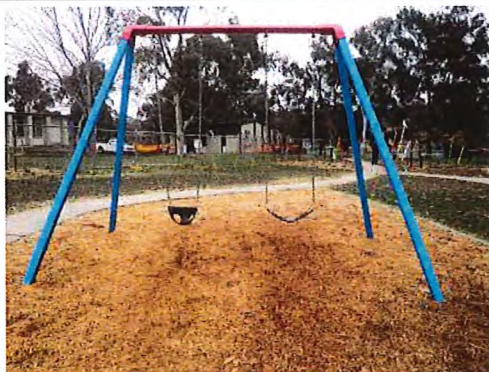
Photo taken: 25/06/2010

Comments: Grommets are loose. Monitor.

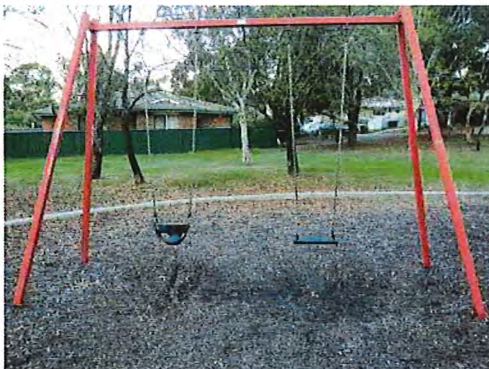
Photo taken: 24/05/2017

Comments: Small split in edge of strap seat, and bent suspension mounts. Monitor.

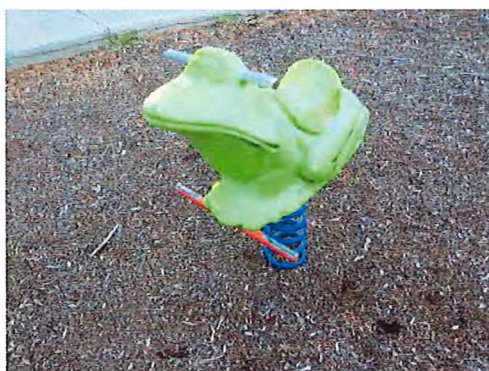
Photo taken: 24/05/2017

Asset_ID	Component	Count	Materials	Date Installed	Est.	Condition	Rocker Type	Removed/Current
1	PLCO6931 Rocker (spring)	1	Plastic	1/01/1995	<input checked="" type="checkbox"/>	3	Frog	Current
Comments: Coating is worn on the footrest.

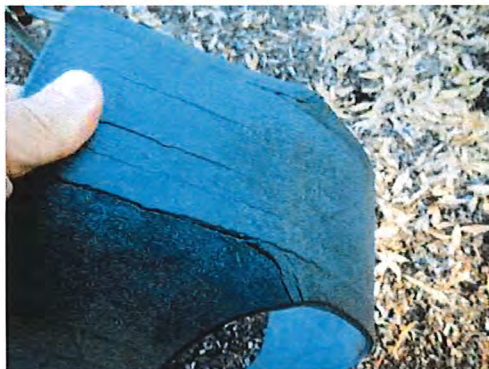
Asset_ID	Component	Count	Materials	Date Installed	Est.	Condition	Rocker Type	Removed/Current
1	PLCO6956 Swing (flat seat)	1	Rubber	1/01/2011	<input checked="" type="checkbox"/>	2		Current
			Comments: Height=490mm. Chain/ Hammerlock openings=15/~10mm.					
2	PLCO6957 Swing (toddler seat)	1	Rubber	1/01/2018	<input checked="" type="checkbox"/>	1		Current
			Comments: Height=450mm. Chain/ Hammerlock openings=15/grommet.

Photo taken: 25/05/2017 Toddler seat cracking. Monitor.

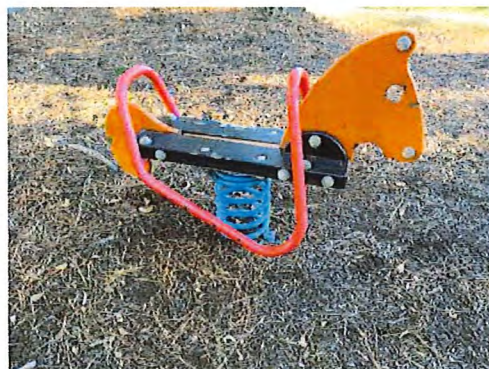
Photo taken: 18/04/2018

Asset_ID	Component	Count	Materials	Date Installed	Est.	Condition	Rocker Type	Removed/Current
1	PLCO6958 Rocker (spring)	1	Plyboard (painted)	1/01/2004	<input checked="" type="checkbox"/>	3	Horse	Current
			Comments: Kompan Product 'Crazy Horse'. Coating is peeling, hand and footrests are chipped.

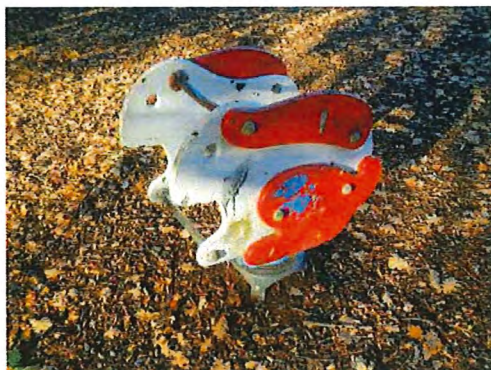
Photo taken: 25/05/2017

<u>Item Components</u>			Date	Condition	Rocker	Removed/		
Asset_ID	Component	Count	Installed	Est.	1-new to 5-Bad	Type	Current	
1	PLCO6942 Rocker (spring)	1	Plyboard (painted)	1/01/1995	<input type="checkbox"/>	3	Rabbit	Current
Comments: Kompan Product 'Crazy Rabbit'. Hand support is bent and rusting, coating is peeling. Monitor.

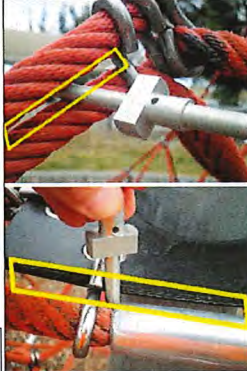
<p>PLAR146. Item 2. Climber (spacenet)</p> <p>Priority: Medium Level of Risk: 4 - Low (E4)</p> <p>Works ID: 3308 Works Type: General Order ID:</p> <p>Where 2 ropes run parallel to one another there is a gap between them. The importer of the net has indicated that they do not consider this a finger entrapment. However, fingers can be inserted into this gap and become trapped, especially when slid down to near the connection at the base of the hole (as per photos). As such these gaps should be considered potential finger entrapment. On the outside the rubber shields between the ropes there are some gaps >8mm wide that could be potential fingers traps.</p> <p>Cost(\$):</p> <p>Last Observed: 18/04/2018 First Identified: 3/05/2011</p>	<p>Approved: <input type="checkbox"/></p> <p>Started: <input type="checkbox"/></p> <p>Completed: <input type="checkbox"/></p> <p>Checked: <input type="checkbox"/></p>

<p>Comments: It's up to the owner of the net as to what risk they are willing to accept taking into account other factors such as performance history of this style of net and likelihood of someone getting a finger caught and then falling.</p>		
<p>PLAR146. Item 2. Climber (spacenet)</p> <p>Priority: Medium Level of Risk: 6 - Moderate (D3)</p> <p>Works ID: 7244 Works Type: General Order ID:</p> <p>Exposed turnbuckles could be potential trip points. Build up and maintain mulch over the exposed turnbuckles.</p> <p>Cost(\$):</p> <p>Last Observed: 18/04/2018 First Identified: 18/04/2018</p>	<p>Approved: <input type="checkbox"/></p> <p>Started: <input type="checkbox"/></p> <p>Completed: <input type="checkbox"/></p> <p>Checked: <input type="checkbox"/></p>

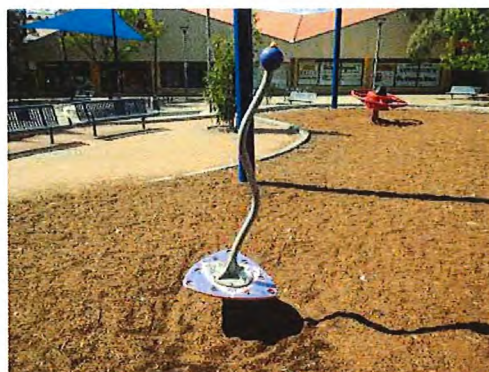
Comments: On a slight lean, bolt caps are worn, top of spinner is loose and the support pole exhibits slight movement - monitor. On a 12 degree tilt.

Photo taken: 01/04/2015 Spin pole on a lean.

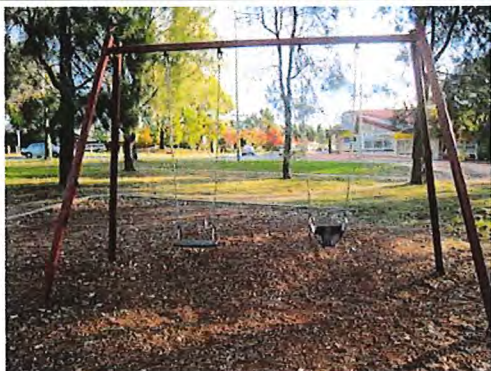
Photo taken: 01/05/2012

Comments: Swing frame coating exhibits wear. Monitor.

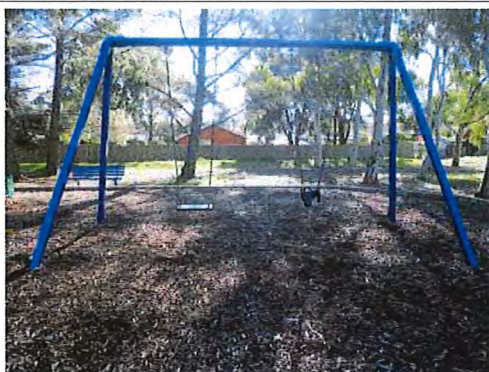
Photo taken: 13/05/2010

Comments: Cuts in flat seat - monitor.

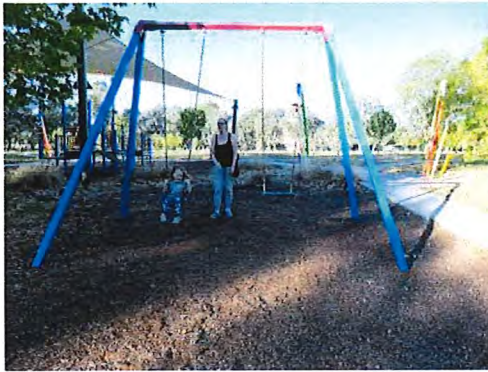
Photo taken: 18/04/2018

Comments: Grommets are loose. Monitor.
