Report on
Detailed Site Investigation for Contamination

Project Roger
Part Rural Block 2249, Jerrabomberra

Prepared for
Jacobs Group (Australia) Pty Ltd

Project 103028.01
September 2020

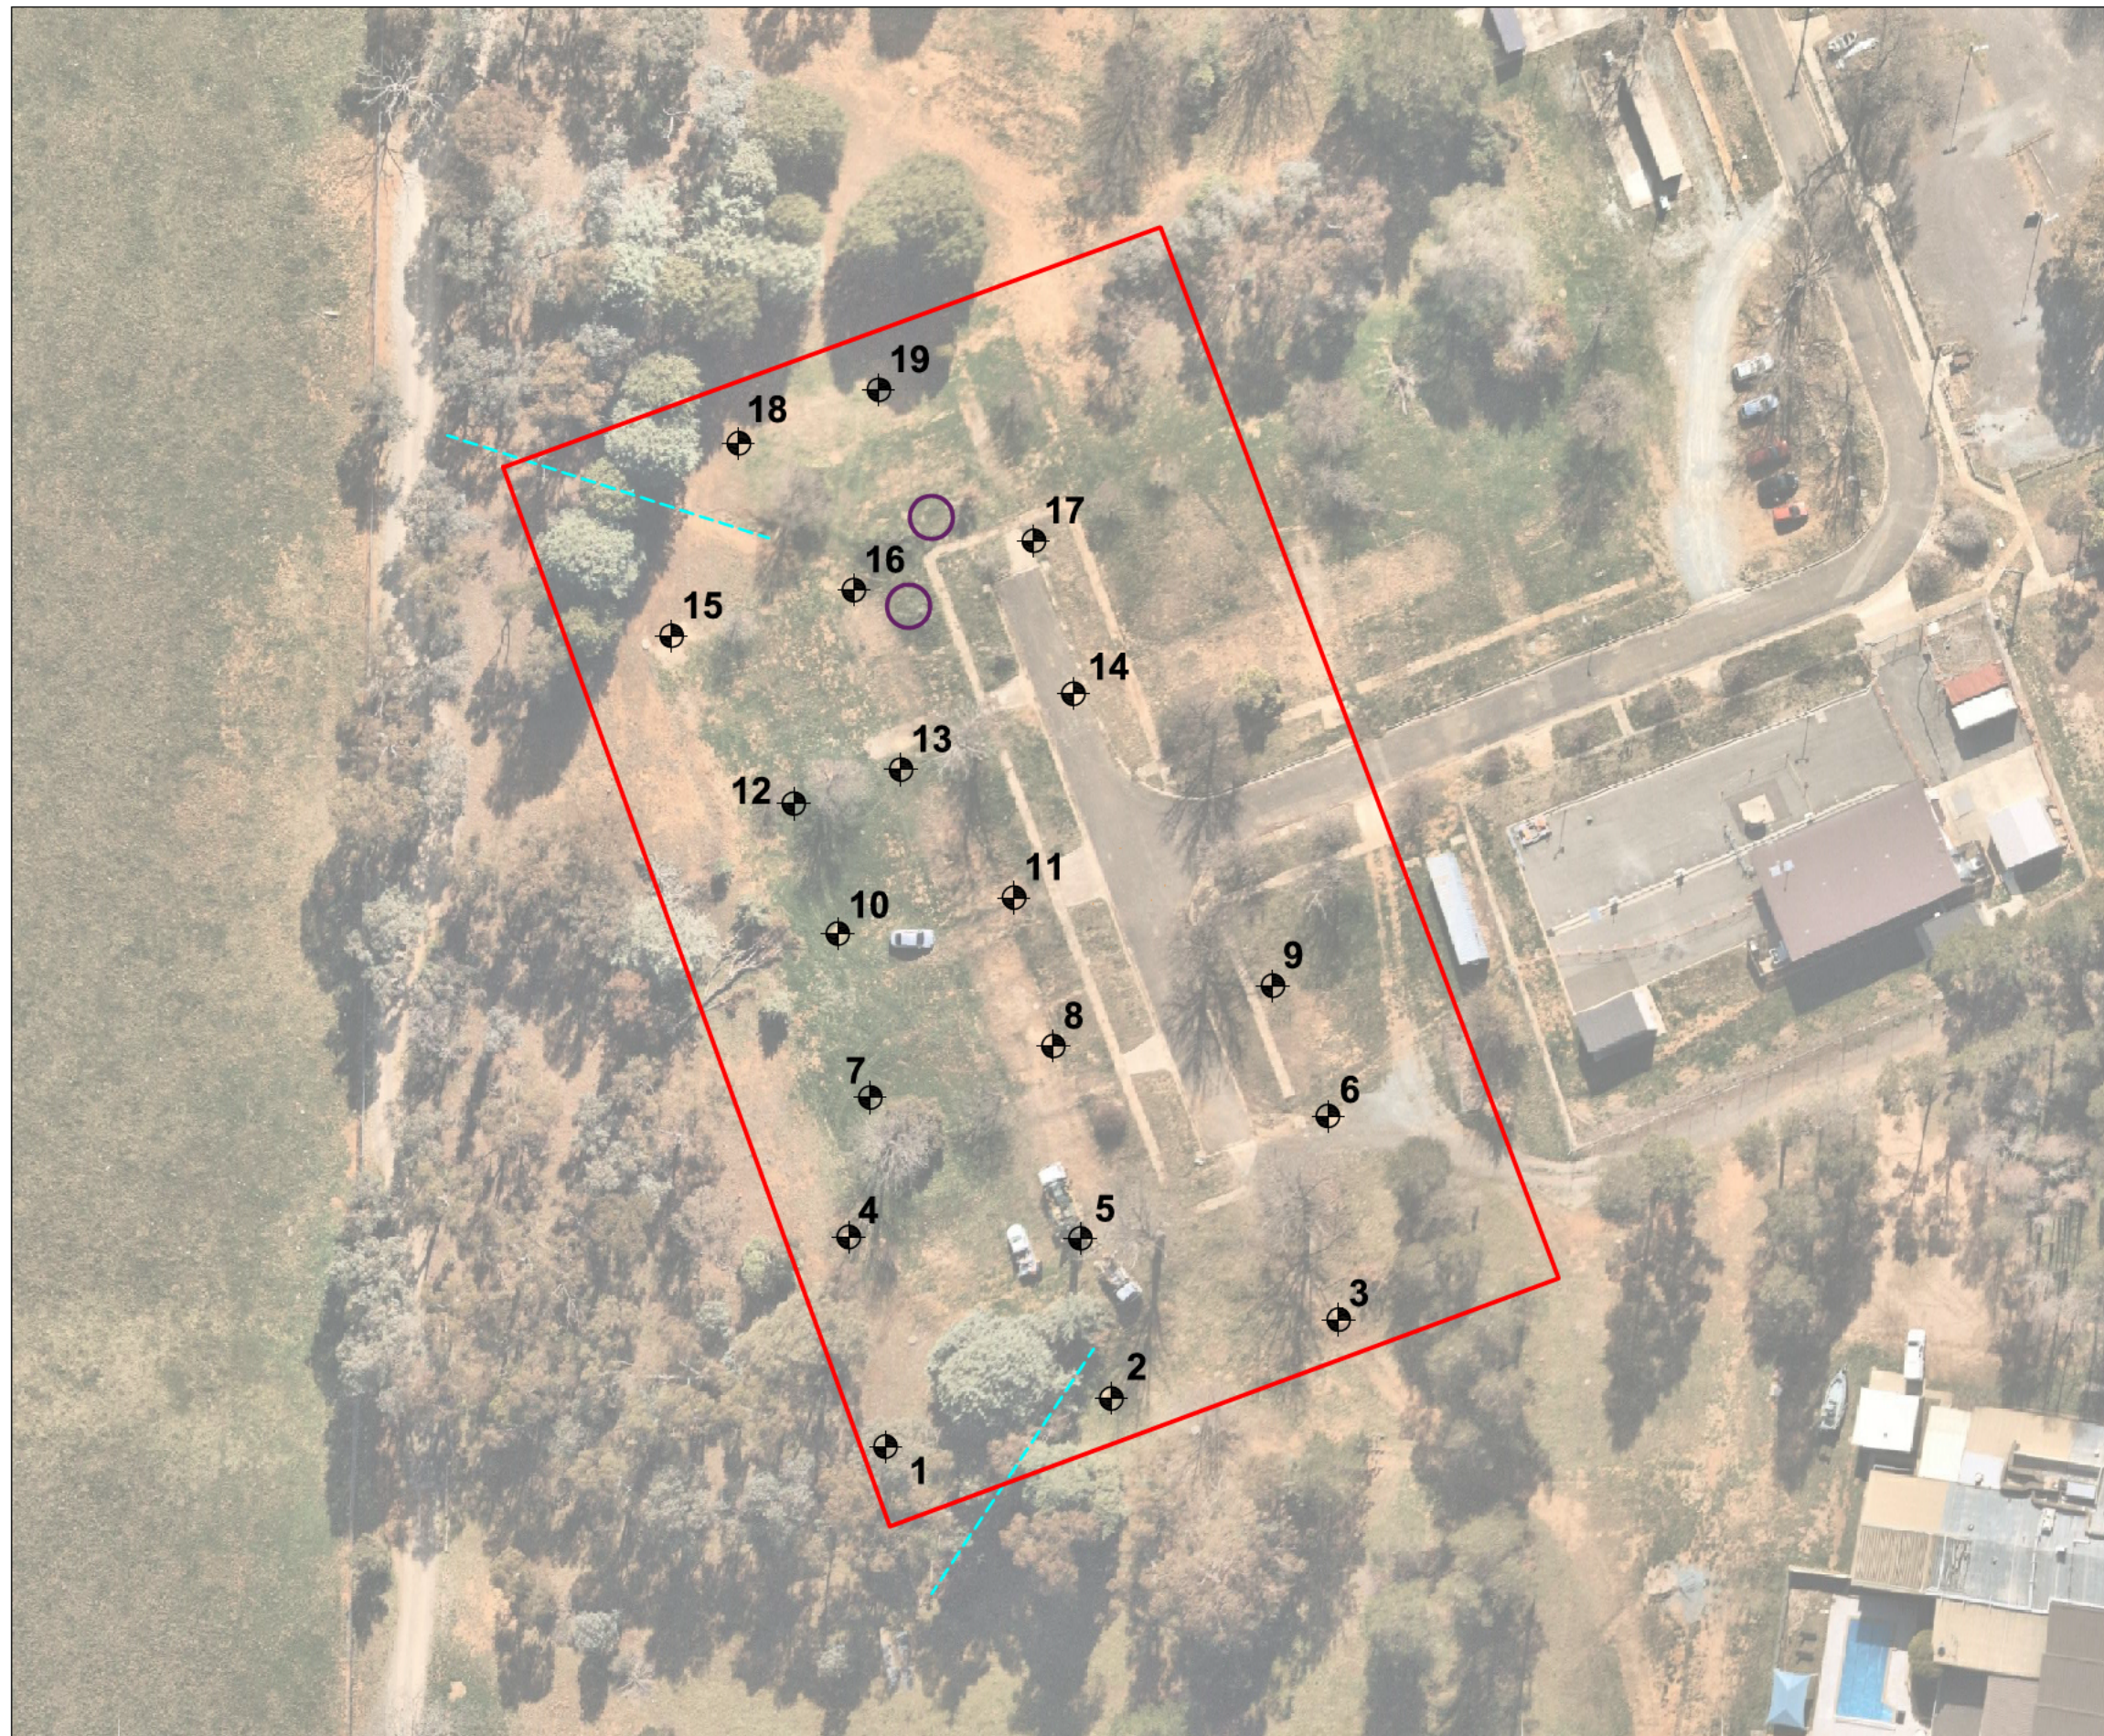
- No areas of staining or odours were observed; and
- Two fragments of potential asbestos containing material (PACM) were observed within the northern portion of the site (see Drawing 1, Appendix B for the approximate locations).

M1 and M2 (PACM fragments observed on site) were tested positive for containing asbestos.
