FREEDOM OF INFORMATION COVERSHEET

FOI reference: TCCSFOI 20-096

CHIPPINDALL CIRCUIT

Playground ID: PLGR263

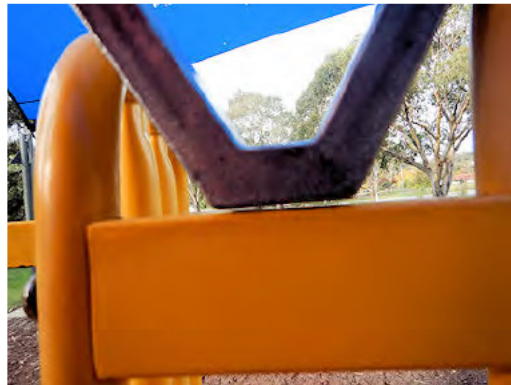
Photo taken: 08/04/2020 Neck probe just not touching the bottom.

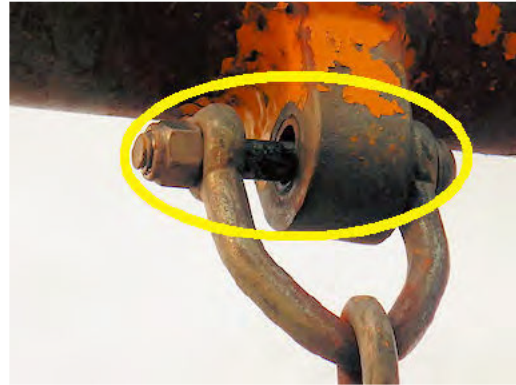
Comments: Crossbeam is chipped and peeling. Monitor.

Photo taken: 08/04/2020 Upper shackles worn. Monitor.

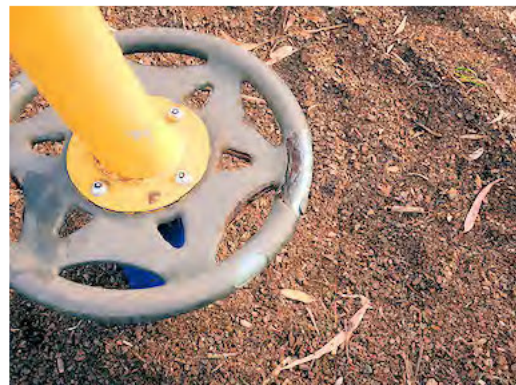
<u>Item Components</u>								
Asset_ID	Component	Count	Materials	Date Installed	Est.	Condition 1-new to 5-Bad	Rocker Type	Removed/ Current
1	PLCO5764 Spin Pole	1	Metal (powder ctd)/Rubber	1/01/2000	<input checked="" type="checkbox"/>	2		Current
Comments: Rubber coating worn.

Photo taken: 08/04/2020 Rubber coating worn on foot pad. Monitor.

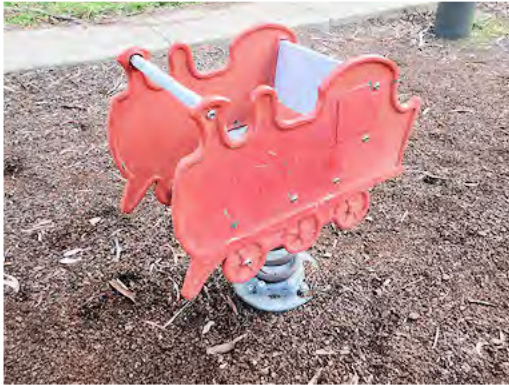
Photo taken: 08/04/2020

4 - Rocker				Asset ID: PLST1473 Area ID: PLAR318		Current Level of Risk: E3 - Low	
Materials: Metal (powder ctd)		Make: Playspace		Has Markings per Sectn 4, AS? NA		Inspection Date: 8/04/2020	
Condition: 2- Good		Model:		Installed by:		Installation Date: 1/01/2000 Est. <input checked="" type="checkbox"/>	
Item Components							
Asset_ID	Component	Count	Materials	Date Installed	Est.	Condition 1-new to 5-Bad	Rocker Type Removed/Current
1	PLCO5040	Rocker (spring)	1	Metal (powder ctd)	1/01/2000	<input checked="" type="checkbox"/>	2 Train Current
Comments: Coat is faded, loose hand support.

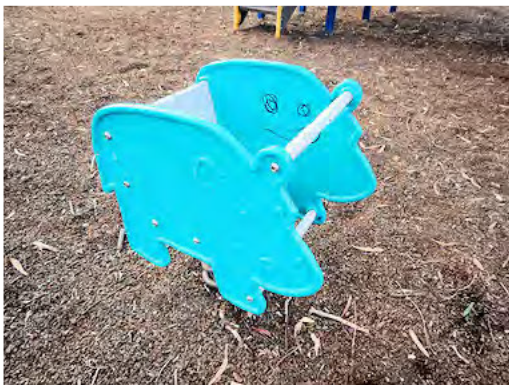
Photo taken: 08/04/2020

5 - Rocker				Asset ID: PLST1474 Area ID: PLAR318		Current Level of Risk: E3 - Low	
Materials: Metal (powder ctd)		Make: Playspace		Has Markings per Sectn 4, AS? NA		Inspection Date: 8/04/2020	
Condition: 2- Good		Model:		Installed by:		Installation Date: 1/01/2000 Est. <input checked="" type="checkbox"/>	
Item Components							
Asset_ID	Component	Count	Materials	Date Installed	Est.	Condition 1-new to 5-Bad	Rocker Type Removed/Current
1	PLCO5039	Rocker (spring)	1	Metal (powder ctd)	1/01/2000	<input checked="" type="checkbox"/>	2 Hippopotamus Current
Comments: Coat is faded.
