## FREEDOM OF INFORMATION COVERSHEET

FOI reference: TCCSFOI 2019-112

# GUNDARA STREET

## Playground Inventory Report

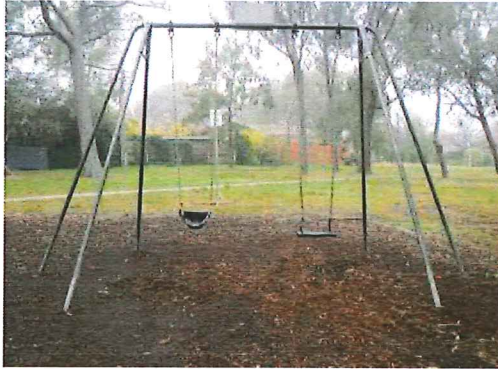
Comments: The flat swing seat is a Miracle seat. Bent seat suspension mounts. Monitor.

Photo taken: 25/05/2017

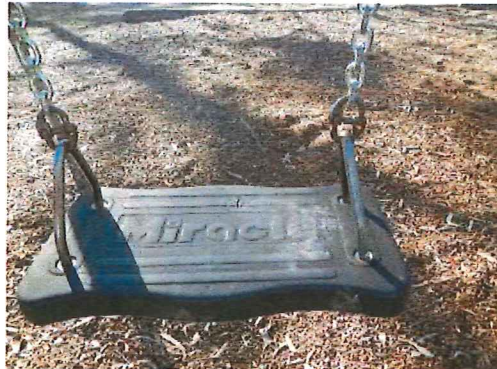
Photo taken: 24/05/2016 Bent suspension mounts.

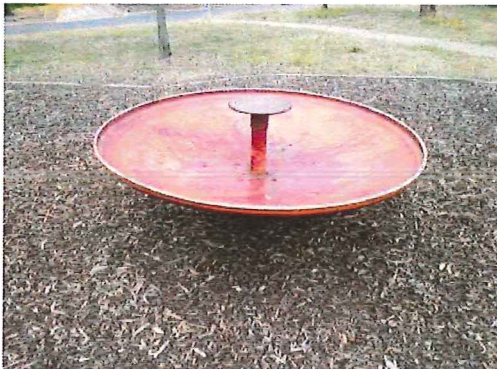
Photo taken: 24/05/2010

Asset_ID	Component	Count	Materials	Date Installed	Est.	Condition 1-new to 5-Bad	Rocker Type	Removed/Current
1	PLCO7115 Carousel (rotating saucer)	1	Metal (powder ctd)	1/01/1990	<input checked="" type="checkbox"/>	3		<b>Current</b>
Comments: Coating worn.

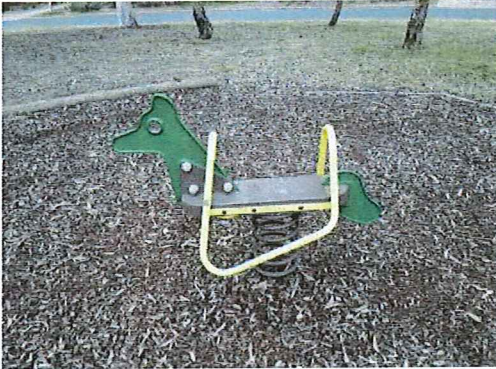
Photo taken: 24/05/2010

Comments: Foot support coating worn.

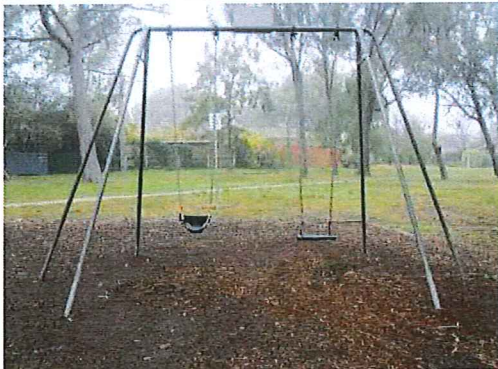
Photo taken: 25/05/2017

Comments: The flat swing seat is a Miracle seat. Bent seat suspension mounts. Monitor.

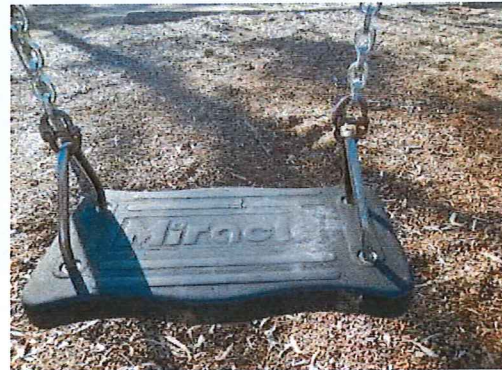
Photo taken: 24/05/2016 Bent suspension mounts.

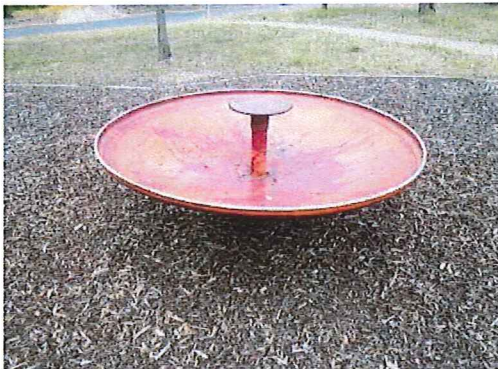
Photo taken: 24/05/2010

Asset_ID	Component	Count	Materials	Date Installed	Est.	Condition 1-new to 5-Bad	Rocker Type	Removed/ Current
1	PLCO7115 Carousel (rotating saucer)	1	Metal (powder ctd) Comments: Coating worn.	1/01/1990	<input checked="" type="checkbox"/>	3		Current

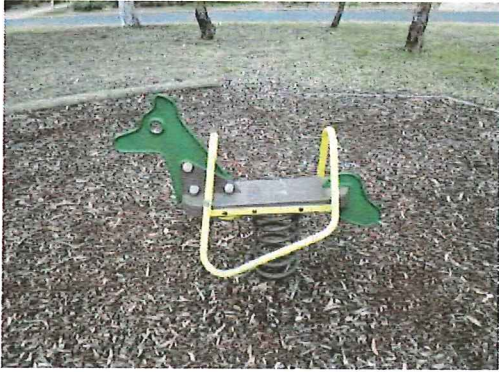
Photo taken: 24/05/2010

<b>Item Components</b>		Count	Materials	Date Installed	Est.	Condition 1-new to 5-Bad	Rocker Type	Removed/Current
1	PLCO7116	1	Rocker (spring) Metal (powder ctd)	1/01/1990	<input checked="" type="checkbox"/>	3	Horse	<b>Current</b>
Comments: Foot support coating worn. Seat height=360mm.

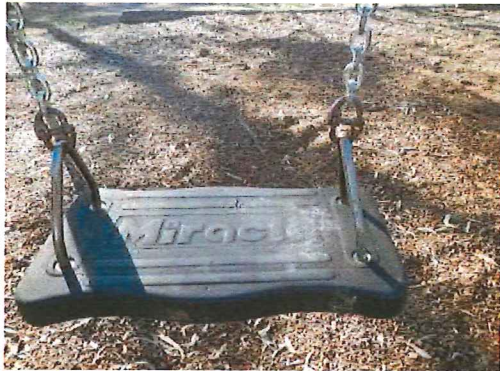
Comments: The flat swing seat is a Miracle seat.

Photo taken: 24/05/2016 Bent suspension mounts.

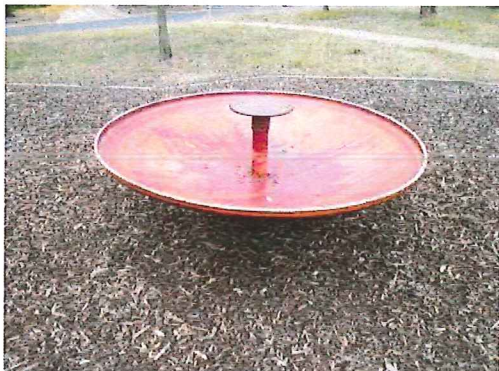
Photo taken: 24/05/2010

<b>Item Components</b>		Count	Materials	Date		Condition 1-new to 5-Bad	Rocker Type	Removed/ Current
Asset_ID	Component			Installed	Est.			
1	PLCO7115 Carousel (rotating saucer)	1	Metal (powder ctd)	1/01/1990	<input checked="" type="checkbox"/>	3		<b>Current</b>
Comments: Coating worn.

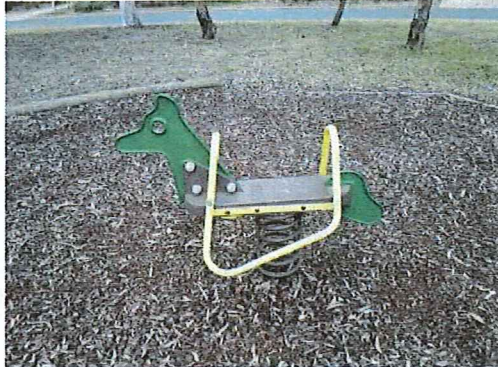
Photo taken: 24/05/2010

Asset_ID	Component	Count	Materials	Date Installed	Est.	Condition 1-new to 5-Bad	Rocker Type	Removed/ Current
1	PLCO7116 Rocker (spring)	1	Metal (powder ctd)	1/01/1990	<input checked="" type="checkbox"/>	3	Horse	<b>Current</b>
Comments: Foot support coating worn

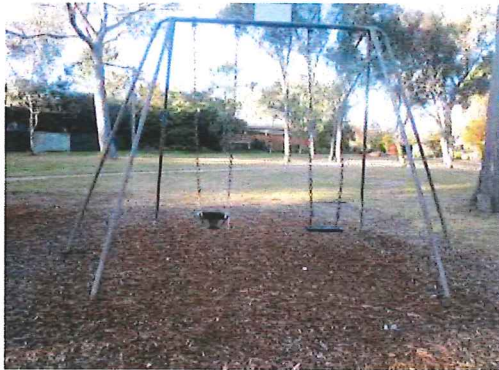
Photo taken: 06/05/2011

Comments: The flat swing seat is a Miracle seat.

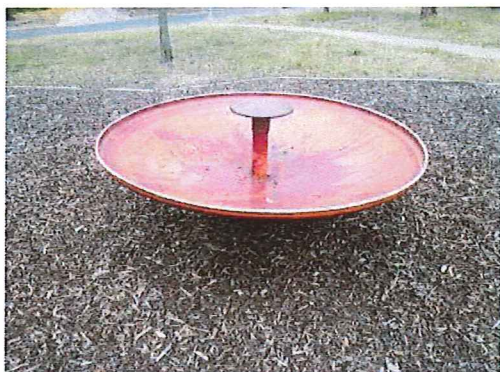
Photo taken: 24/05/2010

Comments: Coating worn.

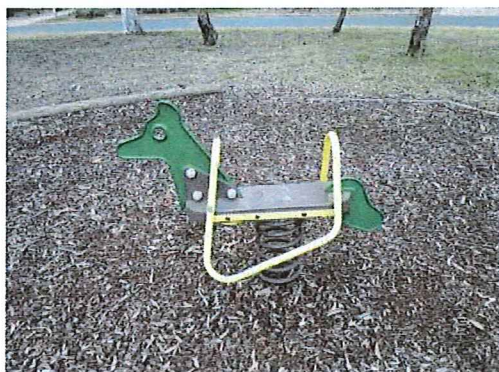
Photo taken: 24/05/2010

Comments: Foot support coating worn
