I seek any or all geotechnical reports held or created by Transport Canberra and City Services and/or ACT Roads in relation to Tarra Place Ngunnawal.

This report summarises the methods and findings of the field investigation and laboratory testing, and includes an assessment of the geotechnical and geological conditions based on the factual information obtained during the field investigation and subsequent laboratory testing, visual assessment of the pavement defects, and provides geotechnical and pavement recommendations for rehabilitation of the pavement. The object of the investigation was to assess the subsurface geotechnical conditions along the pavement and provide geotechnical parameters for the design of the project scope of work.

CLIENT:	Roads ACT
PROJECT	Pavement Failure Investigation Tarra Place, Ngunnawal, ACT
Equipment Type	: EZ36
Hole Diameter	: 300mm

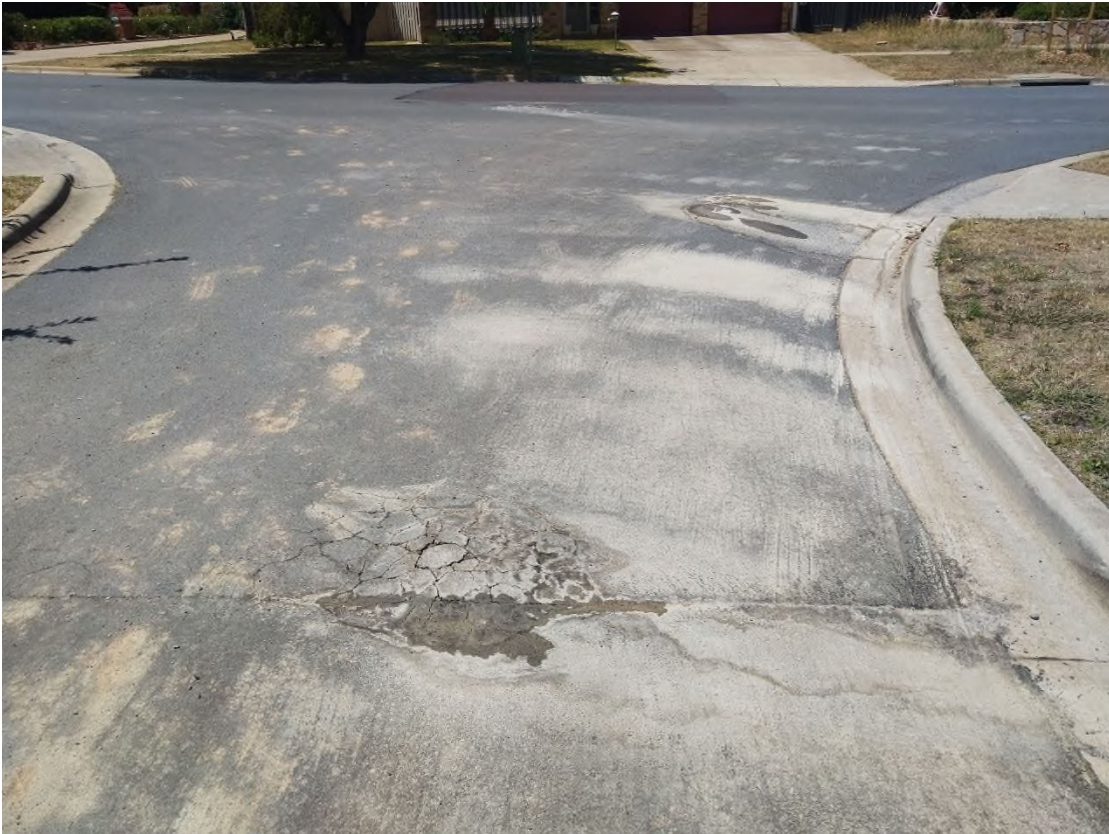
**Plate 1: Crocodile Cracking and seepage from pavement.**

Defect Type	Possible causes	Photograph
<b>Crocodile Cracking</b>	Fatigue induced structural cracking Moisture in formation	Plate 1 & 2

Seepages were observed from the pot hole and two areas near the intersection of Tarra Place and Jabanungga Ave. Seepages are likely occurring due to pumping action from traffic driving over the cracked area forcing moisture within the base course and subgrade to the surface.

The pavement failures in the area are inferred to have been induced by excessive water in the subgrade. Prolonged saturation of the subgrades has significantly weakened the subgrade material, inducing pavement failure when trafficked.

Heavy patching of the pavement in Zone A has been previously undertaken, and to date appears to have largely remediated the issue in this zone. Heavy patching should comprise the milling of the existing wearing course and placement of a minimum asphalt thickness of 200mm. We note however that the performance such patches cannot be guaranteed, as shown by the post-patching failures in Zone B & C. It may also cause the failure of pavements elsewhere in the vicinity due to the sealing in of water in the patched area, causing further migration of the water to other areas.

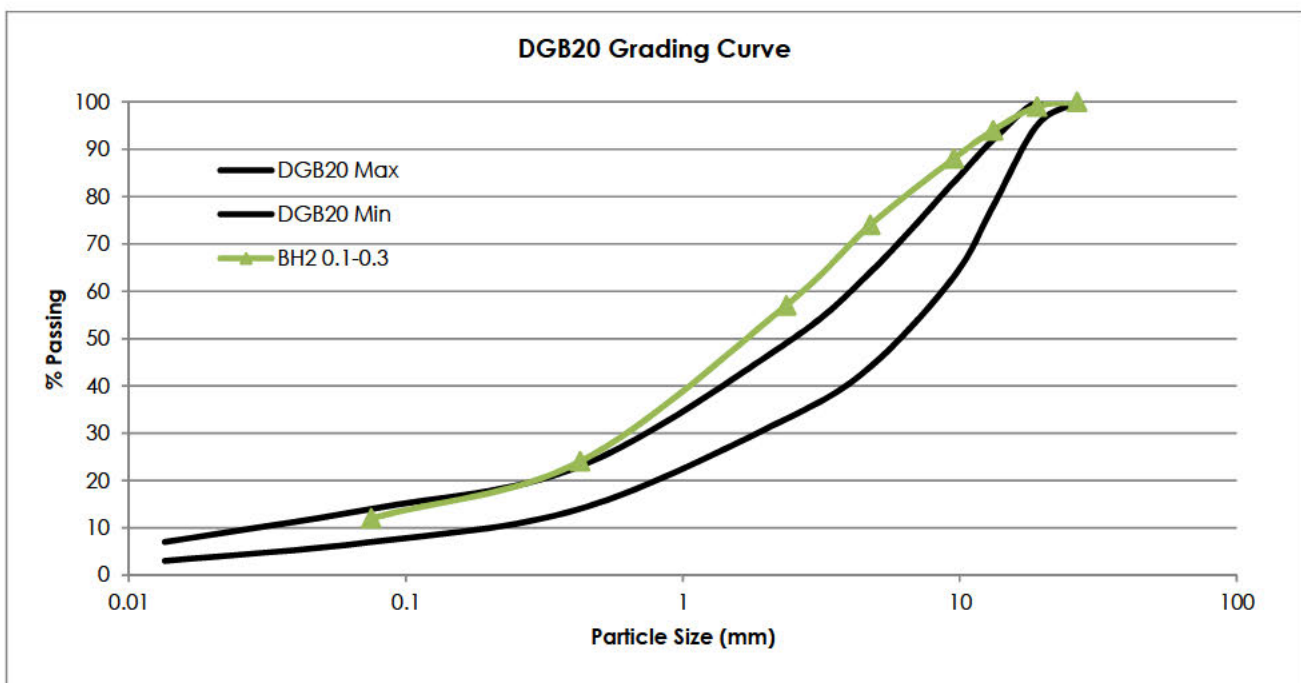
Figure 3: Base course Grading Curve

The result of the particle size distribution of the existing base course has been plotted against the DGB20 grading limits given by TfNSW QA specification 3051- Granular Pavement Base and Subbase Materials, and is shown in Figure 3 below.

The grading curves indicate the sand fraction of the base course exceeds the grading requirement for DGB20, but is generally compliant with the fines requirement. The base course material meets the plasticity requirements.

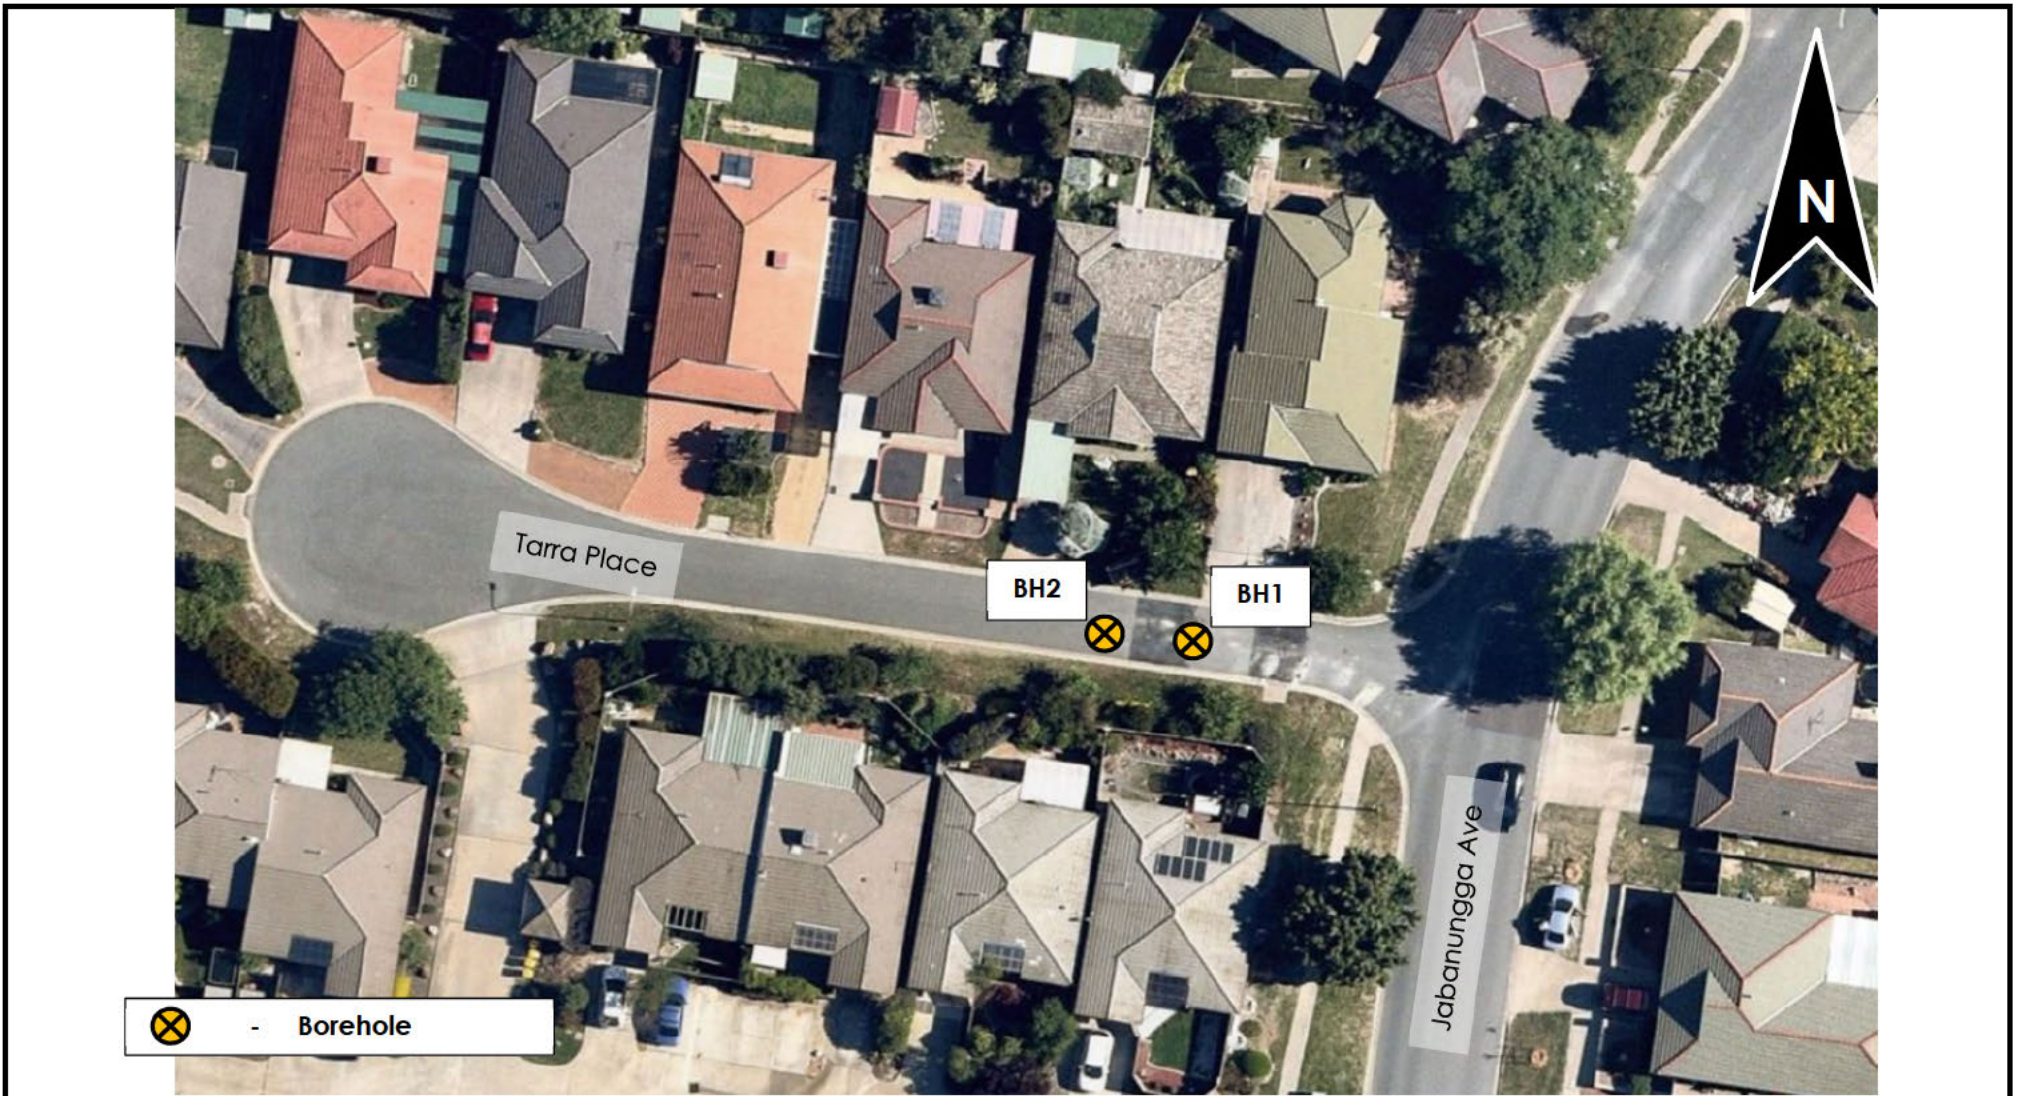
FIGURE 2

To establish the subsurface conditions, a 3.5T excavator with a 300mm diameter auger was used to drill 2 boreholes (designated BH1 to BH2) to 1.5m below ground level (mbgl) or prior refusal. The subsurface profiles were logged general accordance with AS1726-2017. The locations of the boreholes are shown on Figure 1, and the detailed logs are attached to this letter. BH1 was located within an area of failed pavement, while

BH2 was located to the west of the failed section of pavement, where the pavement was showing no visible signs of deterioration.

**ROADS ACT  
TARRA PLACE, NGUNNAWAL  
BOREHOLE LOCATION PLAN**

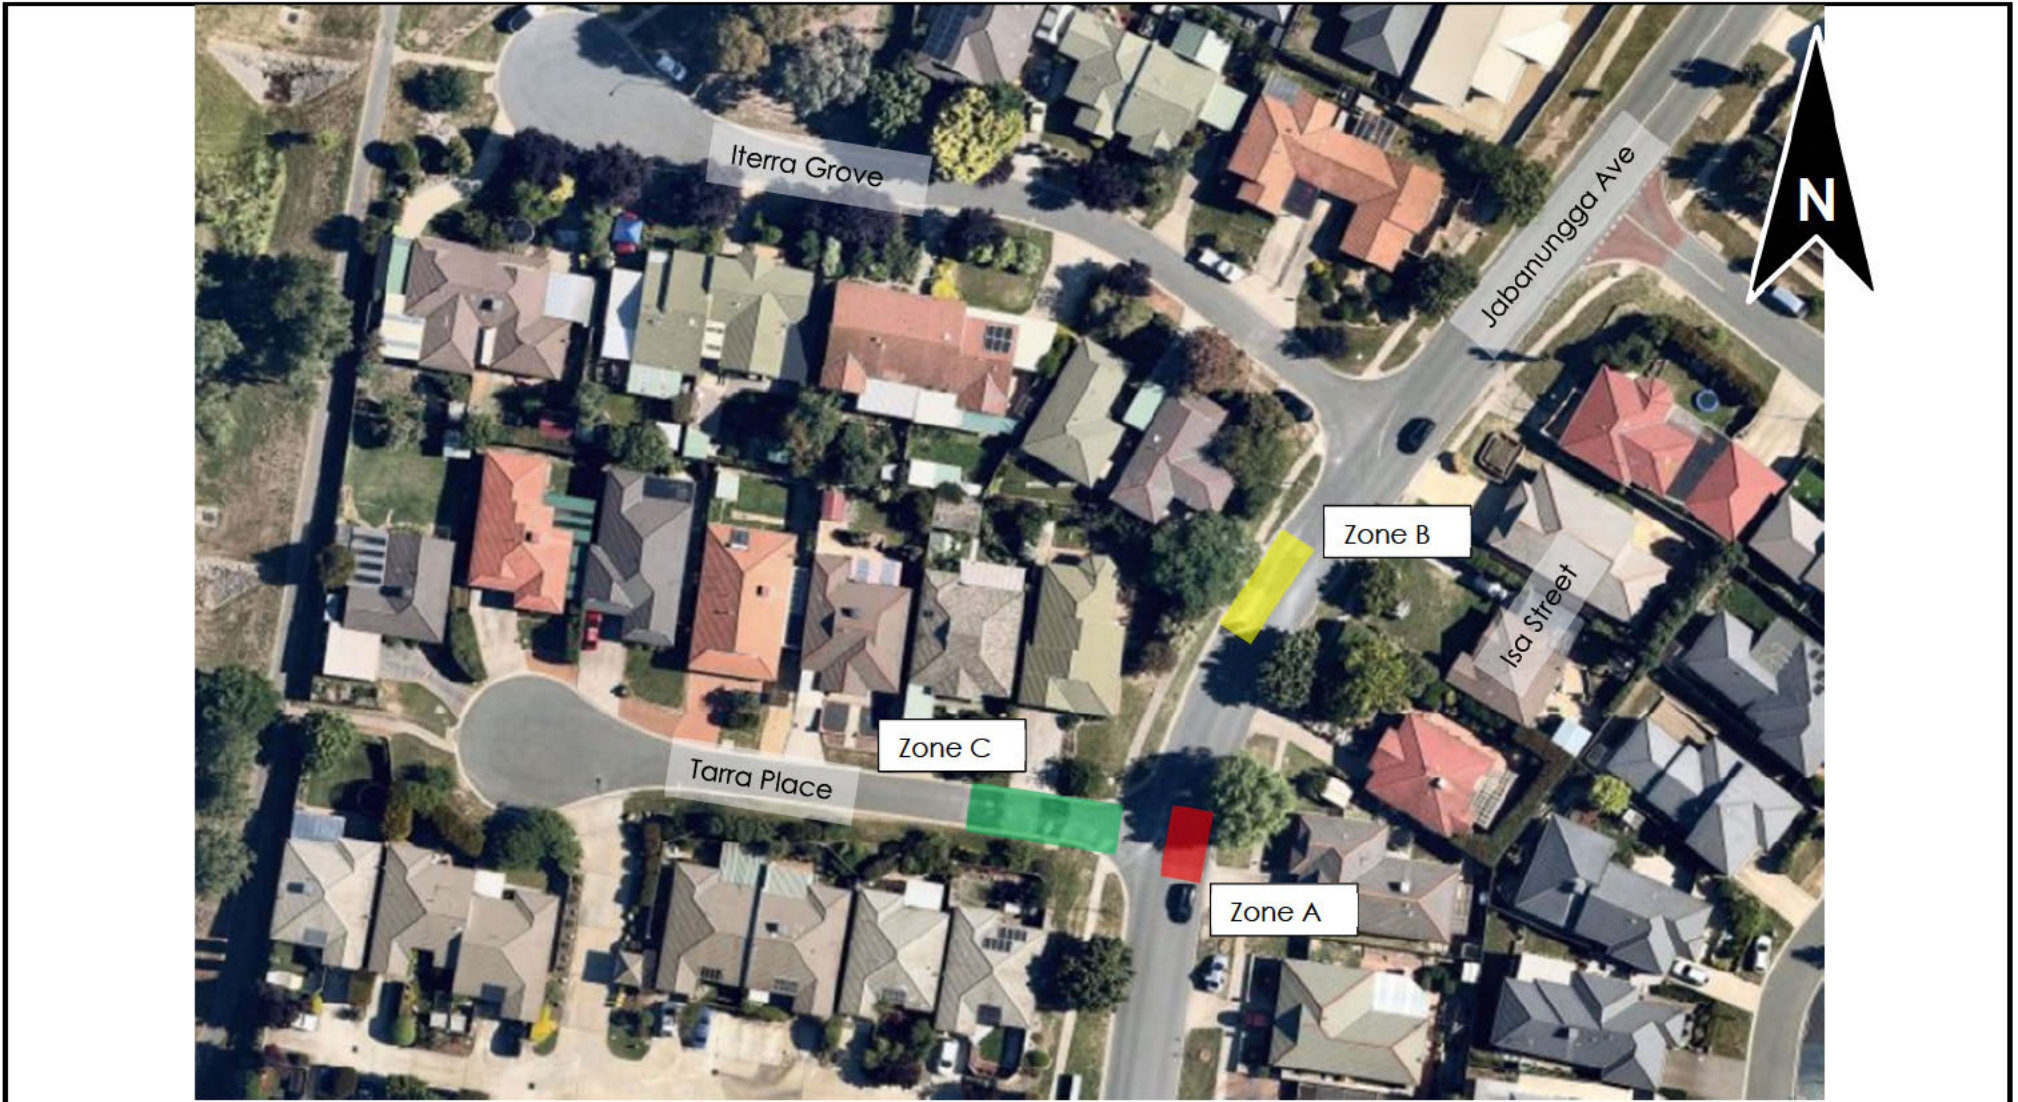
FIGURE 3

A review of the pavement condition was undertaken using aerial photography available from Nearmap and Google Earth to assess the history of the pavement condition in the area. Table 4 summarises the findings. Reference is made to three zones of pavement – Zone A to Zone C – where failures have been observed. Figure 2 shows the locations of these zones.

Photograph Date	Observations
<b>December 2002</b>	Tarra Place, Iterra Grove and Jabanunga Ave have been constructed with residential dwellings on both sides. No development has occurred to the north of the dwellings on the northern side of Iterra Grove. Pavements appear to be in an adequate condition.
<b>November 2009</b>	Development to the west of Horse Park drive in Casey has commenced. Pavements appear to be in an adequate condition.
<b>September 2012</b>	Development of Ngunnawal to the north of Iterra Grove and east of Jabanungga Ave begins. Pavements appear to be in an adequate condition. Some dirt is present on the pavements, likely associated with construction traffic or erosion.
<b>April 2013</b>	Construction of the stormwater dam/wetland to the north begins. Development of Ngunnawal north continuing. Pavements appear to be in an adequate condition. Some dirt is present on the pavements, likely associated with construction traffic and works. Construction of dwellings to the east of Jabanungga Ave begins.

<b>July 2013</b>	Water begins accumulating in the stormwater dam. Pavements appear to be in an adequate condition.
<b>December 2013</b>	Construction of residential dwellings in Ngunnawal north is underway. Pavements appear to be in an adequate condition.
<b>February 2016</b>	Pavement failure in Zone A has occurred.
<b>August 2016</b>	Heavy patching of Zone A undertaken.
<b>October 2016</b>	Pavement failure in Zone B has occurred.
<b>December 2016</b>	Heavy patching of Zone B has been undertaken.
<b>March 2017</b>	Dilapidation of the patch in Zone B is occurring.
<b>April 2017</b>	Repatching of an area of Zone B has been undertaken.
<b>Novemebr 2018</b>	Some deterioration of the pavement in the north of Zone B appears.
<b>June 2020</b>	Minor deterioration of pavement in Zone C
<b>August 2020</b>	Major deterioration of pavement in Zone C
<b>December 2020</b>	Heavy patching of Zone C undertaken. Failures through the patches and to the east occurring. Seepages and failure in the south of Zone B appear.

**ROADS ACT  
TARRA PLACE, NGUNNAWAL  
HISTORIC PAVEMENT FAILURES**

Given that the pavement failures in the area started to occur shortly after the development to the north and east of the site, it is considered likely that water is naturally occurring seepage from an upslope source. Development may have changed the water infiltration and runoff pathways, and water may be migrating

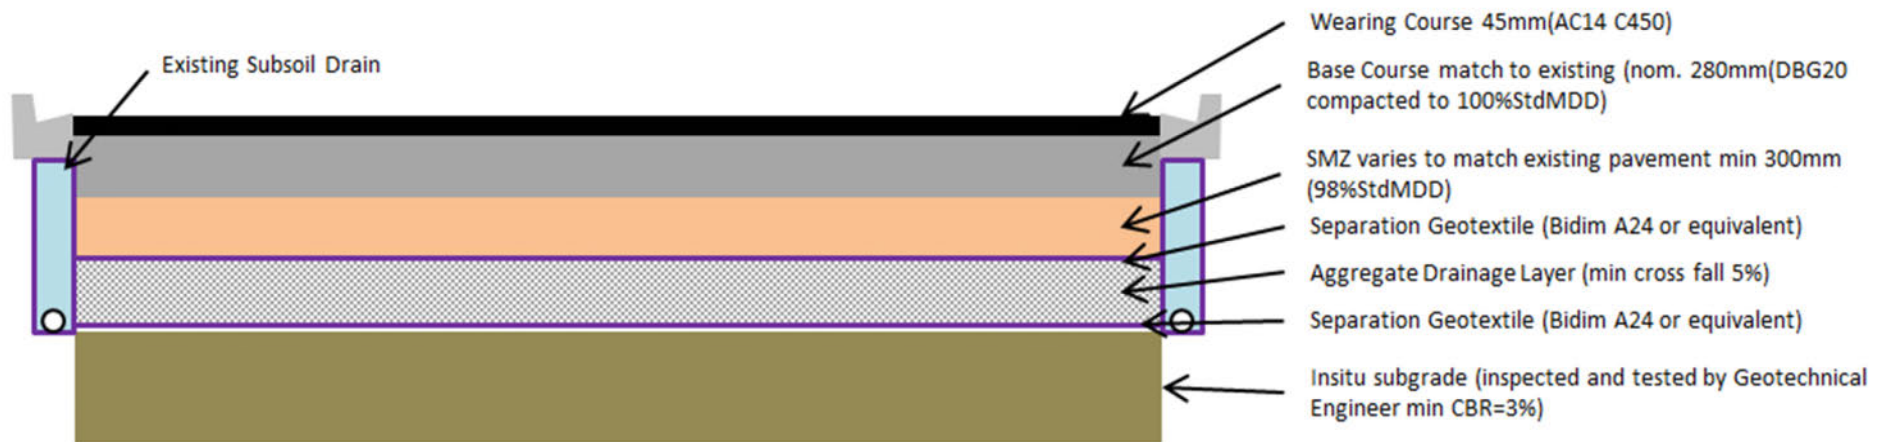
FIGURE 4

ROADS ACT  
TARRA PLACE, NGUNNAWAL  
FULL DEPTH RECONSTRUCTION

1. Milling of existing wearing course;
2. Excavation of existing granular base course. This material would likely be suitable for reuse in the new pavement layers, but confirmation of suitability for use as base course would be required following laboratory testing of the stockpiled materials;

3. Excavation and offsite disposal of water effected subgrade soils. Based on the profile in BH1, this is likely up to 900mm below surface level. Wet soils (moisture content above optimum moisture content (OMC)) would not be suitable for reuse without air drying. Any soils with an in situ moisture content less than OMC may be suitable for reuse with approval from a suitability qualified geotechnical engineer;

6. Placement of a Select Material Zone (SMZ) with a thickness of 300mm. It is recommended that the SMZ material be lime-treated (2%) to minimise its susceptibility to moisture changes; and,

Figure 4 shows the details of this option. Detailed design would require review of the existing subsoil drainage details and confirmation installation and performance. Adoption of this option may result in pavement failures in other areas.

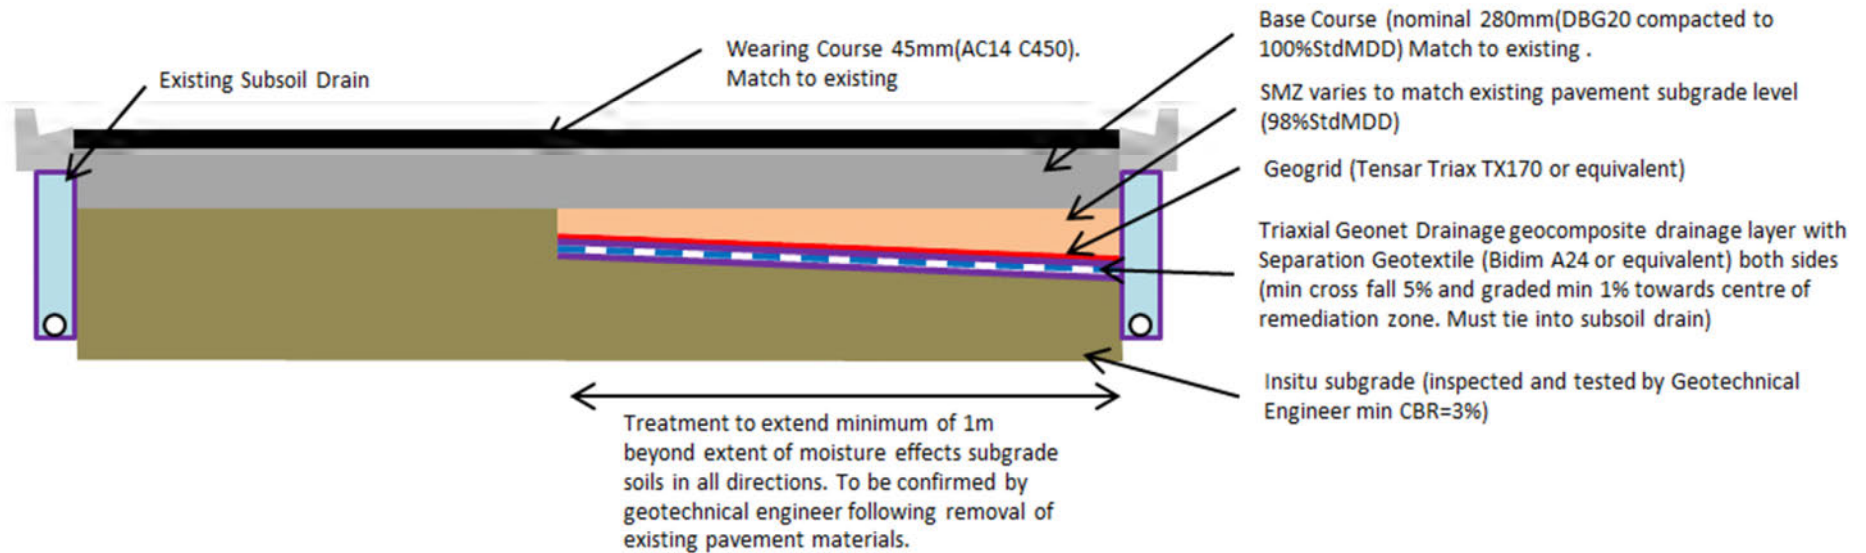
FIGURE 5

**ROADS ACT  
TARRA PLACE, NGUNNAWAL  
LOCAL PAVEMENT REINFORCEMENT**

Localised pavement reinforcement would require full depth reconstruction of the pavement locally where the pavement failures are occurring. Pavement reinforcement would comprise the following procedure:

1. Milling of existing wearing course;
2. Excavation of existing granular base course. This material would likely be suitable for reuse in the new pavement layers, but confirmation of acceptability for use as base course would be required following laboratory testing of the stockpiled materials;

6. Placement of a Select Material Zone (SMZ) with a thickness of 300mm. It is recommended that the SMZ material be lime-treated (2%) to minimize its susceptibility to moisture changed; and,

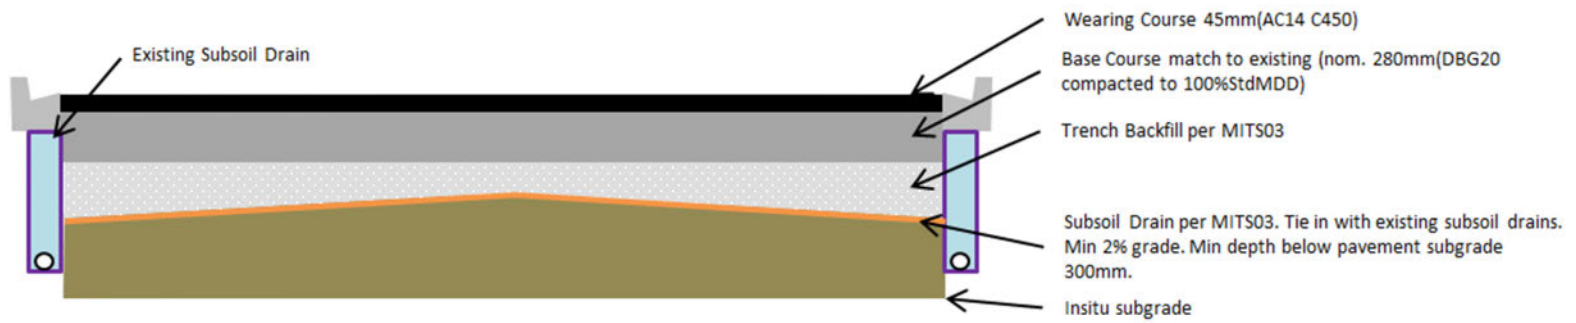
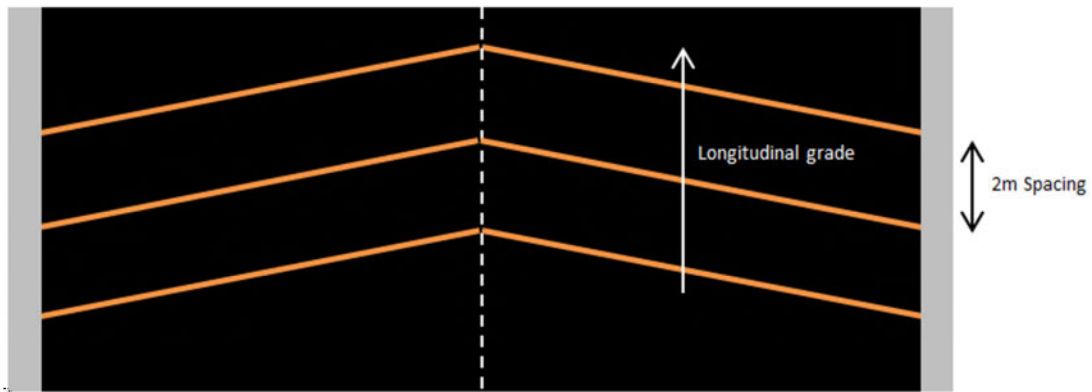
**ROADS ACT  
TARRA PLACE, NGUNNAWAL  
HERRING BONE SUBSOIL DRAINS**

Section

Plan

Installation of subsoil drains within the pavement subgrade could allow for moisture within the formation to be collected prior to saturating the subgrade within 300mm of the pavement.

1. Excavate subsoil trenches within the failed pavement area to a minimum depth of 300mm below subgrade level (approx. 600mm) at 2m longitudinal spacing in the configuration shown on Figure 5;
2. Install subsoil drains and tie into existing subsoil drains in accordance with MITS03;
3. Backfill trenches in accordance with MITS03;
4. Undertake deep lift patching of the failed pavement areas;
5. Patch trench excavations;
6. Monitor performance of pavement for 12 months; and,
7. If the pavement is performing adequately, mill and resheet wearing course of entire treated area.
