Lake Ginninderra Community Path Feasibility Study Report

Transport Canberra and
City Services

Tait Network

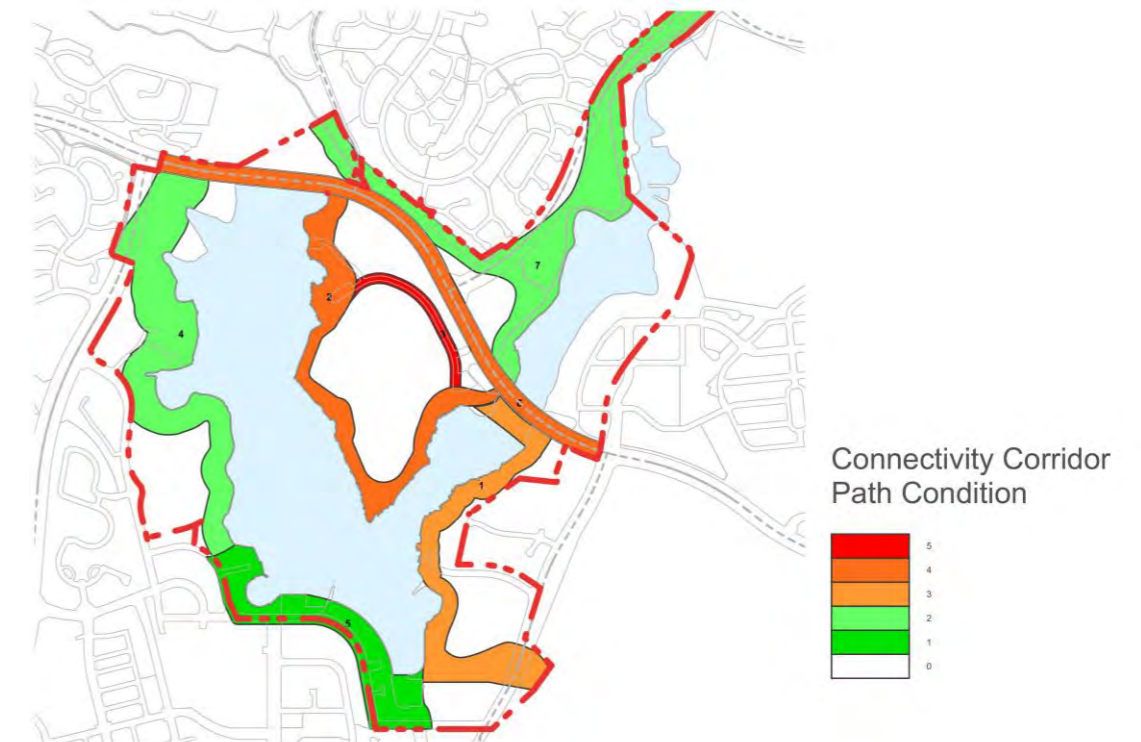
Connectivity Corridor Average Path Condition Ranking

The audit data of path condition assessment has been averaged across each connectivity corridor to produce a ranking of 1 to 5.

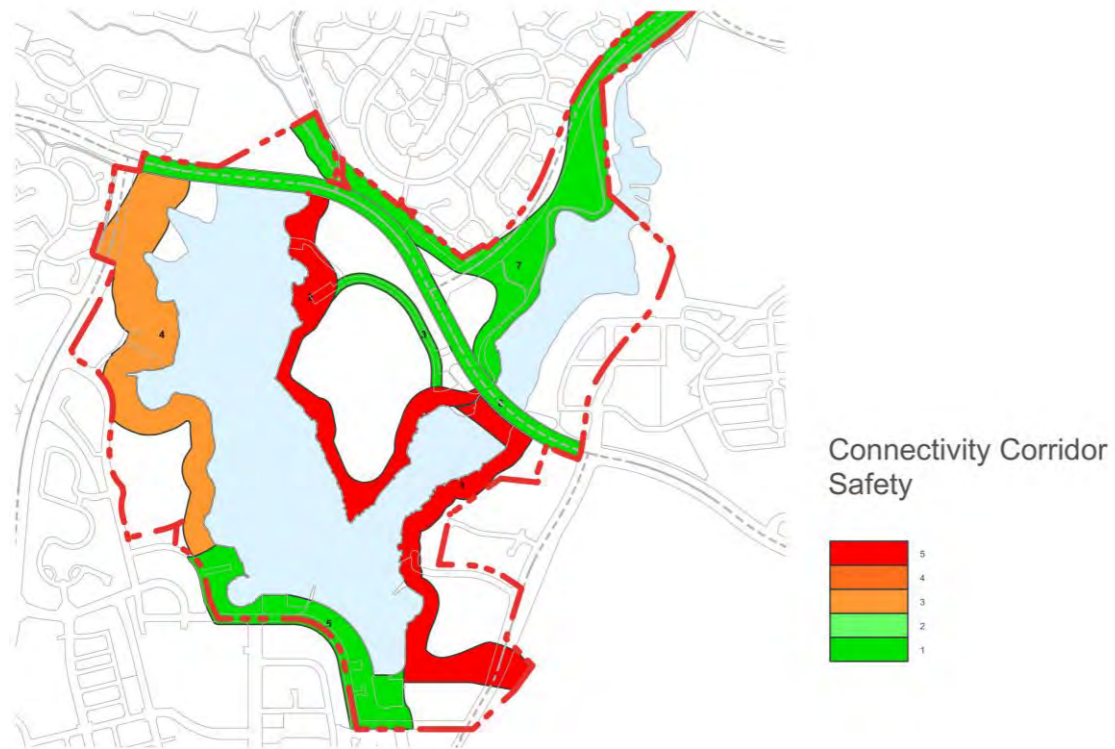
Connectivity Corridor Path Safety Ranking

The audit data of path safety assessment has been averaged across each connectivity corridor to produce a ranking of 1 to 5.

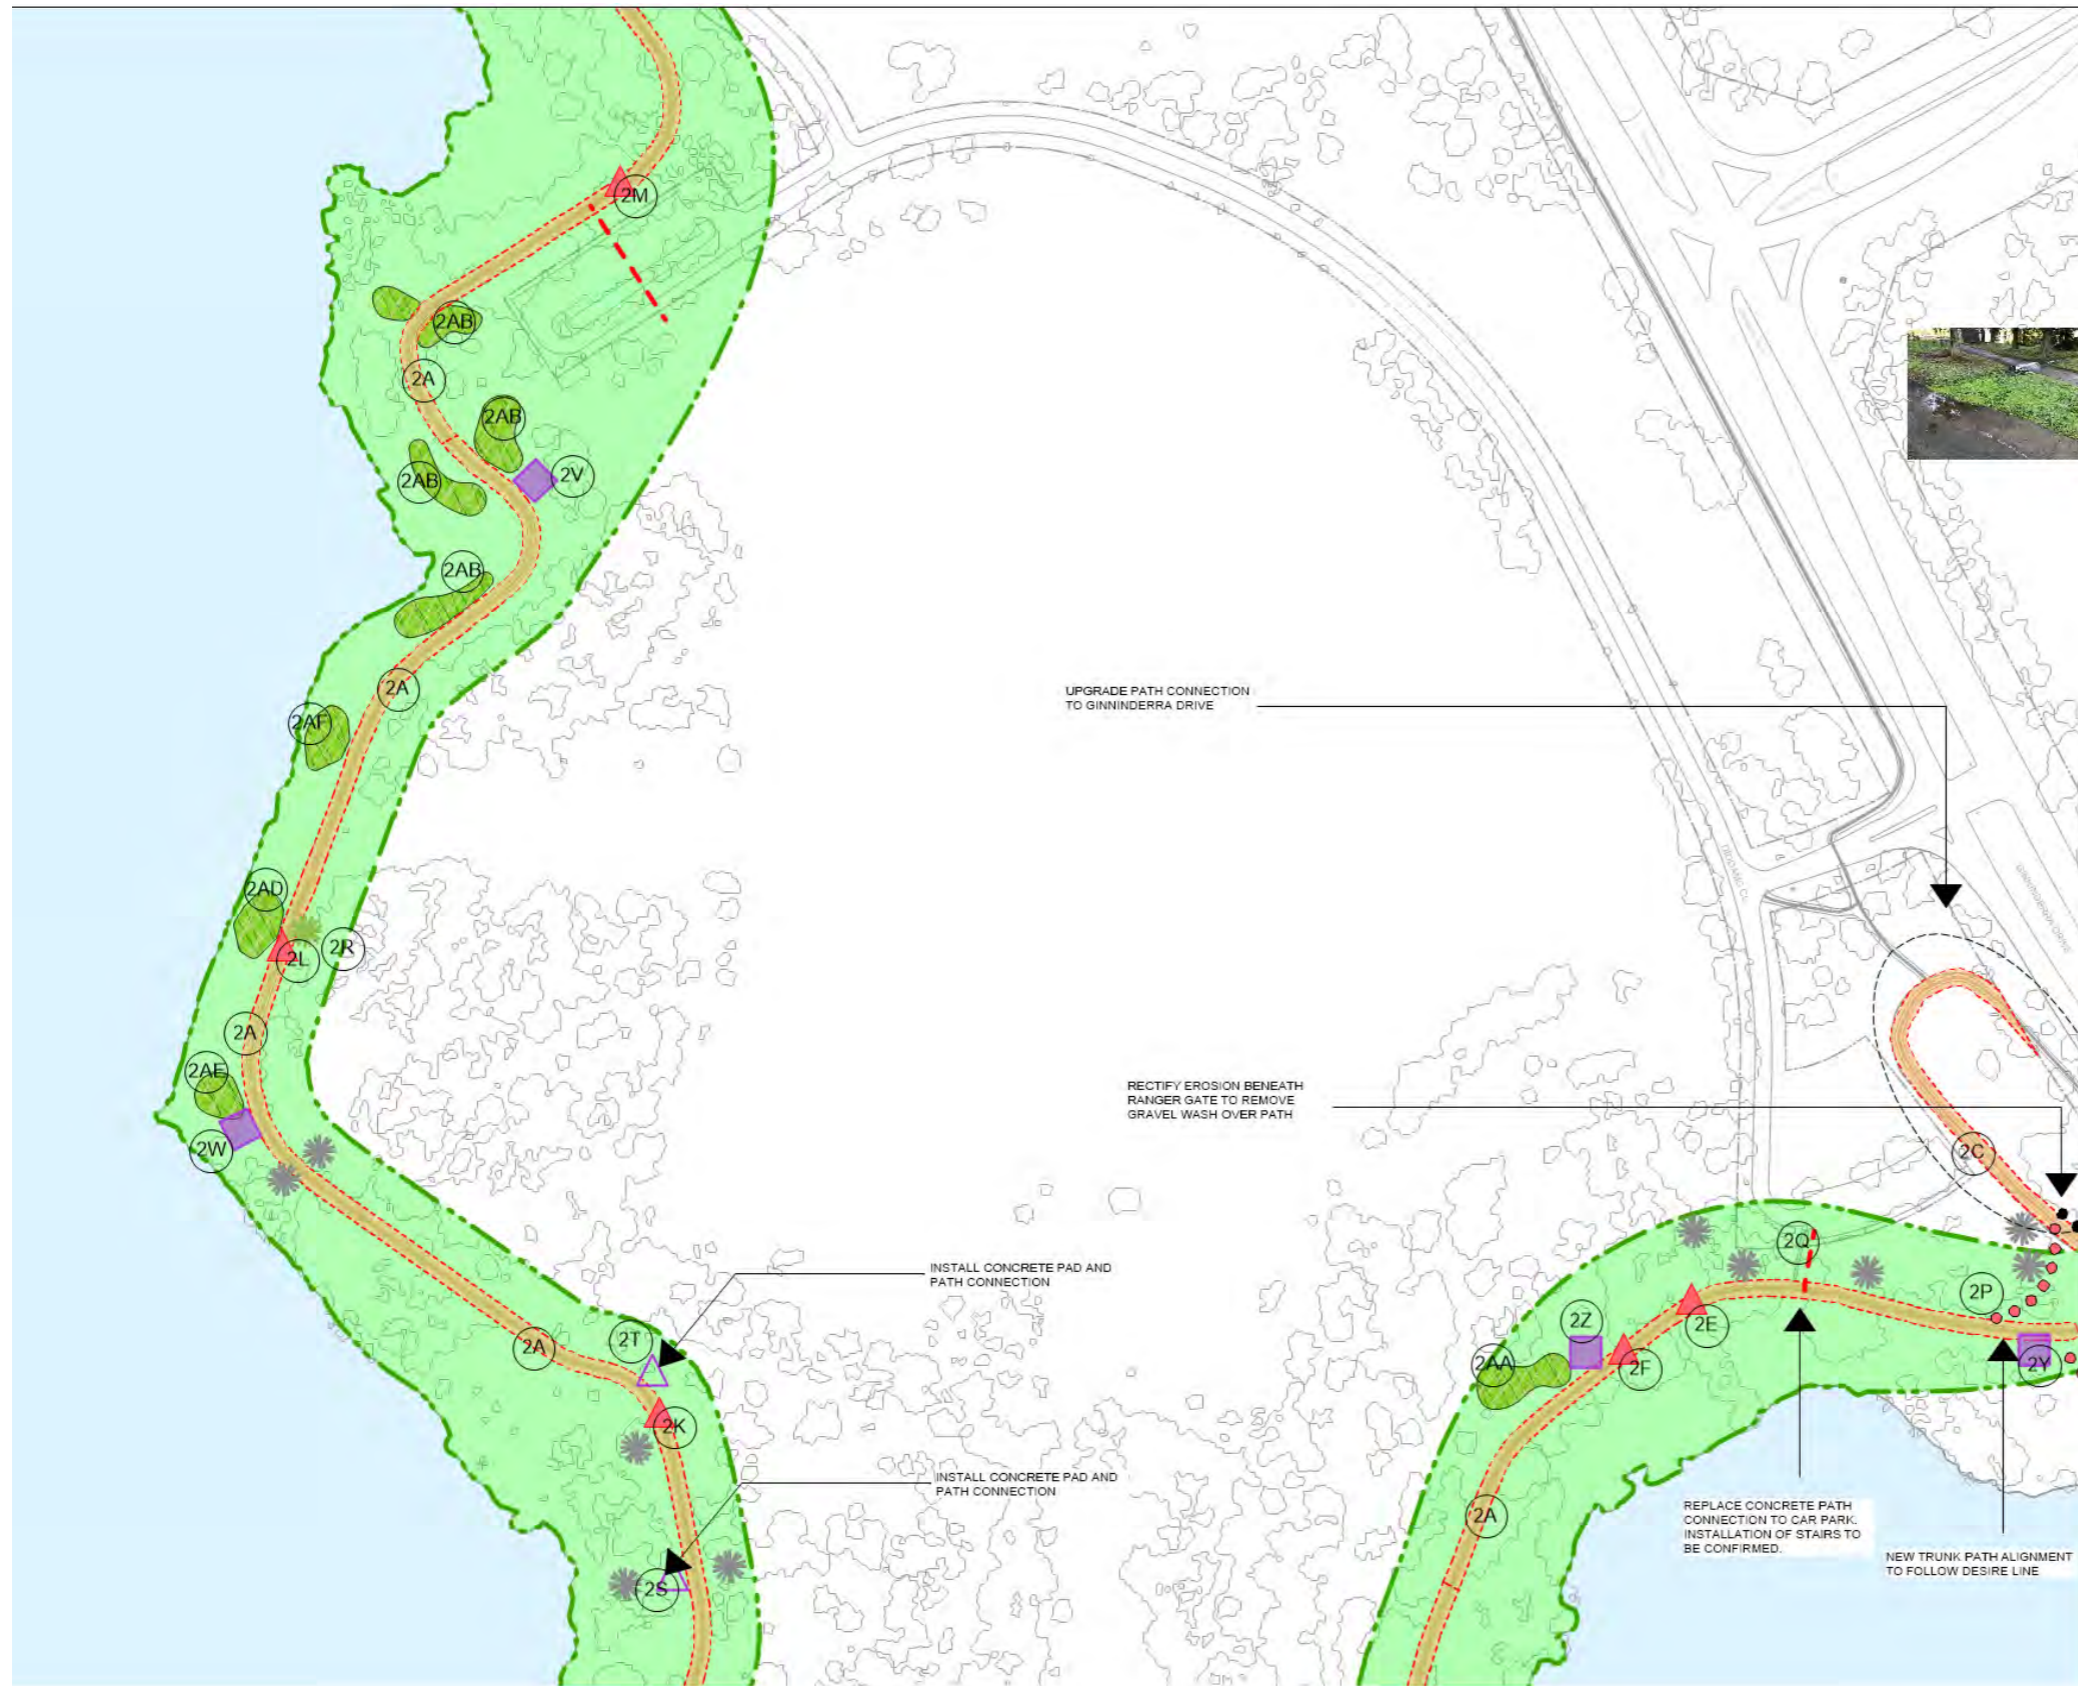
2D

The path area at the eastern end of the corridor adjacent to the Ginninderra Drive underpass contains the following defect issues:

- Poor drainage results in path flooding (2D) which will be resolved through path regrading and the installation of culverts and swales
- A major desire line cuts across from the main path to the connection to the bridge (2Q). This is to be formalised to become the main path route. This path connection is proposed to be lit, with one new light column centrally located, one to the southern end of the new path and an existing light to the northern end of the path being converted to a double sided luminaire.
- An area of erosion adjacent to the bridge connection path (2P) causes dirt and gravel to wash across the path. This is to be remediated through stabilisation works

The overarching proposal in this corridor is the widening of the existing path (Paths 2A, 2B and 2C) to 4m allowing for increased capacity. A number of path defects will be addressed in conjunction with the path widening.

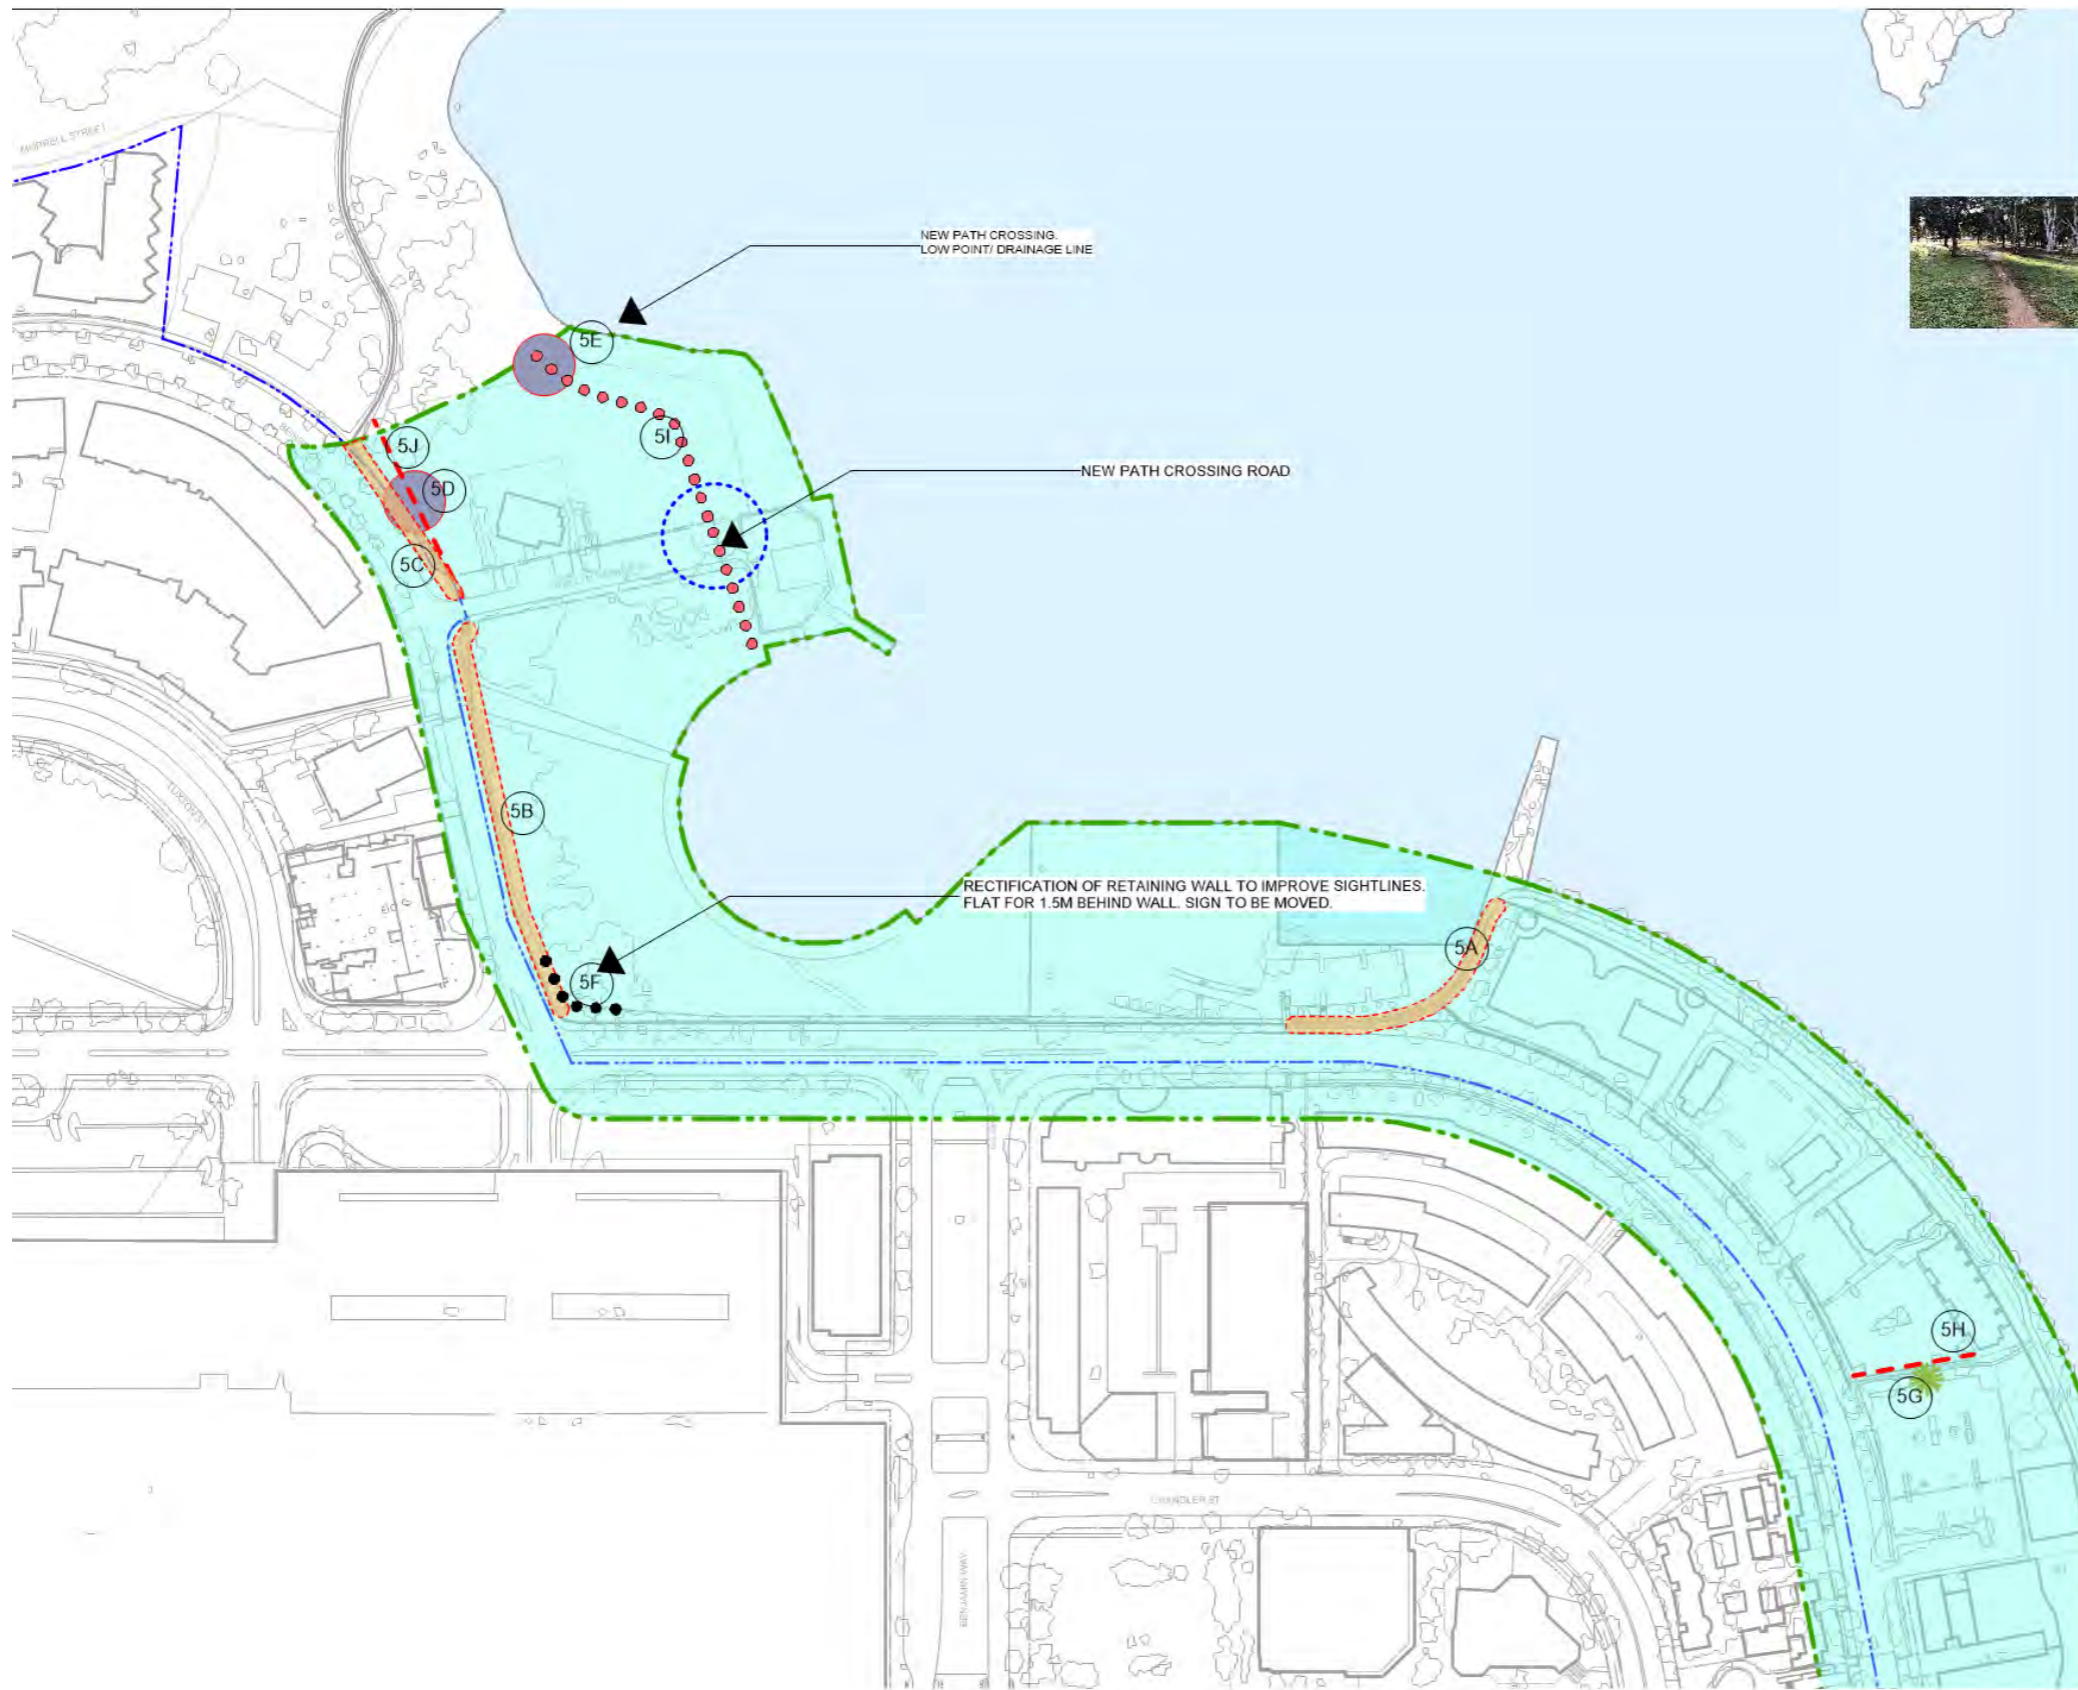
5D

A safety issue has been identified to the corner of Emu Bank and Beissel Street with an existing retaining wall impacting site lines of cyclists using the path at this corner. It is proposed to remodel the retaining wall and relocate the sign on top of it to alleviate this issue.
