local shopping centre upgrade program 2016-17

forward design report  
15 December 2017

campbell shops

CAMPBELL Shops  
 Local Shopping Centre Upgrade Program 2016-2017  
 Feasibility Design Studies

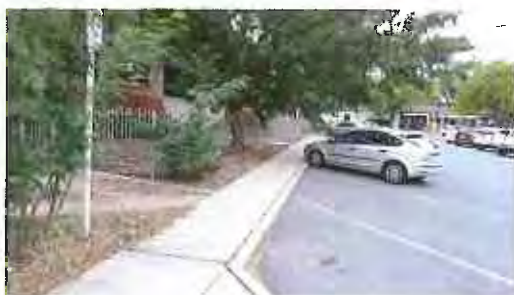
*Narrow footpaths and vehicle overhang*

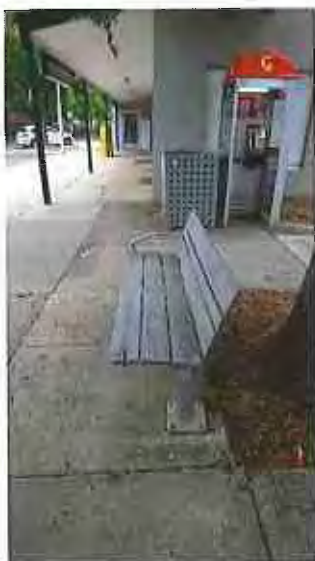
*Eastern shops have greater than 1:40 cross fall and stepped entry*

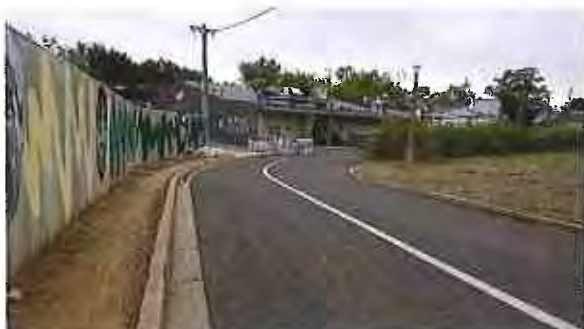
*Entry to secondary car park obscured by tall bushes*

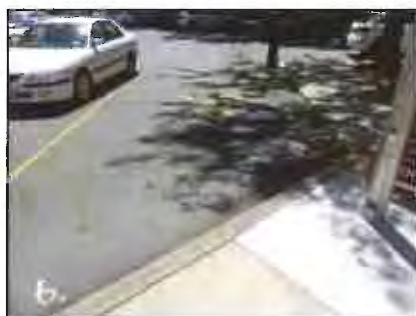
Figure 1

There are two designated angled parking spaces for people with disabilities that are compliant with the old standard AS2890.1, except gradients are slightly in excess of 2.5%. These designated spaces do not meet the current standards as outlined in AS2890.6.

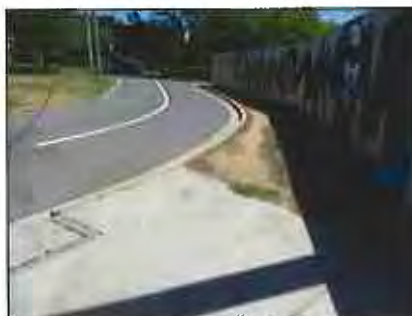
**Figure 4**

Cross falls on the footpath on the Northern side of the car park on Blamey Place and the Southern footpath along Chauvel Street are often in excess of 1 in 40 (2.5%). The access along the shops on the Eastern side is too steep.

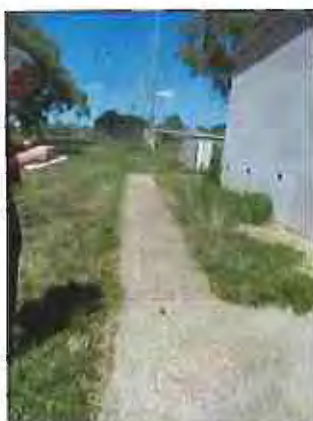
**Figure 5**

The footpath on the South Eastern corner (next to the Scout Hall) does not comply. The width is 1170mm and cross falls are in excess of 1 in 40 (2.5%).

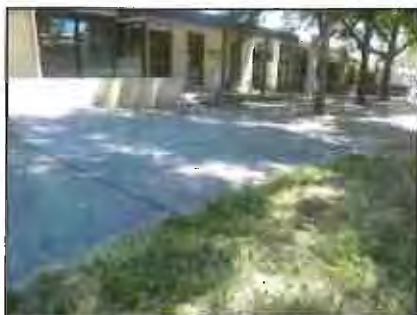
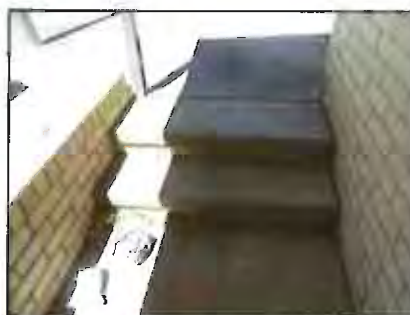
The access way between the buildings on the Eastern side is in excess of 1 in 20 (5%). The stairs have no TGS, handrail or contrast nosing.

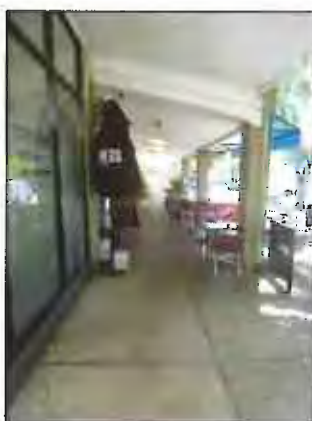
Figure 8

There are a few obstructions in the access way against the shops building/property line such as chairs, tables, umbrellas, signs, and an ice machine.

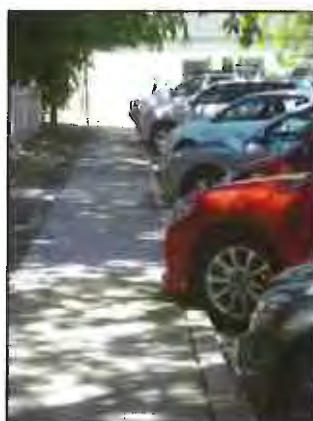
Figure 9

There is a minor overhang of cars over the footpath on the northern and southern sides of the car park on Blamey Place.

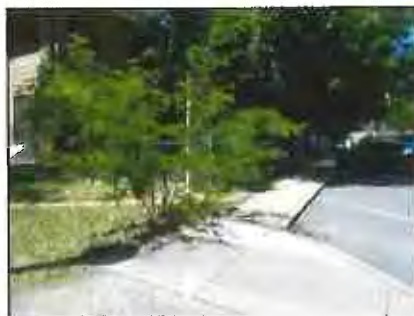
Figure 10

The footpath on the North Western corner of Blamey Place has a shrub growing over the access way.

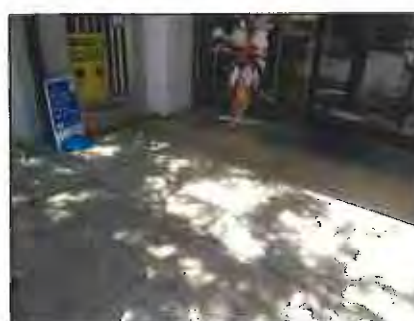
Figure 11

Most shops have step access on the Eastern side.

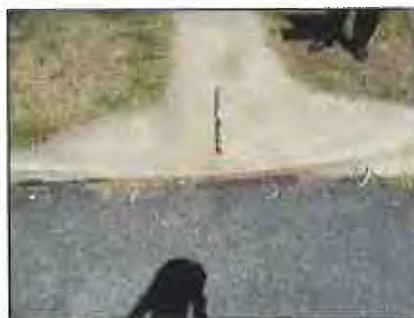
Figure 12

The gradients of most kerb ramps generally comply. A few have a lip and a few are too steep.

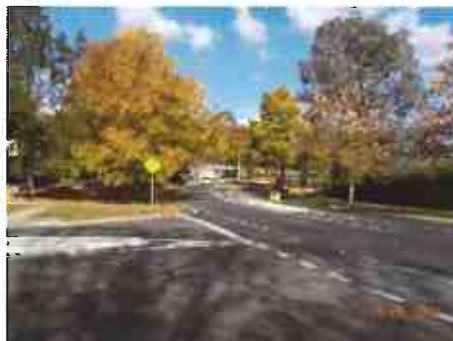
**Figure 5: 114m North on Blamey Crescent**

114m north of shops on Blamey Crescent – no obstruction in drivers view as per Austroads standards and is acceptable.

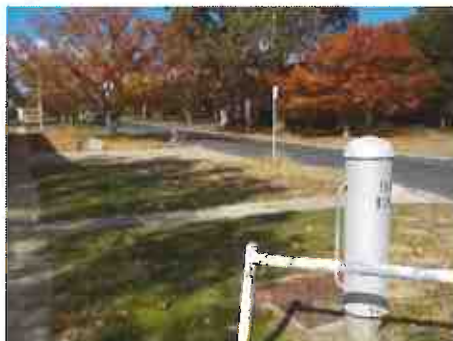
**Figure 6: 48m West on Chauvel Street**

48m west of shops on Chauvel Street – no obstruction in drivers view. Only measured to 48m due to proximity of existing road.

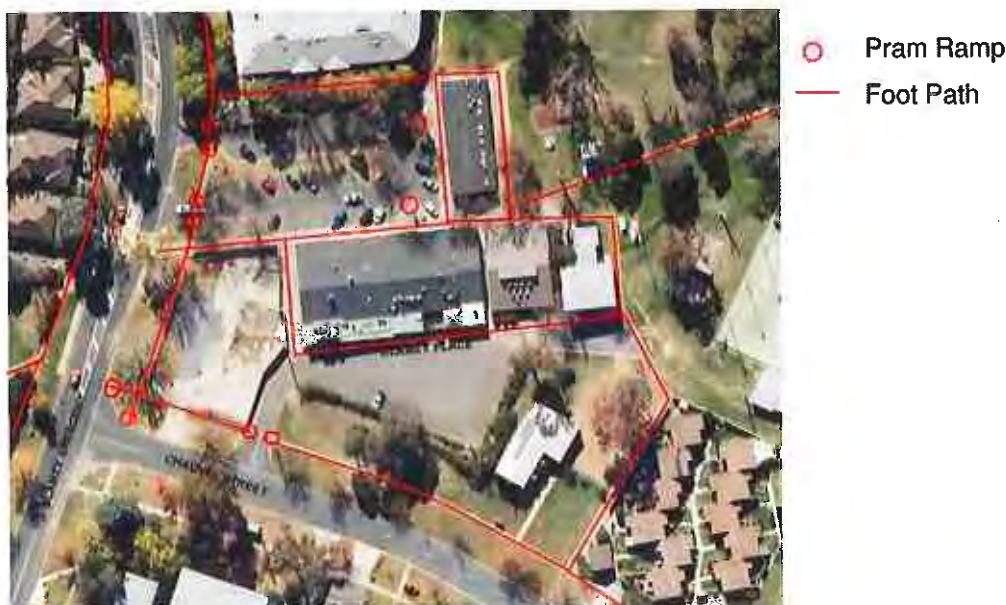
**Figure 8: Foot Paths and Pram Ramps near Campbell Shops**

At either end and at the middle of the island at the primary car park at Campbell, there are pedestrian foot paths. There are pram ramps located near the paths at the eastern side of the island however the other foot paths do not have pram ramps.

There is a foot path around the perimeter of the car park. The northern footpath is restricted by space due to an existing fence however the western and southern foot paths have a larger distance from the kerb to the shop fronts. Figure 8 illustrates the locations of the foot paths and pram ramps.

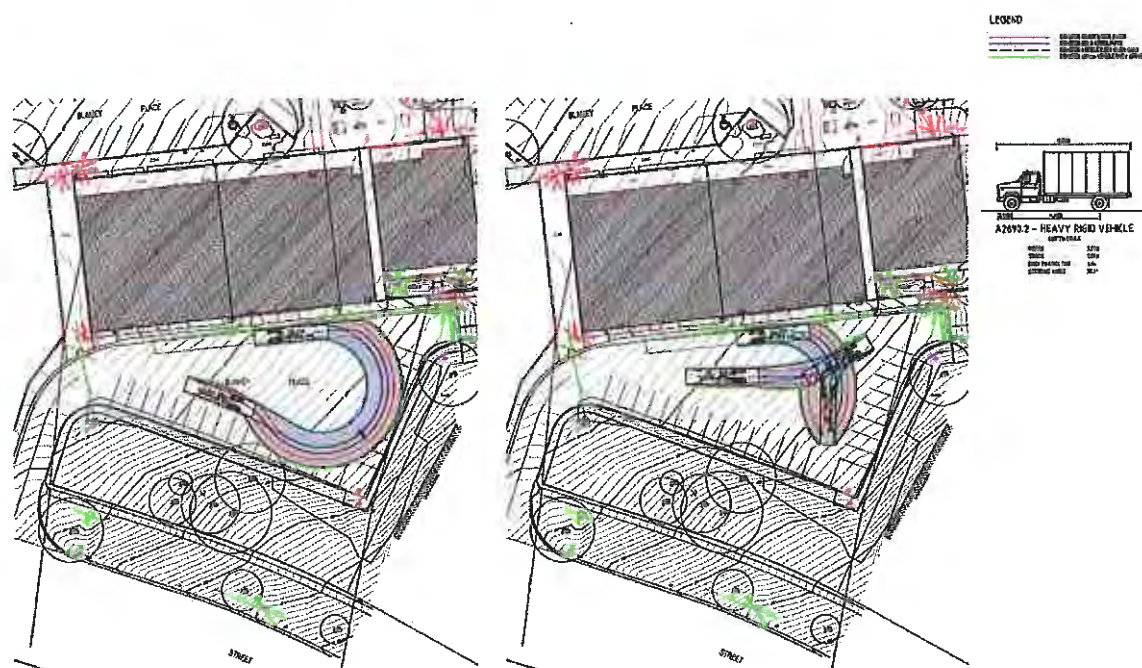
Figure 13: Blamey Place Shops Waste Truck Turning Template

The service vehicle access complies with AS 2890.2 in regards to the waste vehicle access and turning circle. When the loading area is occupied by waste or cars, or when the centre of the car park has parked cars, the turning circles will not work. Figure 13 illustrates the turning alternatives. It is anticipated that waste collection will occur outside of operating hours for the shops.
