local shopping centre upgrade program 2016-17

forward design report

15 December 2017

duffy shops

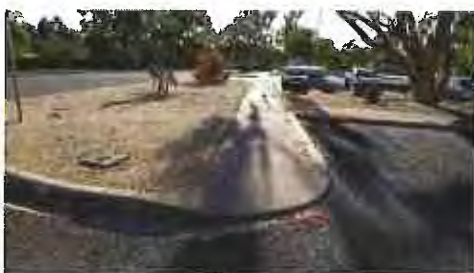
Non-compliant kerb ramps

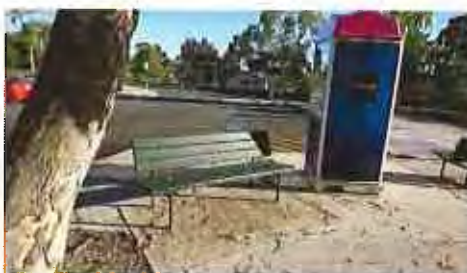
Telephone booth not accessible

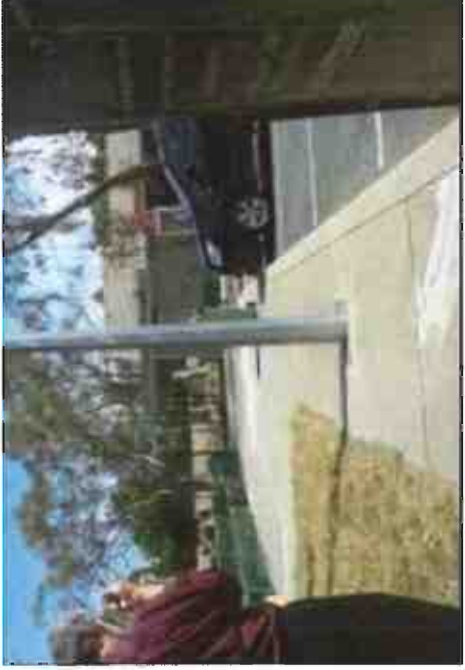
2 Light pole in the middle of path - impedes access

The footpath on the Eastern side of the car park has a pole in the middle of the path with a clearance of 580mm. Footpaths against kerbs are not wide enough where a 1600mm width is required.

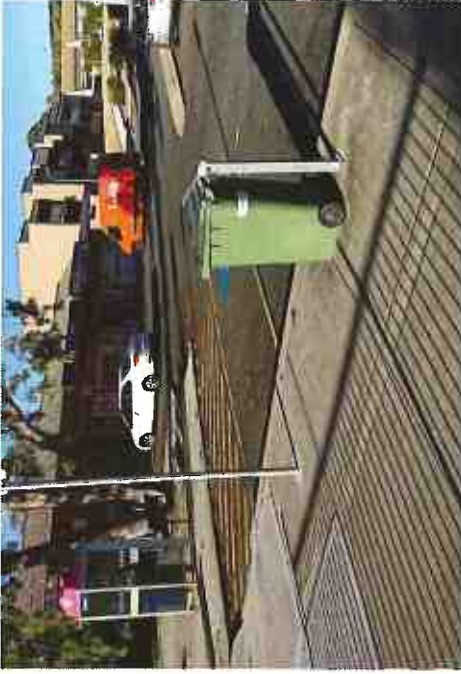
1 Disable carparks - compliant

There are two designated parking spaces for people with disabilities that are compliant to current standards (AS2890.6).
