BRITTEN JONES DRIVE

Playground Inventory Report

Playground ID: PLGR121

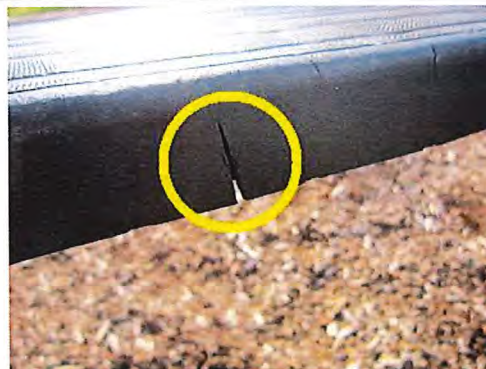
Photo taken: 01/05/2012 Small split in edge of flat seat. Monitor.

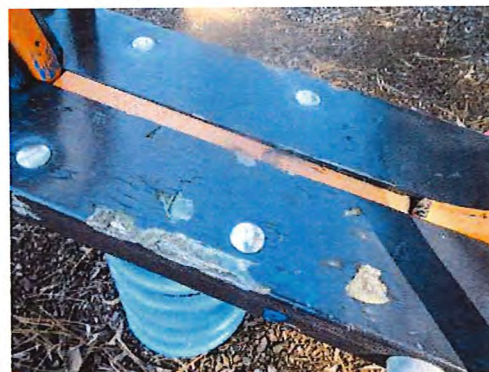
Item Components				Date Installed	Est.	Condition	Rocker Type	Removed/Current
1	PLCO6958	Rocker (spring)	1	Plyboard (painted)	1/01/2004	<input checked="" type="checkbox"/>	3	Current
Comments: Kompan Product 'Crazy Horse'. Coating is peeling, hand and footrests are chipped. Seat height=370mm.

Photo taken: 23/05/2016 Peeling coating, monitor.

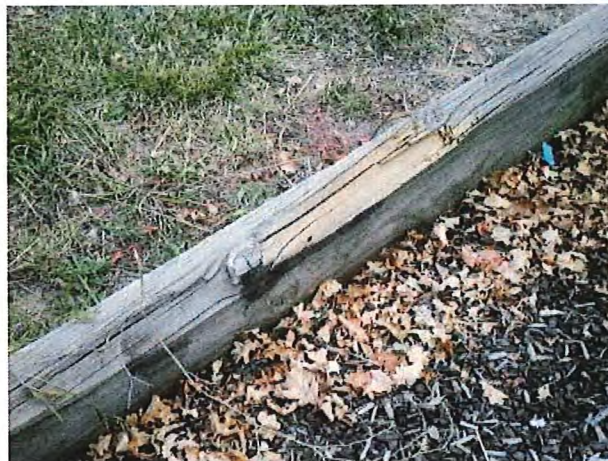
Comments: Some sections of timber edging exhibit splitting. Monitor.

Photo taken: 03/05/2011 Some sections of timber edging are splitting. Monitor.

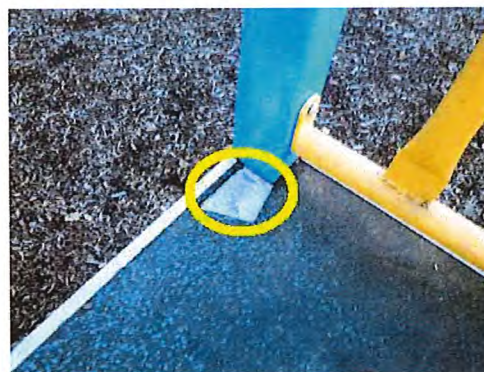
Photo taken: 13/05/2010 Coating cut off deck. Monitor.

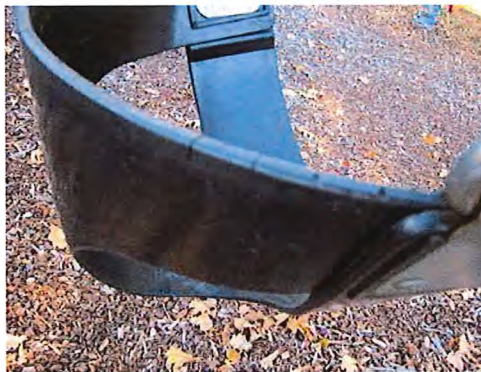
Photo taken: 01/05/2012 Cuts along top edge of toddler seat. Monitor.

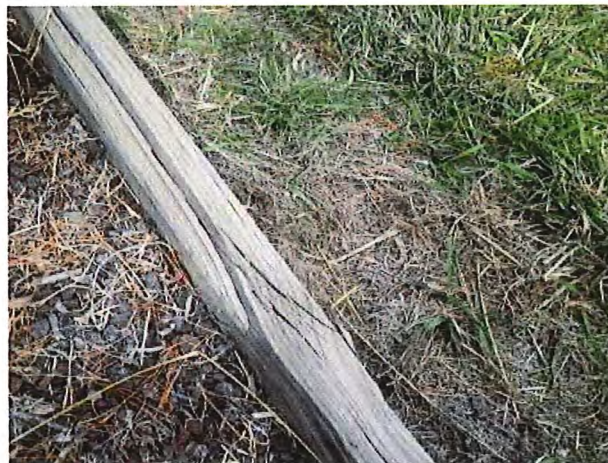
Comments: Some sections of timber edging exhibit splitting. Monitor.

Photo taken: 03/05/2011 Some sections of timber edging exhibit splitting. Monitor.

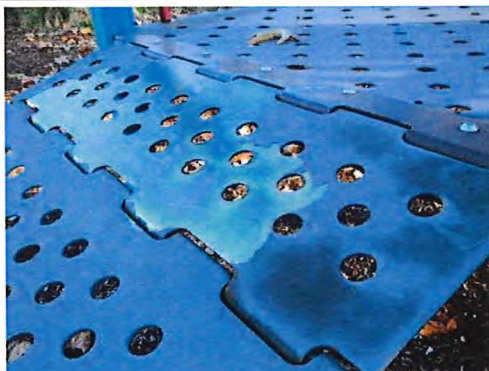
Photo taken: 25/05/2017 Clatter bridge coating peeling, monitor.

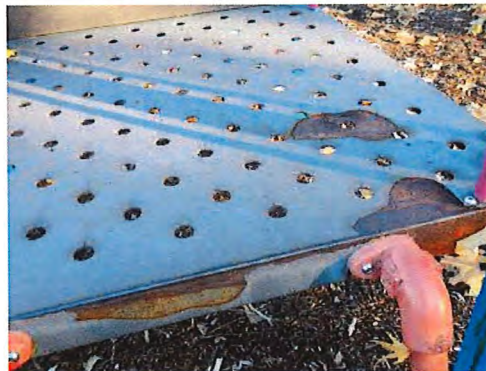
Photo taken: 25/05/2017 Deck coat peeling. Monitor.

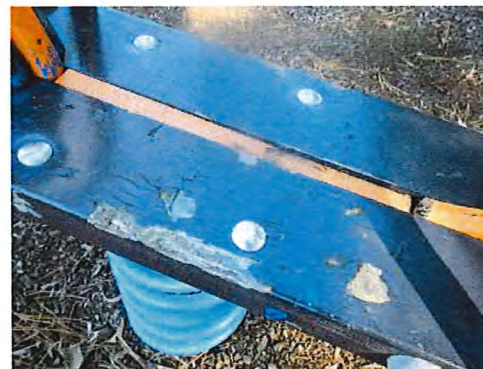
Asset_ID	Component	Count	Materials	Date Installed	Est.	Condition	Rocker Type	Removed/Current
1	PLCO6958 Rocker (spring)	1	Plyboard (painted)	1/01/2004	<input checked="" type="checkbox"/>	3	Horse	Current
			Comments: Kompan Product 'Crazy Horse'. Coating is peeling, hand and footrests are chipped.

Photo taken: 23/05/2016 Peeling coating, monitor.

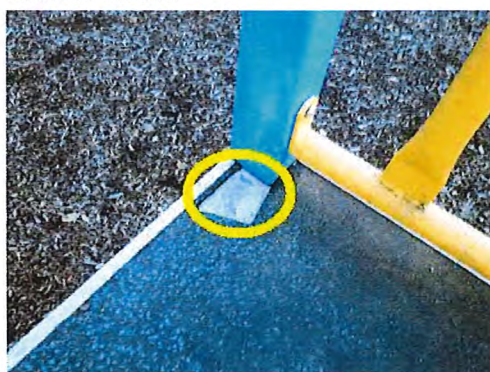
Photo taken: 13/05/2010 Coating cut off deck. Monitor.

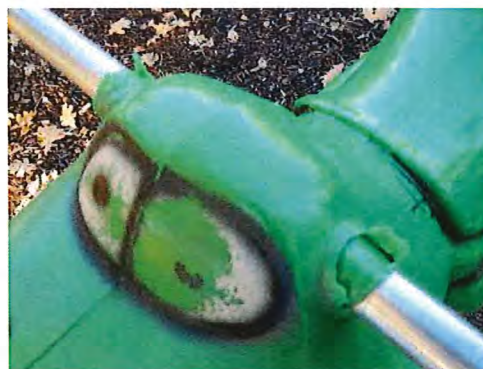
Photo taken: 25/05/2017 Plastic peeling with sharp edges. Monitor.

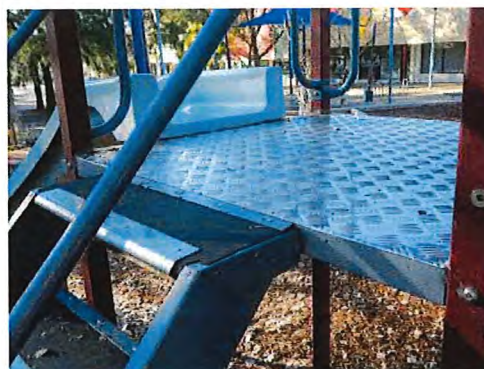
Photo taken: 25/05/2017 Slide deck covered with aluminium sheeting.

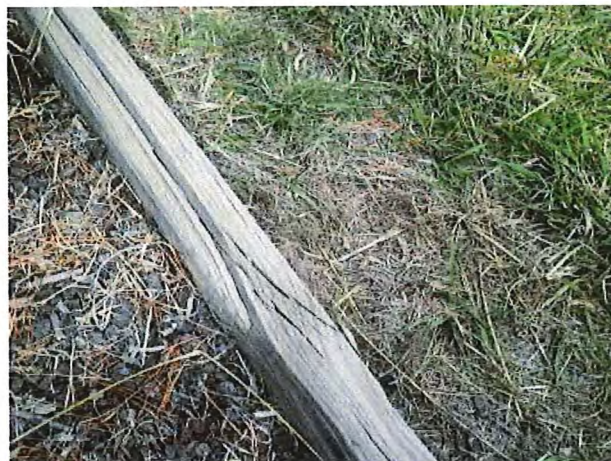
Photo taken: 03/05/2011 Some sections of timber edging exhibit splitting. Monitor.

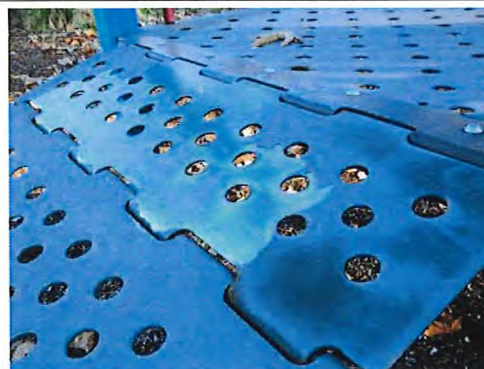
Photo taken: 25/05/2017 Clatter bridge coating peeling, monitor.

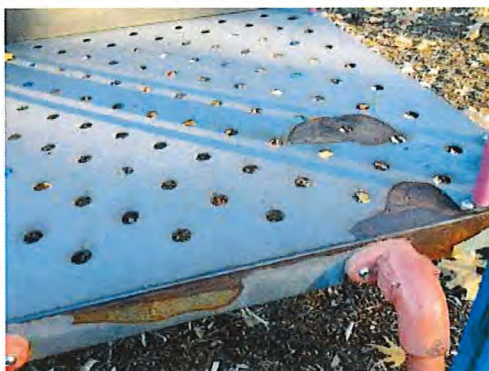
Photo taken: 25/05/2017 Deck coat peeling. Monitor.

8. Is the protective paint or coating (where req.) in good cond.? (NA for trtd timber or stainless / galv steel)	<input checked="" type="checkbox"/> N
9. Are all ends of steel sections capped?	<input checked="" type="checkbox"/> Y
