FOI reference: 21-119

Marconi Crescent, Summerland Circuit, Livingston Avenue Safe Systems Infrastructure Assessment – Design Option

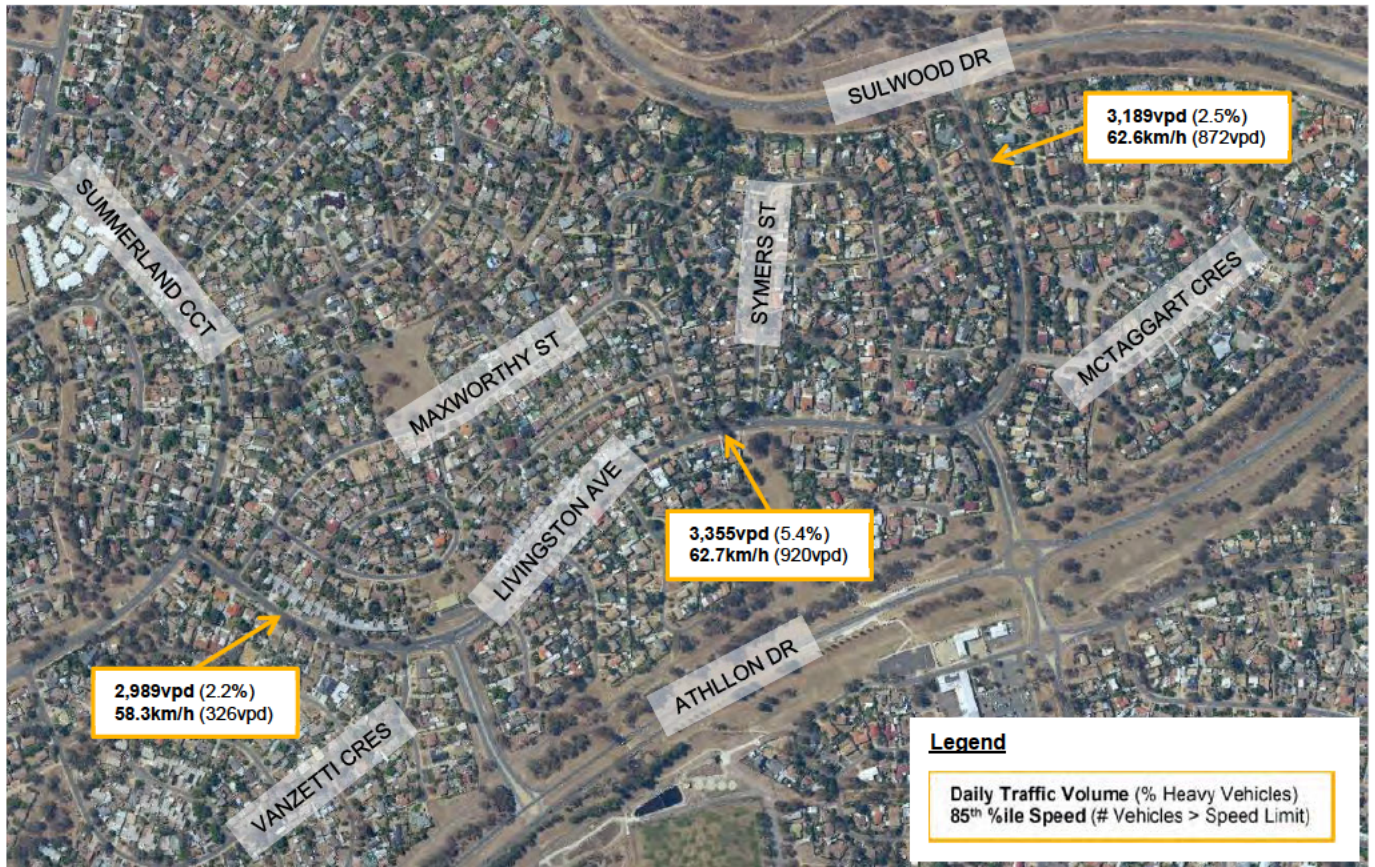
Automatic Traffic Counts undertaken in May 2018 identified the traffic demands and speeds at three (3) locations along Livingston Avenue. Figure 2 below presents a summary of the key traffic statistics at the three (3) survey locations. Further details of the traffic data are presented as an attachment to this document.

Figure 2 Traffic Data – Livingston Avenue

These surveys found that Livingston Avenue carried approximately 3,000-3,400 vehicles per day, including up to 5.4% heavy vehicles. These daily traffic demands and heavy vehicle percentages are considered to be appropriate. Furthermore, it was found that the 85th percentile speed of traffic on Livingston Avenue varied between 58.3km/h and 62.7km/h, with up to 920 vehicles per day exceeding the posted 60km/h speed limit. The 85th percentile speed itself, while greater than the posted speed limit at two (2) locations) is not considered to be problematic in itself. However, the number of vehicles observed to be exceeding the speed limit along Livingston Avenue does indicate the presence of a traffic speed issue.

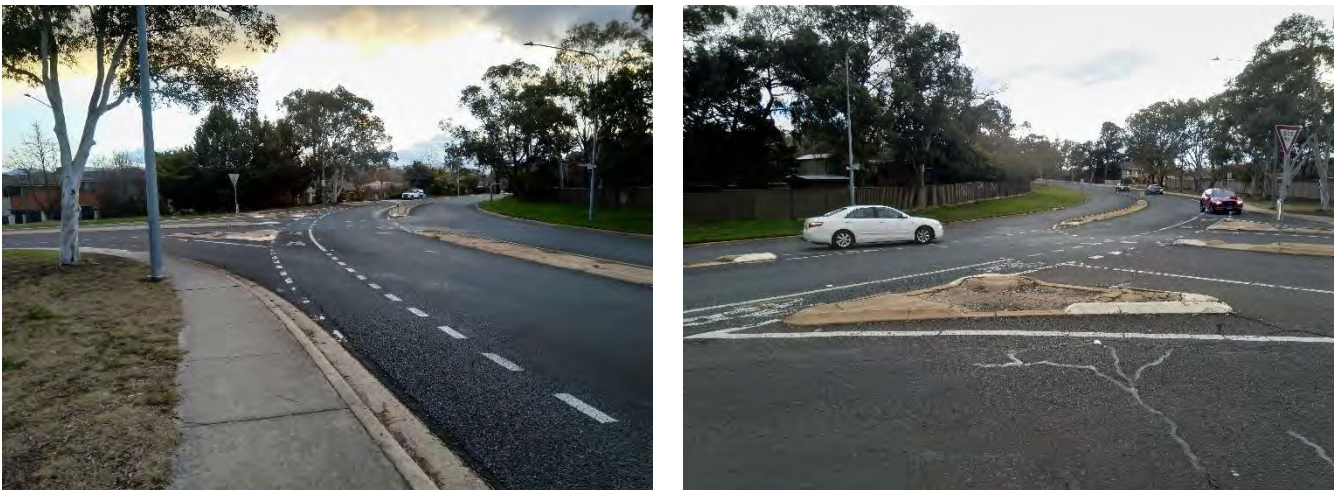
During the site visit, confusion over which movements have priority (particularly between the left- and right-turns into Atkin Street) were observed. This is exacerbated by high vehicle speeds through the intersection due to the wide approaches and large radius turns via the left-turn slip-lanes on the south and east approaches (Atkin Street and Livingston Avenue, respectively).

Furthermore, the poor condition of the pedestrian paths and long crossing distances at the intersection were noted. Both of these factors, along with the high vehicle speeds through the intersection, contribute to create poor pedestrian amenity and safety at the intersection.

Figure 4 Atkin Street / Livingston Avenue Intersection

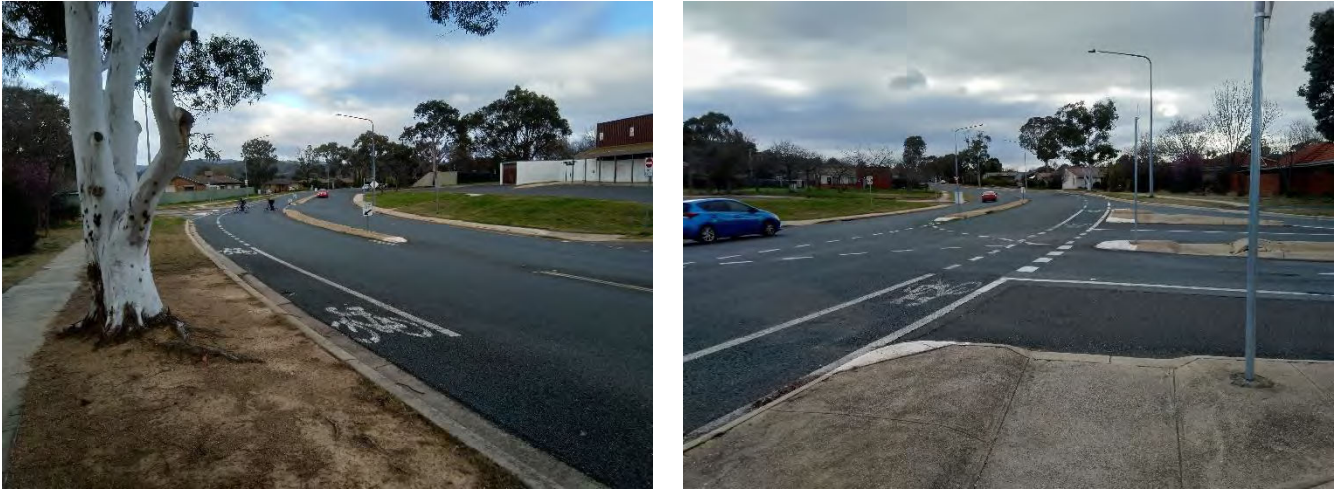
During the site visit, a near-miss was observed between a child, cycling to school, crossing the road from north to south and a vehicle travelling through the intersection from west to east. While the child failed to look for traffic before beginning to cross the road, the speed of the vehicle through the intersection is expected to have been significantly in excess of the safe system speed for pedestrian and cyclist crashes and on this basis would be expected to have a high likelihood of resulting in serious injury or death. In addition to high vehicle speeds through the intersection, the poor-quality pedestrian facilities and long crossing distances at the intersection, both contributed to the conflict.

Figure 5 Livingston Avenue / Vosper Street Intersection

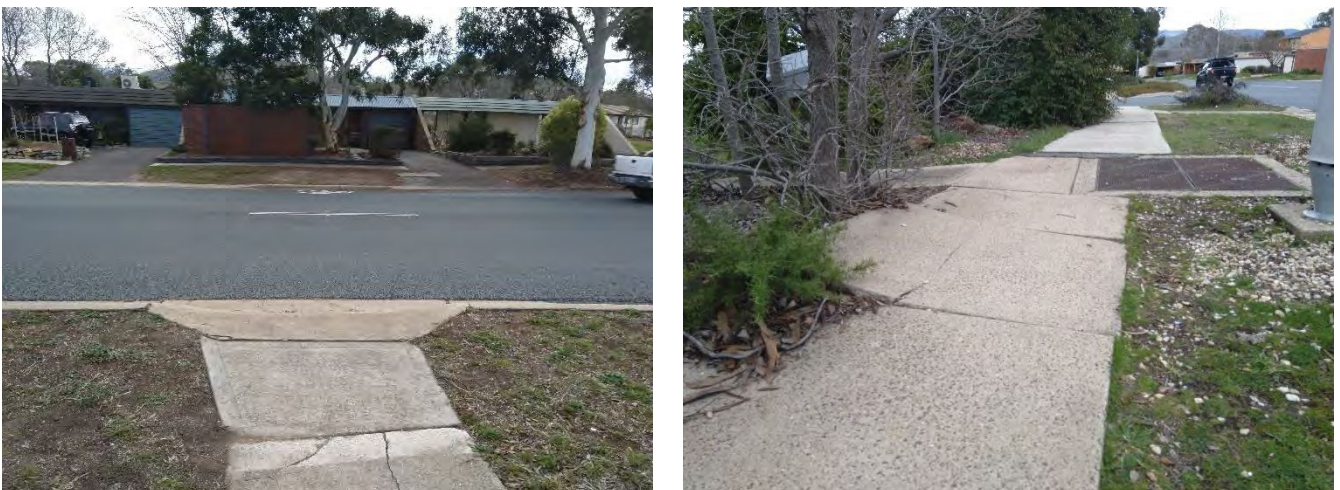
Along the length of Livingston Avenue, the poor condition of pedestrian facilities was noted. This included missing links, uneven pedestrian paths, paths blocked by vehicles and vegetation, misaligned kerb ramps, and paths located at the back of kerb, close to high speed traffic.

Missing links and uneven pedestrian paths present trip hazards, particularly for less mobile members of the community. As such, they reflect poor pedestrian amenity and discourage the community from making short trips on-foot.

Misaligned kerb ramps are particularly hazardous for members of the community with low vision, as well as those travelling with wheeled devices including bicycles, prams and wheelchairs, as they are directed into the centre of the intersection, rather than directly towards the complimentary kerb ramp.

Similarly, pedestrian paths located at the back of kerb result in poor pedestrian amenity due to their close proximity to vehicular traffic. This can also be hazardous, due to the limited separation between vehicles and pedestrians.

Figure 6 Pedestrian Paths and Kerb Ramps – Livingston Avenue

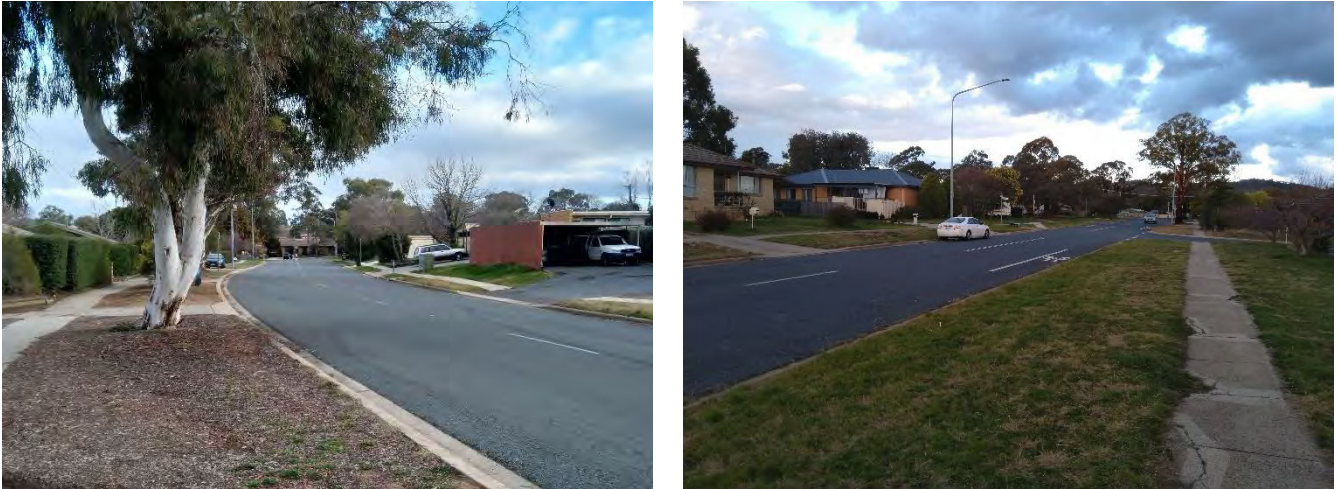
The traffic data collected in May 2018 identified a high number of vehicles exceeding the speed limit as an issue. The width of the carriageway, particularly with the lack of on-street parking observed, was considered to be a key contributor to this issue. By providing traffic lanes of effectively 5.0m width in each direction, the road environment gives drivers the impression that their path is clear of conflicts, encouraging high vehicle speeds across a large proportion of drivers.

Figure 7 Carriageway Width

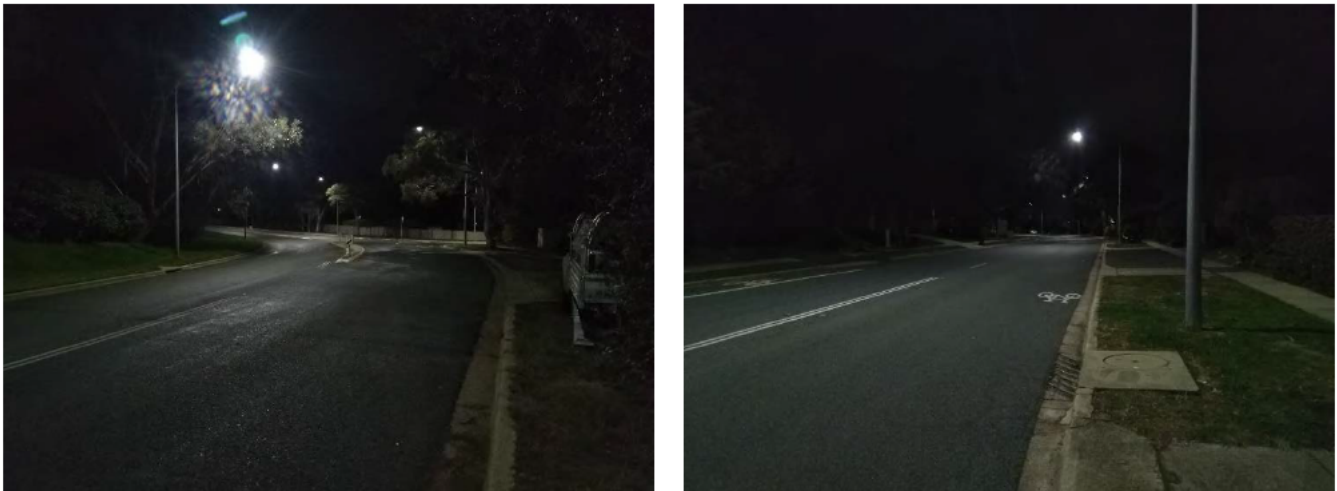
LED street lighting was observed to provide suitable lighting conditions, at night, along the length of Livingston Avenue.

Figure 9 Street Lighting Conditions – Livingston Avenue

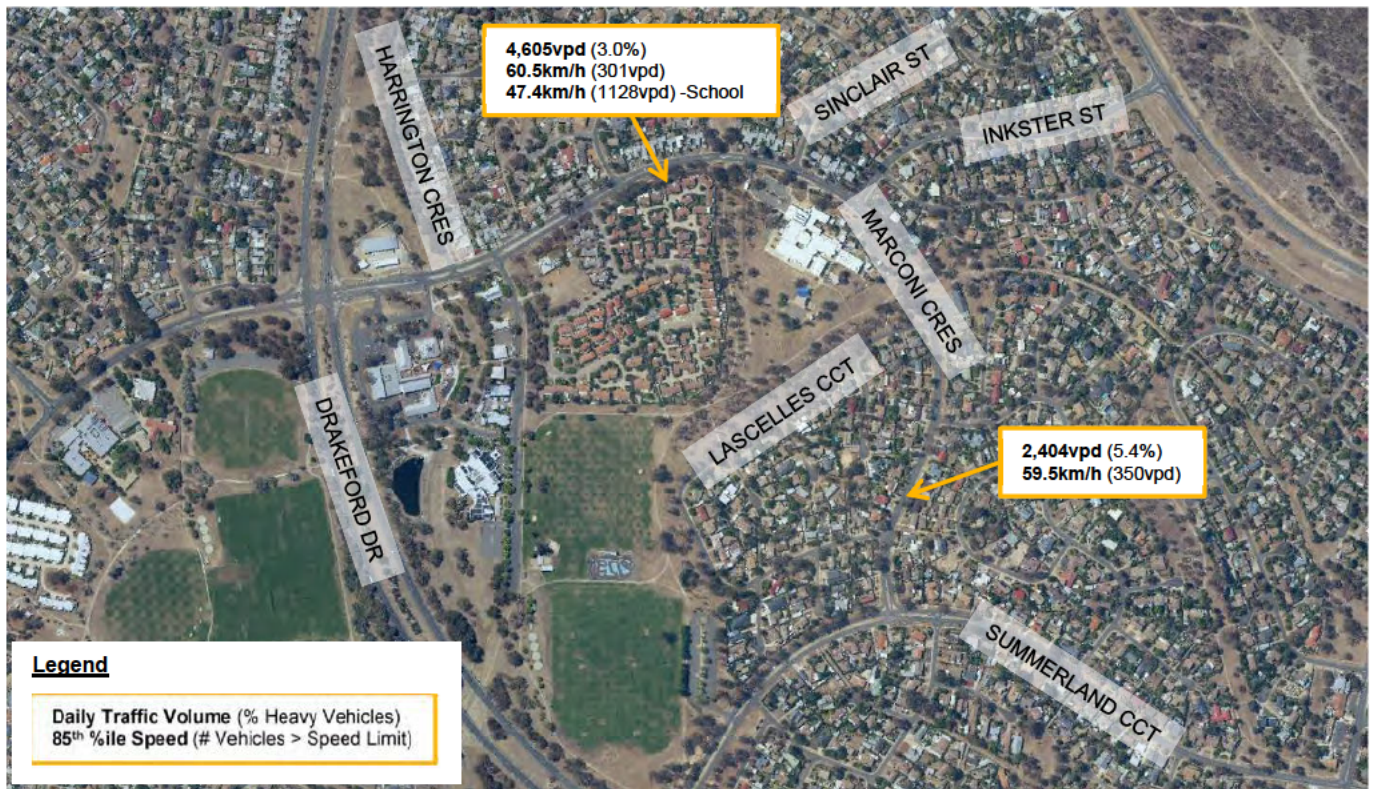
Automatic Traffic Counts undertaken in August 2015 and May 2018 identified the traffic demands and speeds at two (2) locations along Marconi Crescent. Figure 10 below presents a summary of the key traffic statistics at the two (2) survey locations. Further details of the traffic data are presented as an attachment to this document.

Figure 10 Traffic Data – Marconi Crescent

These surveys found that Marconi Crescent carried approximately 4,600 vehicles per day to the west of Taylor Primary School, and approximately 2,400 vehicles per day to the east. This included up to 5.4% heavy vehicles. These daily traffic demands and heavy vehicle percentages are considered to be appropriate. Furthermore, it was found that the 85th percentile speed of traffic on Marconi Crescent varied between 59.5km/h and 60.5km/h outside of school zone hours, with up to 350 vehicles per day exceeding the applicable speed limit. During school hours, the 85th percentile speed was found to be 47.4km/h, significantly exceeding the applicable 40km/h speed limit. This is further reflected in the total of 1128 vehicles observed to be exceeding the speed limit. This indicates the presence of a traffic speed issue during school hours.

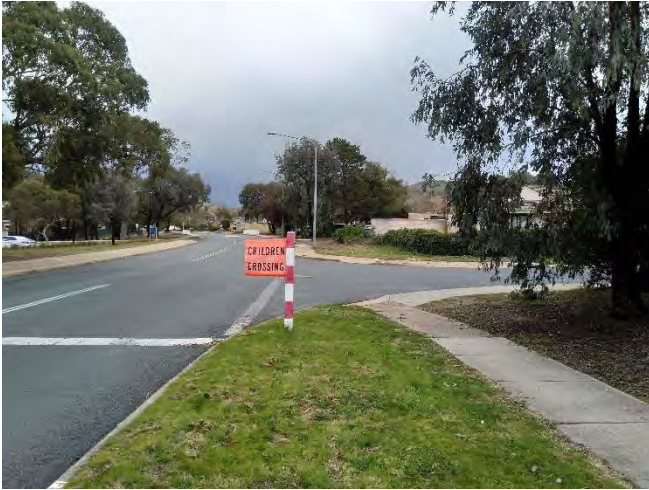
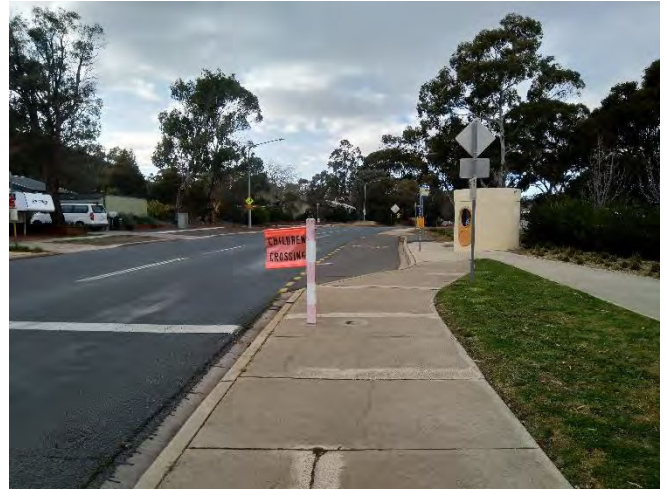
TCCS have advised that concerns have been raised by the community in relation to poor driver compliance with the children's crossing adjacent to Taylor Primary School. This poor compliance was observed during the site visits with numerous drivers (from both directions) failing to stop for children (without adults) waiting to cross the road. This occurred within approximately 20m of the mobile speed camera. Furthermore, it was noted that when drivers did stop for pedestrians, the pedestrians appeared uncomfortable when crossing the road (i.e. rushed / jogged across the road, waved apologetically to the drivers).

As demonstrated by the photographs at Figure 13 below, sight distance at the crossing is unimpeded. While it was noted that buses in the indented bus bay (westbound) did limit sight distance to the east of the crossing, this was not considered to be a significant issue, given the infrequency of bus services (30 minute headways) and the remaining available sight distance.

Figure 13 Marconi Crescent Children's Crossing

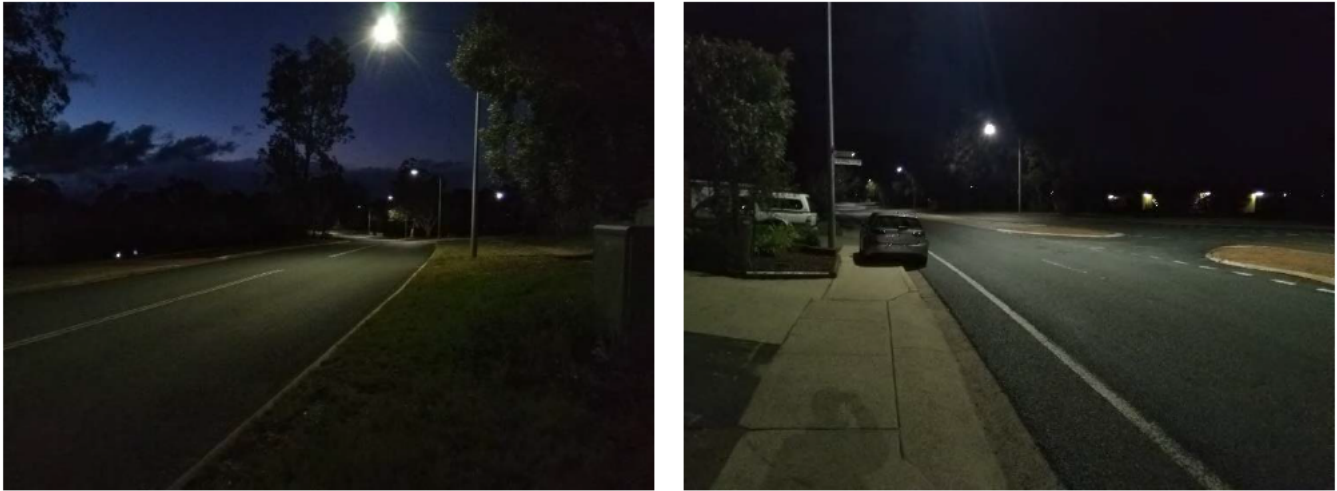
LED street lighting was observed to provide suitable lighting conditions, at night, along the length of Marconi Crescent.

Figure 15 Street Lighting Conditions – Marconi Crescent

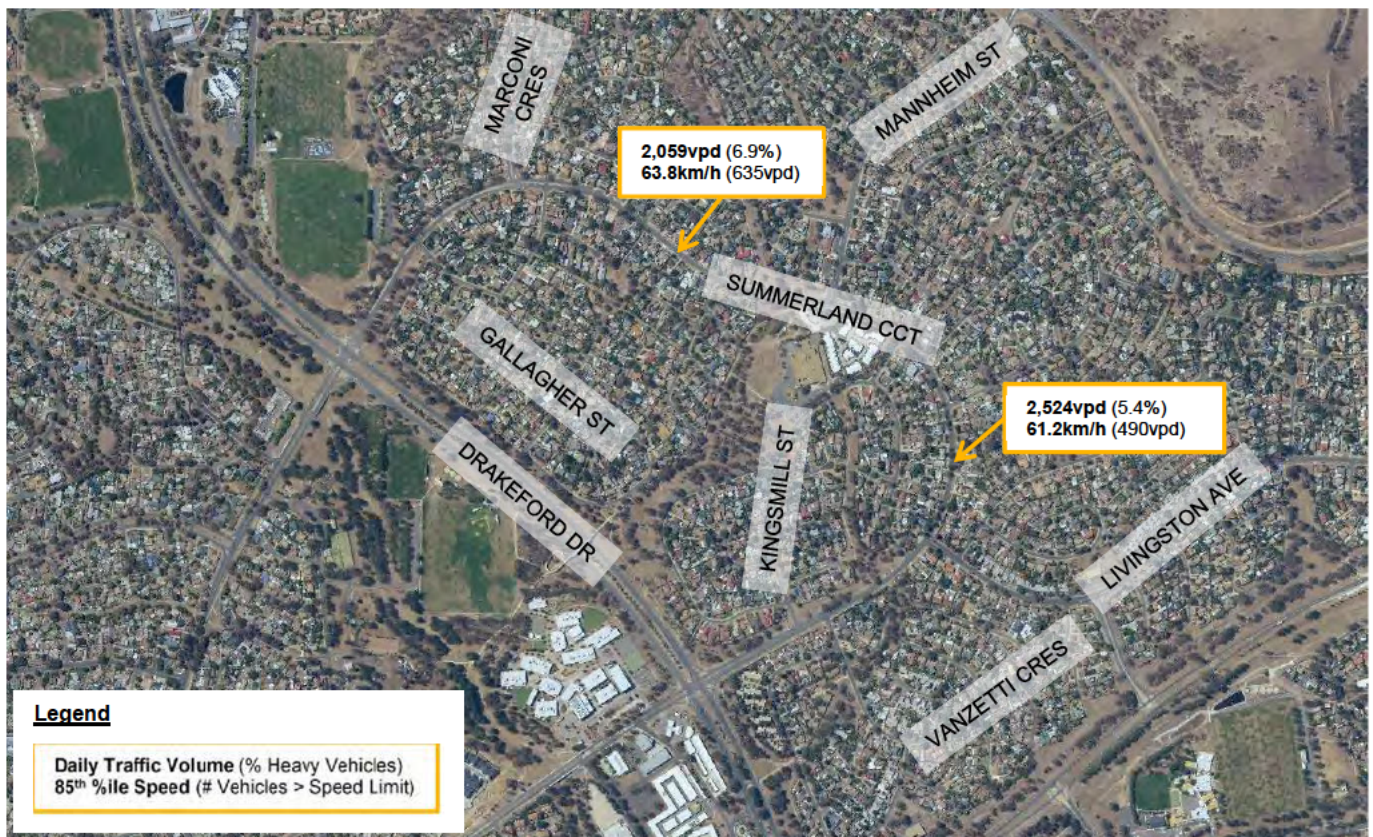
Automatic Traffic Counts undertaken in August 2017 identified the traffic demands and speeds at two (2) locations along Summerland Circuit. Figure 16 below presents a summary of the key traffic statistics at the two (2) survey locations. Further details of the traffic data are presented as an attachment to this document.

Figure 16 Traffic Data – Summerland Circuit

These surveys found that Summerland Circuit carried approximately 2,100-2,500 vehicles per day, including up to 6.9% heavy vehicles. These daily traffic demands, and heavy vehicle percentages are considered to be appropriate, however, the heavy vehicle percentages are noted to be approaching the upper limit for a residential area. It was noted that aerial images from 2017 (the year of the survey) show construction work was still occurring around the childcare centre, which may have increased the heavy vehicle percentage in the surveys. This isn't known for certain as the exact date of construction works is unknown.

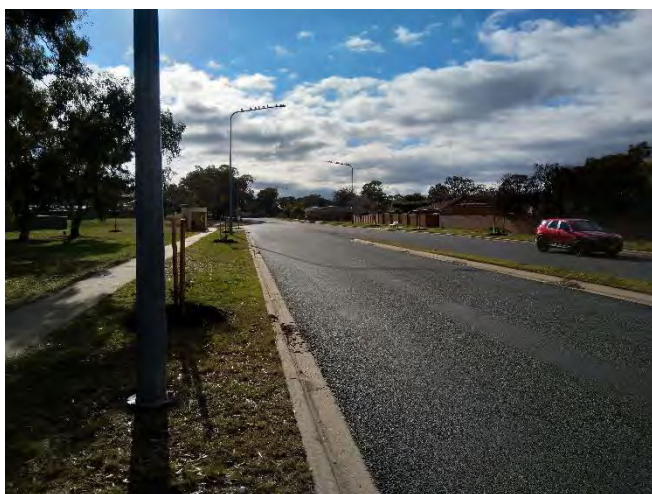
During the site visits vehicles were observed travelling two (2) abreast beyond the Kingsmill Street and Vanzetti Crescent intersections. This is likely due to the lack of signage and linemarking delineating the merge and carriageway width which varies from approximately 17m at the end of the median to approximately 13.5m at Vanzetti Crescent.

Figure 18 Unclear Lane Arrangement

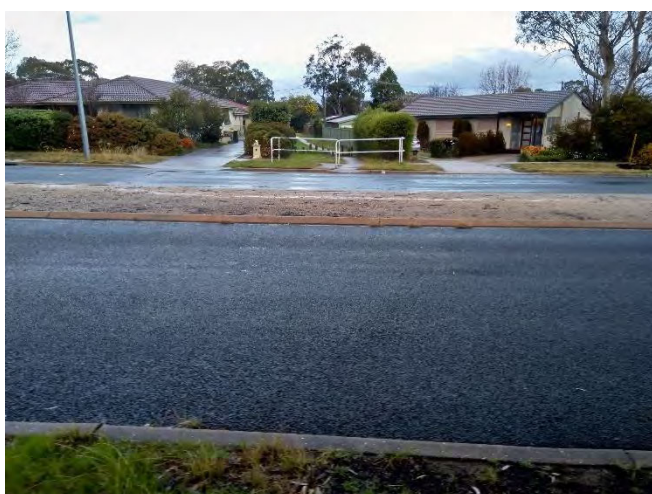
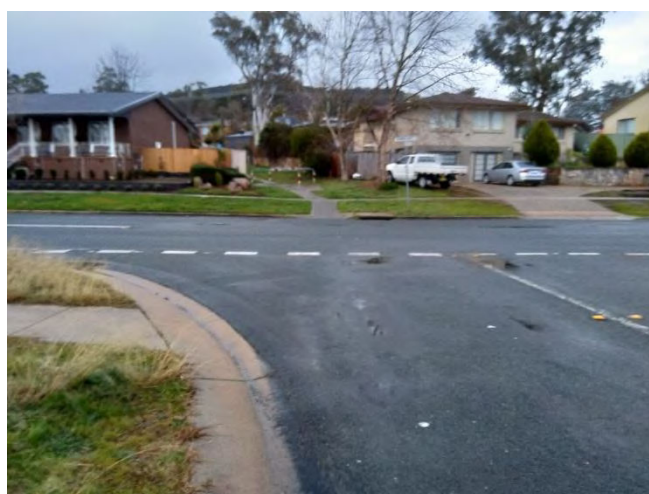
Along the length of Summerland Circuit, the poor condition of pedestrian facilities was noted. This included discontinuous and uneven pedestrian paths, paths blocked by vehicles and vegetation and misaligned kerb ramps.

Figure 19 Pedestrian Paths and Kerb Ramps – Summerland Circuit

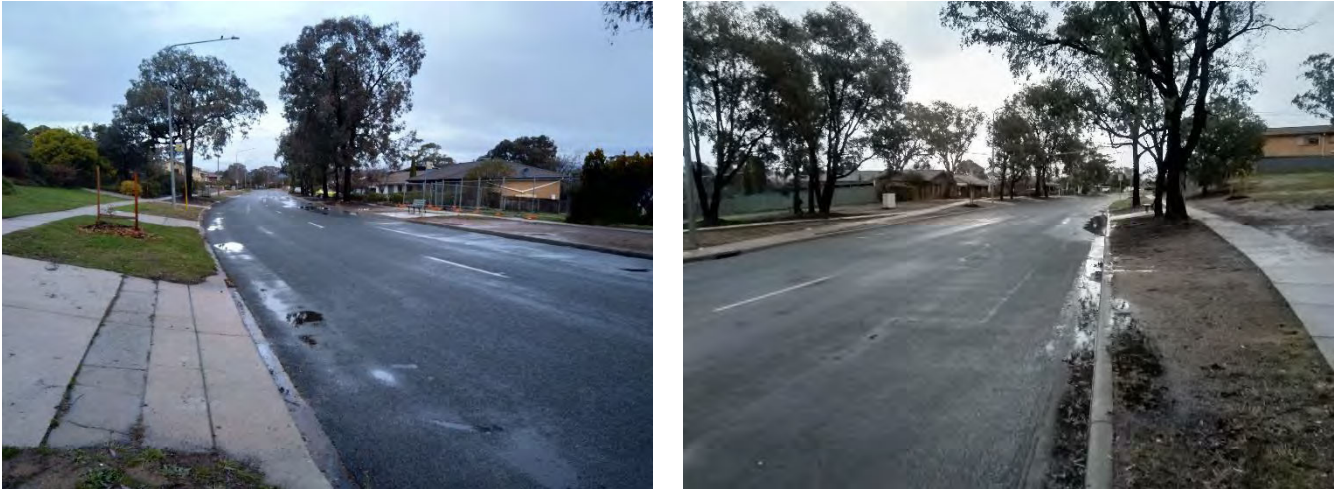
Water ponding on the roadway was observed at two (2) locations along Summerland Circuit during the evening peak hour during the Wednesday site visit. The westbound traffic lane, just west of Hutchison Crescent and the eastbound traffic lane at the Summerland Circuit before Mannheim Street bus stop, where both observed to have significant ponded water. In both of these locations, vehicles were observed using the opposing traffic lane to avoid the surface water.

Figure 20 Water Ponding on Roadway

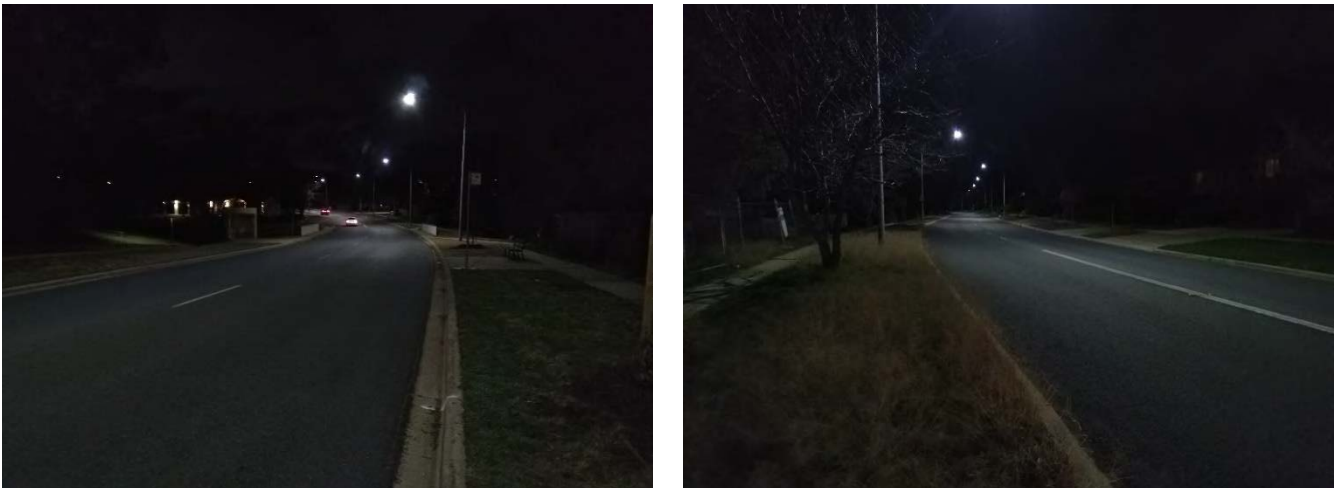
LED street lighting was observed to provide suitable lighting conditions, at night, along the length of Summerland Circuit.

Figure 21 Street Lighting Conditions – Summerland Circuit
