local shopping centre upgrade program 2016-17

forward design report

15 December 2017

duffy shops

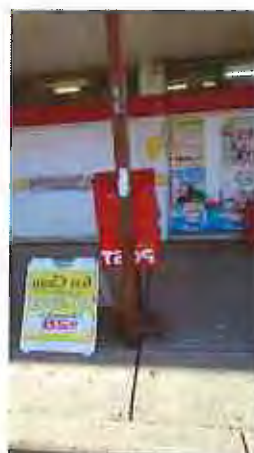
PO Box no accessible

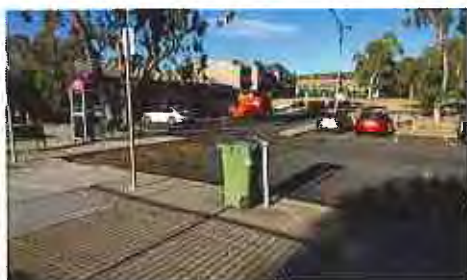
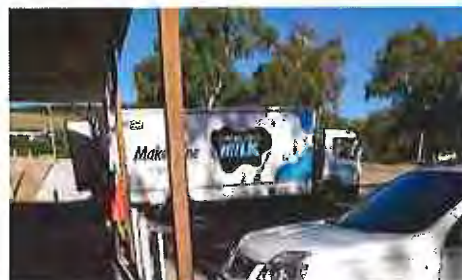
Unofficial delivery location at front of shops Compliant disabled Car Park

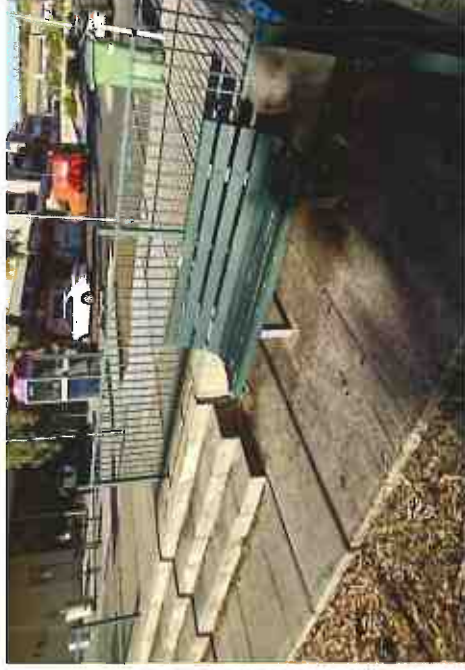
Non-compliant stairs

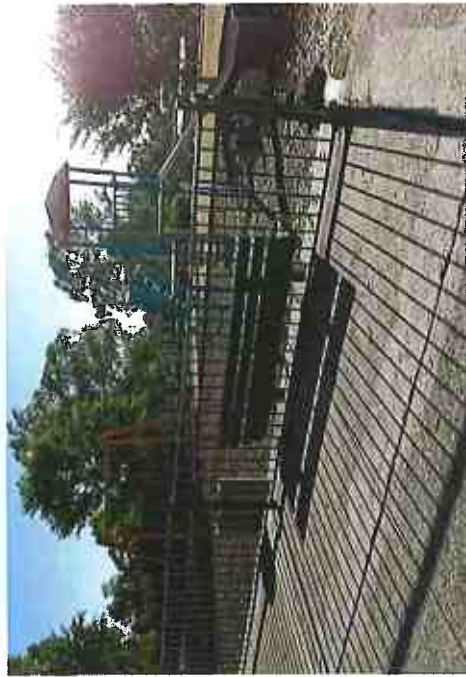
1 Public playground

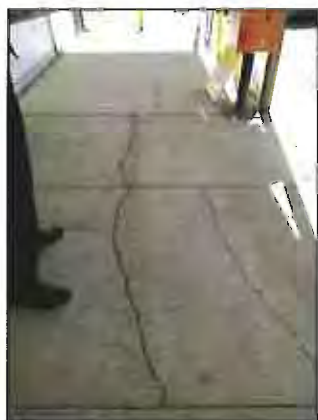
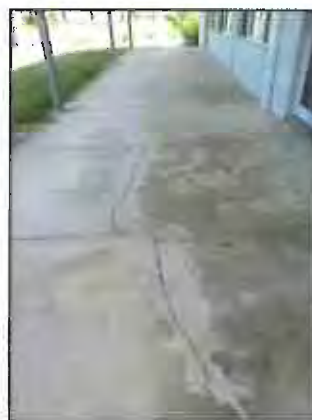
Figure 4

The condition of the footpaths is in variable condition. Many cracks exist in the paving posing trip hazards, as noted in Appendix 1 and 3. Parts have been ground back to reduce this hazard.

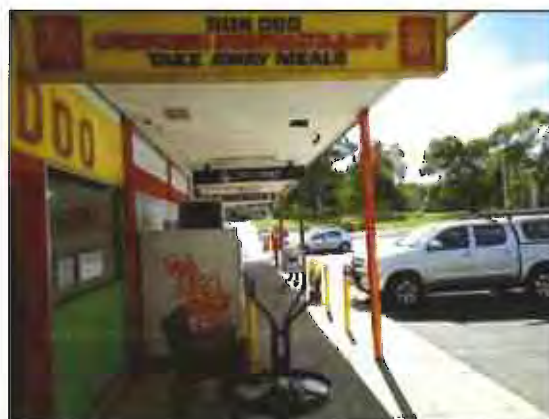
Figure 6

There are a few obstructions in the access way against the shops building/property line such as chairs, tables, signs, and an ice machine.

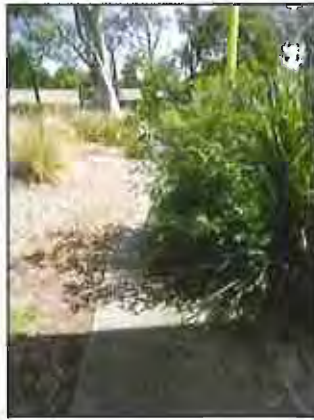
Figure 8

The footpath on the South Eastern corner next to the service yard has shrubs growing over the access way.

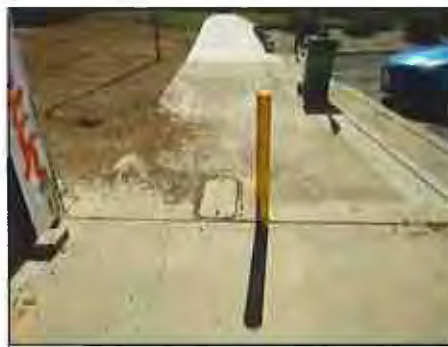
Figure 10

The footpath at the Western end of the shops has gravel on the path posing trip/slip hazard.

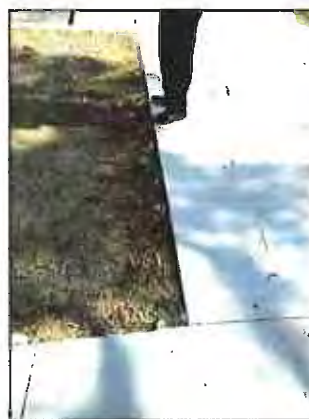
Figure 11

The footpath on the North Eastern side of the car park on Glenmaggie Street drops off at the edge without a barrier.

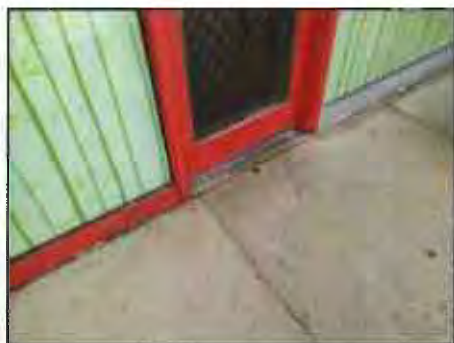
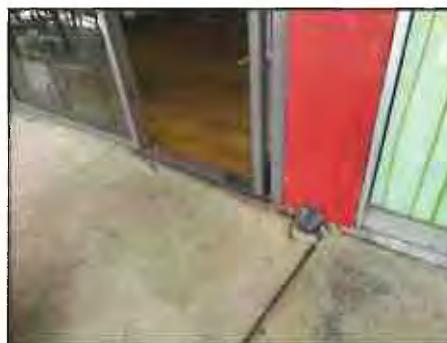
Figure 12

Most shops have a small step for access but are reasonable.

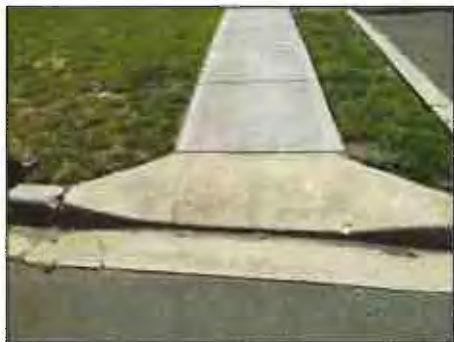
Figure 14

Several kerb ramps are poorly aligned.

The kerb ramps entering Duffy Place on the Northern side do not have landings and one in Burrinjuck Crescent has a small landing.

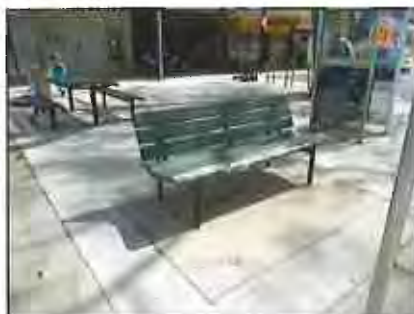
Figure 16

Seats are provided with backrests and no arms.

Table and seats provided are metal which will get hot if exposed to the sun.

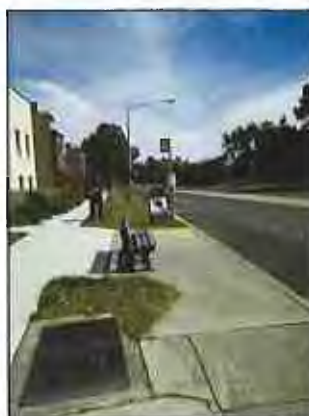
Figure 17

There is one bus stop on Burrinjuck Street with a seat that has a backrest and armrests. The TGSI at the bus stop is not compliant with current standards.

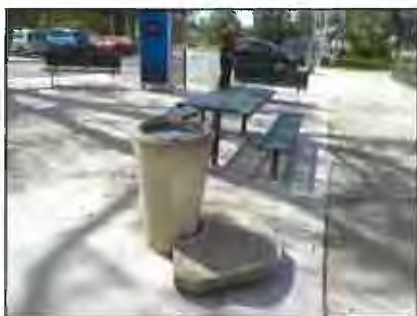
Figure 18

The drinking fountain is not accessible, but is 900mm high.

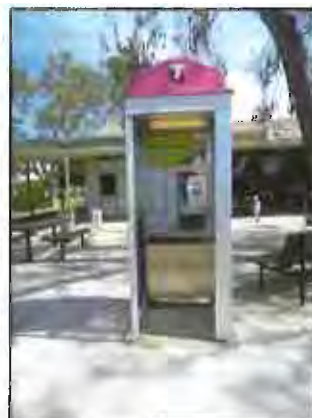
Figure 19

The telephone and PO Box are too high and are not accessible.

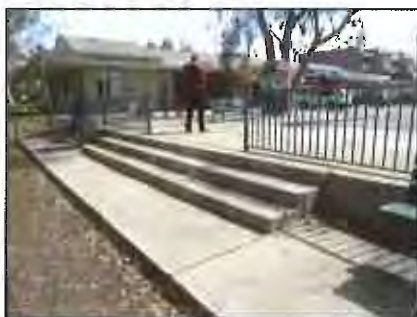
Figure 20

The stairs to the playground have no handrails, no contrast nosing and no TGSi.
