BRITTEN JONES DRIVE

Playground Inventory Report

Playground ID: PLGR121

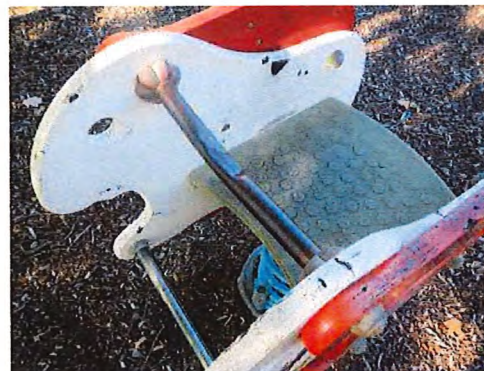
Photo taken: 23/05/2016 Bent hand support, monitor.

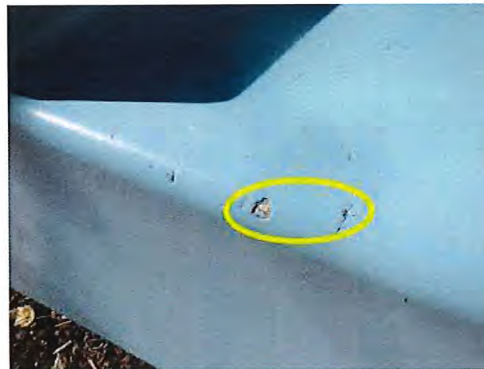
Photo taken: 23/05/2016 Small chips in slide, monitor.

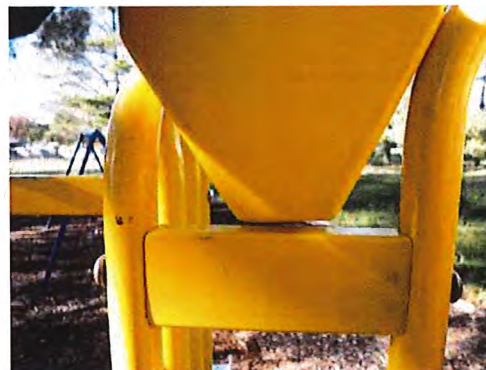
Photo taken: 13/05/2010 Neck probe just not touching the bottom

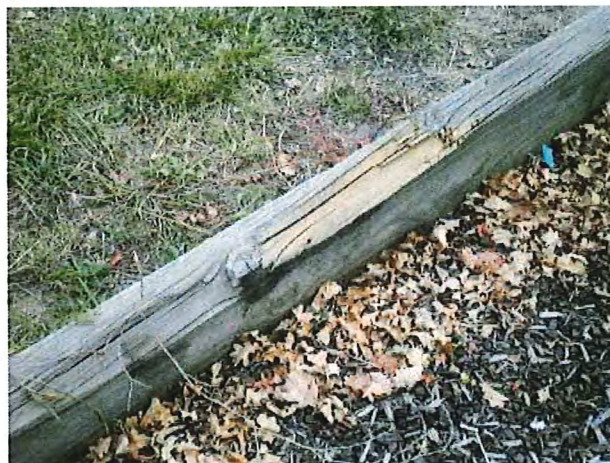
Photo taken: 03/05/2011 Some sections of timber edging are splitting. Monitor.

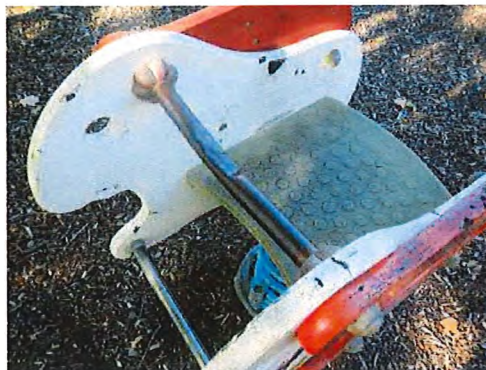
Photo taken: 23/05/2016 Bent hand support, monitor.

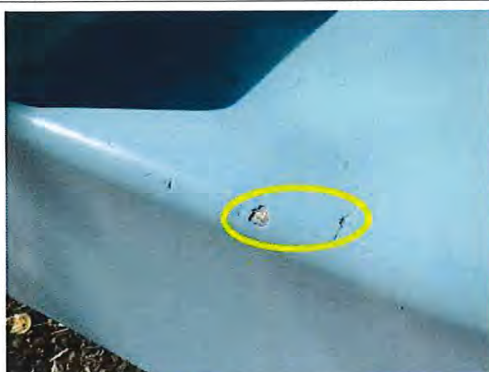
Photo taken: 23/05/2016 Small chips in slide, monitor.

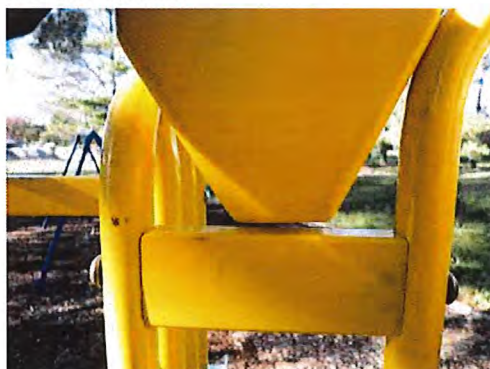
Photo taken: 13/05/2010 Neck probe just not touching the bottom

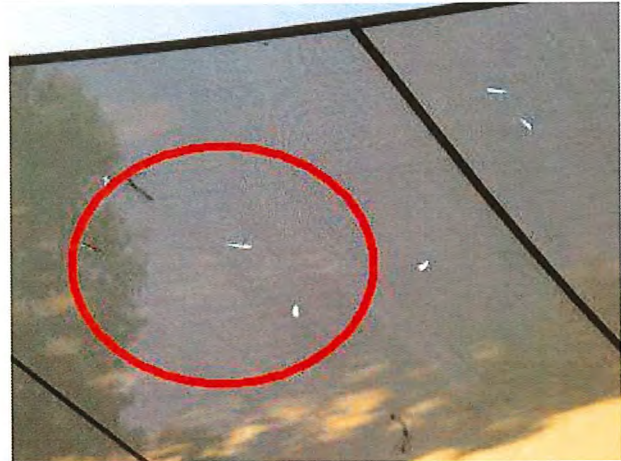
Photo taken: 18/04/2018 Holes in shade cloth. Monitor.
